MIDDLESEX RESERVOIR DAM

PHASE I INSPECTION REPORT

NATIONAL DAM SAFETY PROGRAM

NJ 00377

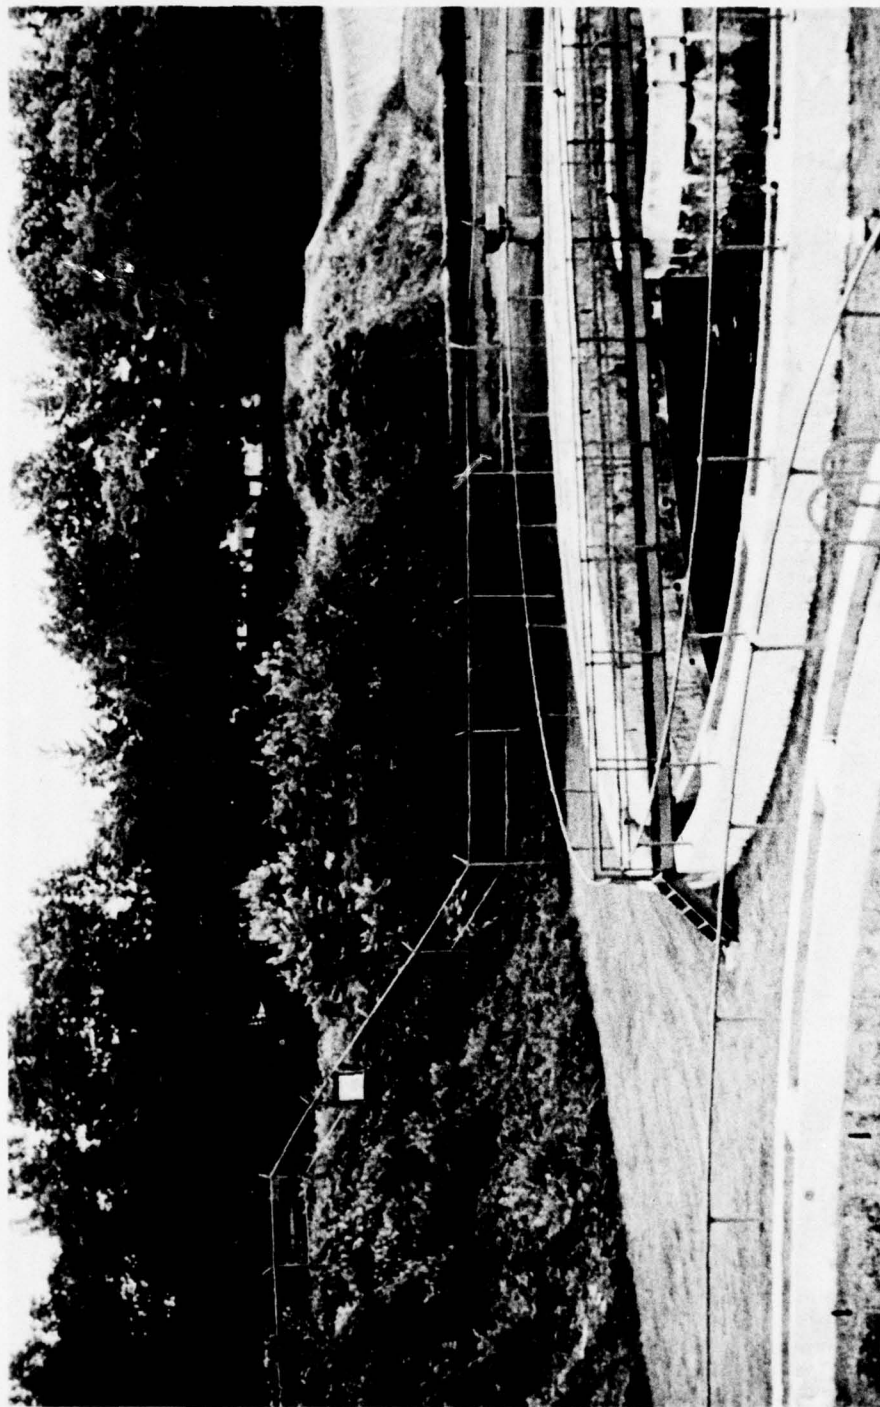
OVERALL VIEW OF DAM

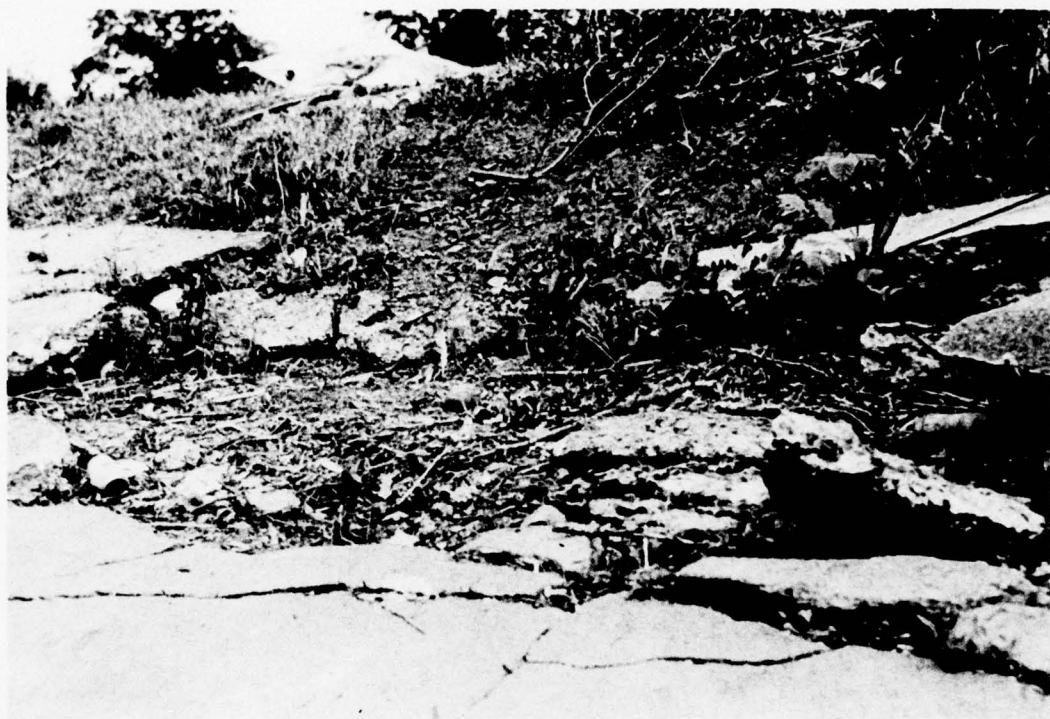
PHOTO 9

Disintegration and settlement of the concrete slope protection is especially severe 50 feet from the spillway, as shown in Photo 9. Near the right abutment a groundhog burrow was observed that extended under the concrete pavement. Numerous small trees and brush are present on the embankment crest and slopes.

(5) The badly deteriorated and failed slope paving on the embankment upstream slope should be replaced or covered with rip-rap, or an alternate means of protection should be developed to protect the embankment slope. The corrective solution for this problem should be engineered.

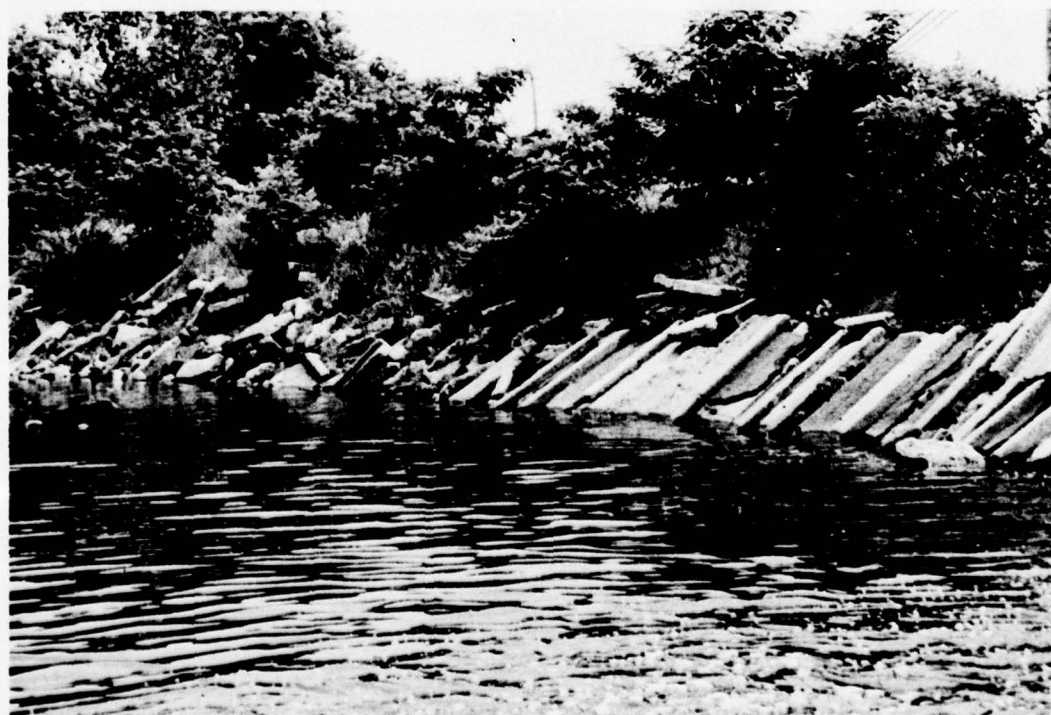
PHOTO 14

Photo 14 - Picture of Lower Portion of Outlet Channel With
Dumped Concrete Rubble Slope Protection) -
June 21, 1978.
