SUSQUEHANNA RIVER BASIN  
GRASSY ISLAND CREEK, LACKAWANNA COUNTY  
PENNSYLVANIA

OLYPHANT NO. 2 DAM  
NDS ID NO. 382  
PENNSYLVANIA GAS AND WATER COMPANY

PHASE I INSPECTION REPORT  
NATIONAL DAM INSPECTION PROGRAM

MAY 1978

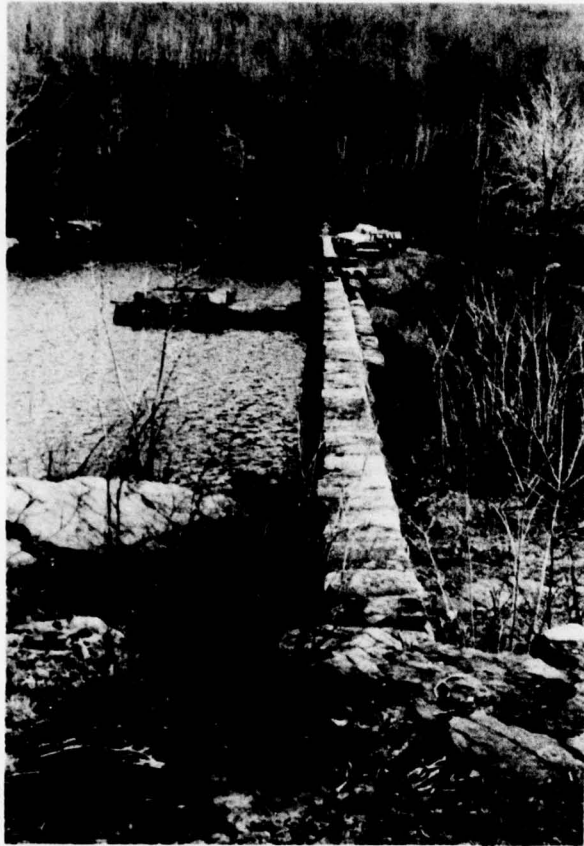
(1) The earthfill on the downstream side of the masonry gravity section was in fair condition. The entire slope was covered with tall brush and small trees (Photograph A). The Owner reported that brush was cut 2 years ago. There was sloughing on one area of the embankment (Photograph H), where there was no brush growing. This sloughed area, about 35 square feet, was at the top of the embankment immediately left of the left spillway wall. The soil in the sloughed area was slightly damper than the adjacent soil; it was not saturated. The earthfill immediately below the sloughed area was too irregular to ascertain if the soil from the sloughed area had been deposited there. The sloughed area is immediately adjacent to the junction of the masonry gravity structure and the left spillway wall. The mortar in the masonry joints at this junction was very deteriorated. Approximately one-half of the way down the earthfill to the left of the spillway, where the slope of the embankment is relatively flat, there were two distinct mounds of soil, each approximately 10 feet long by 6.5 feet wide by 1 foot high. These mounds were overgrown with brush. The earthfill behind the left spillway training wall had settled about 6 inches. There is a wet area (Photograph F) approximately 50 feet long by 16 feet wide, about 100 feet downstream of the spillway crest centerline offset 30 feet left. This wet area is about 50 feet downstream of the toe of earthfill to the left of the left training wall. When the inspector walked over this area, his boot sank about 3 inches. The area is in a 2-inch deep depression. The left training wall ends 20 feet upstream and about 12 feet right of the area. Below the downstream end of the left training wall, in the natural earth slope, clear water is seeping at a rate of about 0.25 gallon per minute. Many other areas of the slope are mossy and appear to have recently been wet. No defects were noted in the earthfill to the right of the spillway, except the extensive brush growth. The dry masonry retaining wall at the toe of this earthfill is overgrown in many areas. The earthfill on the upstream side of the masonry gravity structure was not observable as the reservoir was at spillway crest level. The mortar in almost all the exposed

A. View from Right Abutment

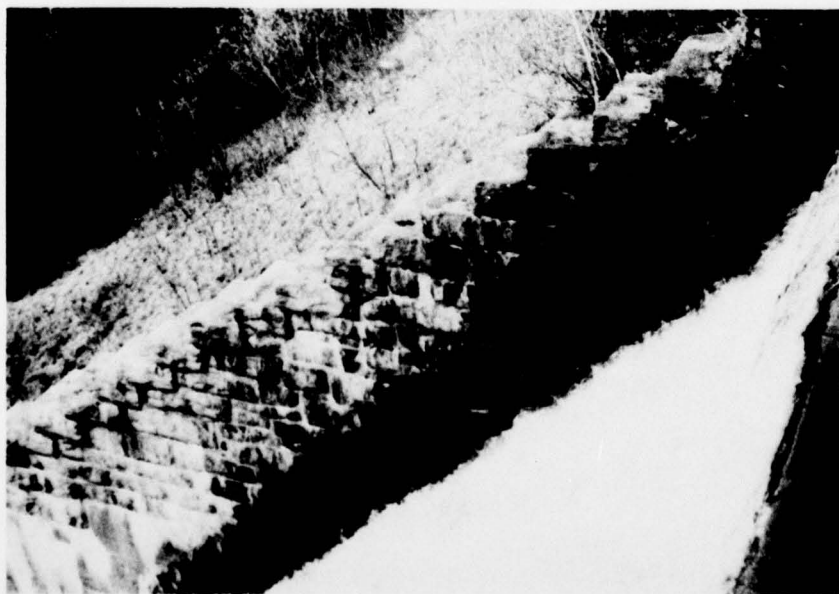
(3) The right training wall was in fair condition. The wall is constructed partially of concrete and partially of masonry. Some of the mortar in the masonry joints has deteriorated. At the area where the masonry section joins the concrete section, the concrete was spalling for about 1-inch depth over a 5-foot length. The concrete in this area had evidence of leaching, as white deposits or efflorescence was observed. Each of the three concrete monoliths downstream of this area had a horizontal crack about 1 foot from the top of wall and 1/16-inch wide, extending over its entire length. The last monolith of this wall was of rubble masonry construction. This monolith extends past the spillway apron. The mortar in the joints of this monolith was in very poor condition. There was evidence of this monolith having been overtopped previously, as the brush behind the wall was bent away from the wall, and stones and other debris were evident.

- (3) The right training wall was showing evidence of deterioration. Lack of maintenance may increase the deterioration and thereby threaten the stability of the wall. Continued overtopping of the wall at the downstream end could threaten the toe of the earthfill. The horizontal cracks in the concrete monoliths are of unknown origin and of slight concern at the present.

B. Right Spillway Wall  
D-1

(5) Repair deteriorating concrete on the spillway walls.

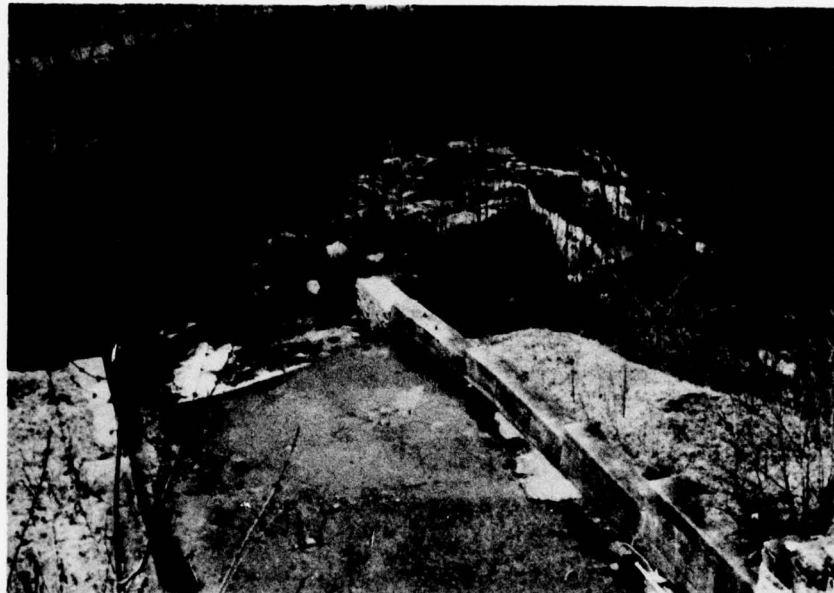
(2) The concrete apron below the spillway (Photograph C) was in poor condition. Much of the concrete had deteriorated to the point where the foundation material, a coarse gravel, was visible. The apron is unevenly bulged over its entire length. There appeared to be seepage from the junction of the apron and the left training wall. Since water was flowing over the apron, a definite conclusion as to the seepage could not be reached. The concrete at the downstream end of the apron, where it meets the natural rock ledge, was completely eroded. Apparently, this junction was originally constructed of rubble blocks covered with concrete. Only the rubble is remaining.

- (1) No conditions were observed on the spillway which might present a significant hazard to the dam.
- (2) The concrete apron was almost completely deteriorated. It may not protect the toe of the spillway or training walls from erosion during high spillway discharges.

C. Spillway Apron and Downstream Channel

(3) Perform investigations and studies to more accurately ascertain structural deficiencies in the spillway apron, left spillway training wall and the sloughed area of the earthfill, as well as the nature and extent of mitigation measures required to make these features structurally adequate. The investigations and studies should also address the structural adequacy of the masonry gravity section and downstream earthfill for all operating conditions.

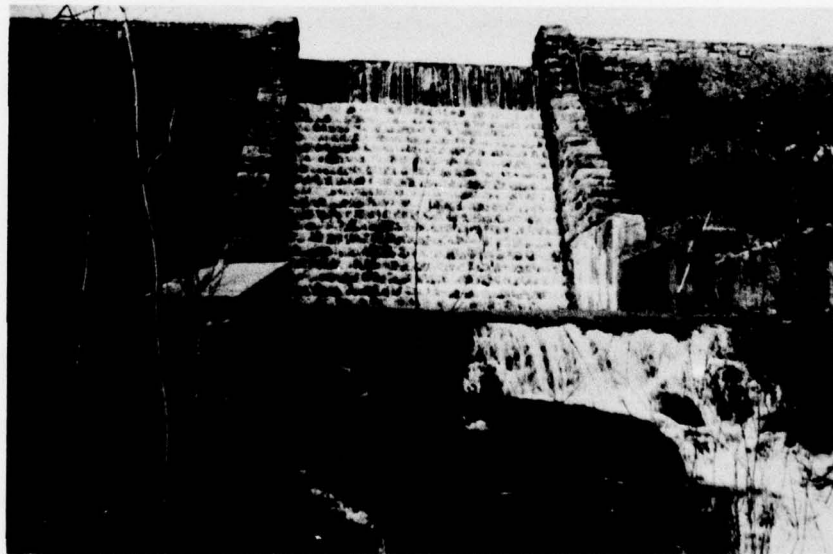
(1) The main spillway (Photograph D) had no observable defects. Water was flowing over the spillway and, therefore, a detailed inspection was not possible.

D. Spillway and Spillway Apron

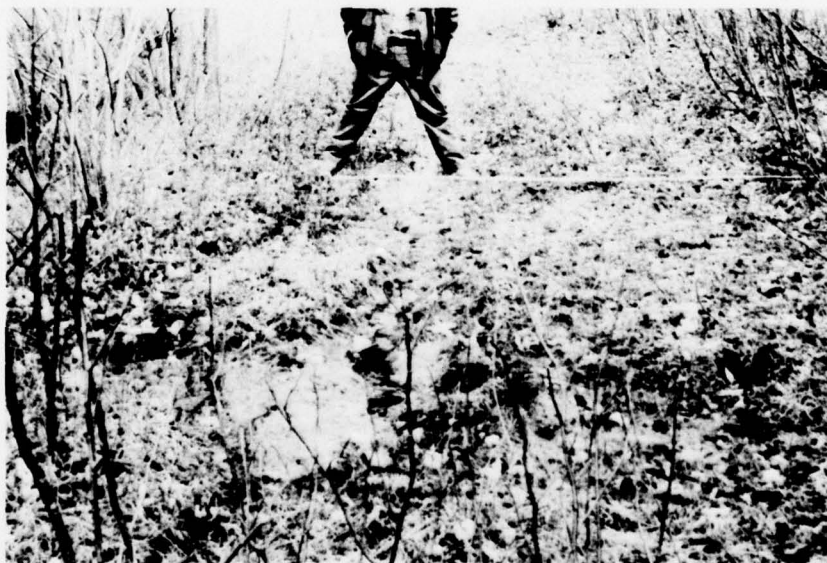
F. Wet Area at Left of Spillway Apron

(2) Provide six observation wells or other instrumentation in the earthfill slopes, three on each side of the spillway. Also, one observation well or other instrumentation should be placed in the vicinity of the wet area. Instruments should be read periodically and any rises in water level should be analyzed to determine the effect on the stability of the earth slopes and earth masonry dam. Monitor wet and seepage areas and if conditions worsen, take necessary action.

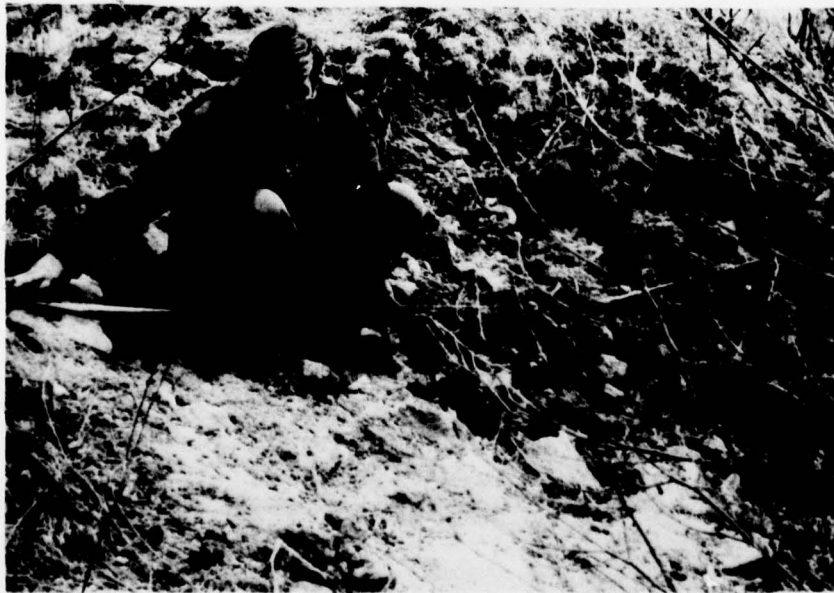
a. Dam. The continued growth of brush on the earthfill is undesirable. The sloughed area could indicate serious embankment problems. A review of available photographs in the files of the Pennsylvania Office of Dams and Encroachments indicates that this area of earthfill apparently had problems previously. The recommendation of the 1914 Pennsylvania Water Supply Commission report on this dam was to raise the spillway training walls to prevent splashing water from eroding the earthfill. Although this recommendation was implemented in the early 1920's,

an inspection by the Pennsylvania Water Supply Commission in 1945 noted that splashing water from the spillway had eroded some of the earthfill at approximately the same location as the present sloughing. There is also a possibility that seepage through the masonry joints in this area, during periods of high pool, could collect sufficiently to erode the area. It is also a possibility that the earthfill in this area is not stable. The sloughed area is of general concern. No special significance could be attached to the two lumps. They could be remnants of construction operations or evidence of past instability. As the lumps are covered with brush, they are apparently not indicators of an active condition. The wet area and seepage at the toe of the earthfill to the left of the spillway were noted on various Pennsylvania Water Supply Commission inspection reports. The wet area was noted in the inspections of 1928, 1933, 1941, 1945 and 1953. It was not noted in inspections before 1928 nor in the inspections of 1930, 1934, 1957 and 1965. The seepage was noted only in the 1933, 1941, 1945 and 1953 inspections. The descriptions in these inspections are insufficient to determine if the areas under discussion are identical. The area has apparently stabilized but, because of the potential seriousness of the problem, it is of general concern. Deteriorated mortar in masonry joints increases the possibility of seepage and does not allow the structure to act as a monolith.

H. Sloughing on Embankment  
Left of Spillway — Near Crest
