**WEST CARROLL TOWNSHIP WATER  
AND SEWER AUTHORITY DAM  
(BAKERTON DAM)**

**PHASE I INSPECTION REPORT  
NATIONAL DAM SAFETY PROGRAM**

**JUNE 1978**

NDI No PA 436

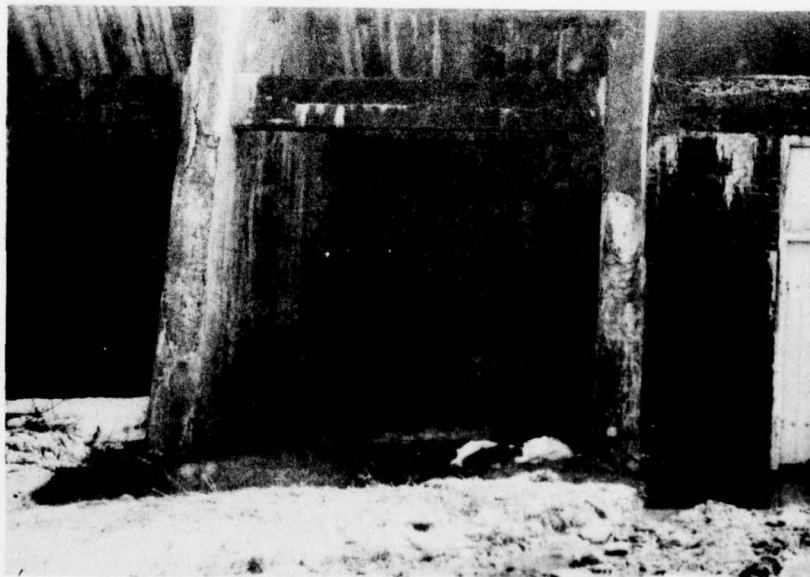
GENERAL VIEW OF TYPICAL BAY OF DAM
