LONG PINE RUN DAM

INVENTORY NUMBER NDS 328

PHASE I INSPECTION REPORT

PHASE I REPORT  
NATIONAL DAM SAFETY PROGRAM

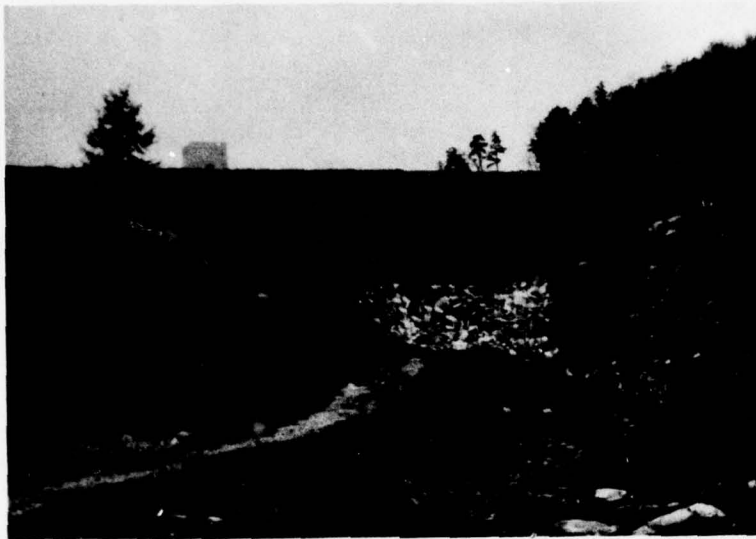
There were no visual observations of undue embankment stresses or sloughage. Motorbike tracks and some erosion has scarred the downstream slope, but have not caused any serious problems. The seepage out of the 24" toe drain does not appear to be excessive.

General View of  
Downstream  
Embankment

1. Owner should employ an experienced engineer to investigate the erosion in the spillway chute and contract for necessary repairs if deemed necessary to prevent undermining of the retaining wall.
2. Owner should maintain embankment slopes by repairing eroded areas and seed ground cover.

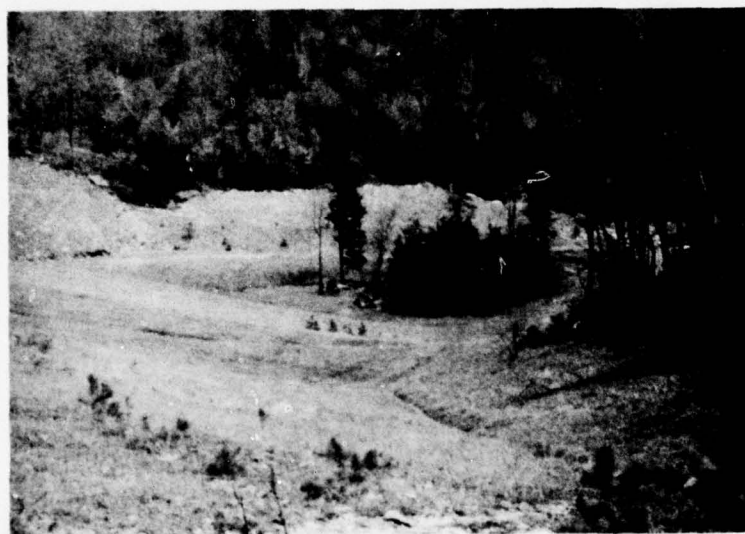
Right  
Embankment  
Abutment

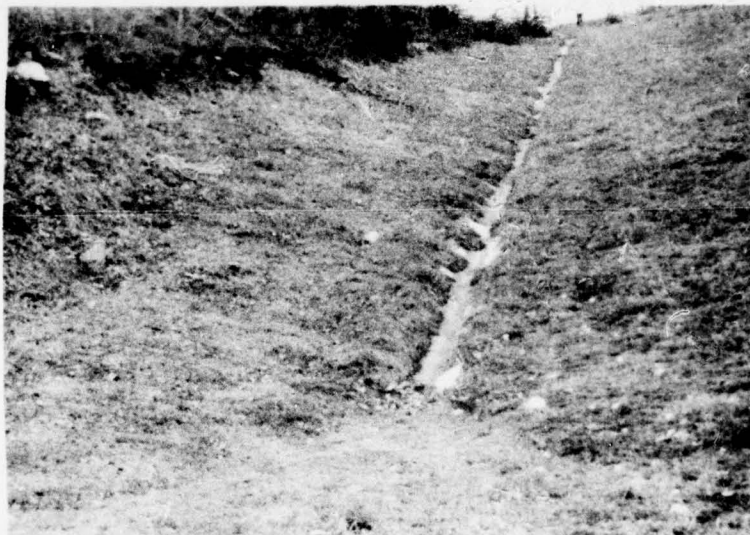
D. VERTICAL & HORIZONTAL ALIGNMENT OF CREST	No distress stoned roadway on breast	
E. RIPRAP FAILURES	No evidence	
F. JUNCTION EMBANKMENT & ABUTMENT OR SPILLWAY	Appears sound - no distress Some rutting due to roadway extension up over slopes to top of dam	Concrete gutter on right abutment should be cleaned

Right Concrete  
Gutter

1. The owner shall inspect the spillway erosion to determine if the retaining wall is or may be undermined.
2. The owner shall repair damaged areas on the downstream embankment and improve the drainage of the gutter at the right abutment.

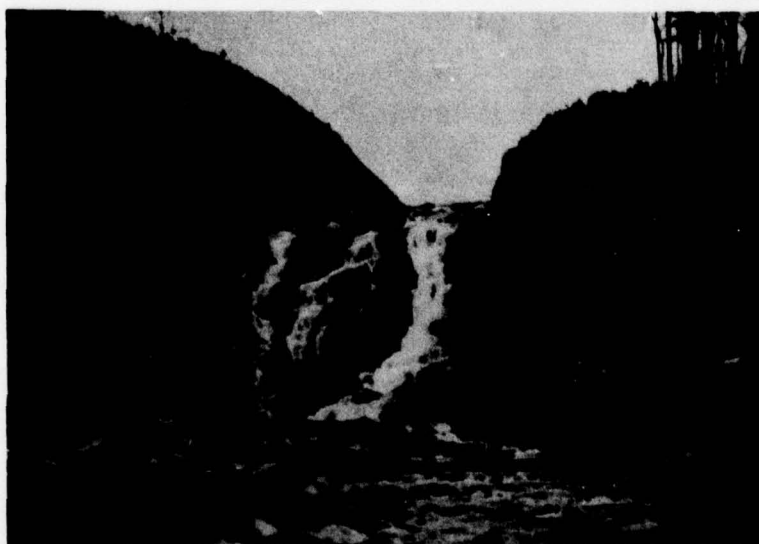
Spillway and  
Stilling Basin
