## LOCH RAVEN DAM

### PHASE I INSPECTION REPORT

⑥  
National Dam Safety Program. Loch  
Raven Dam (MD-0002), Gunpowder River  
Basin, Gunpowder Falls, Baltimore County,  
Maryland. Phase I Inspection Report.

Name of Dam: Loch Raven  
State Located: Maryland  
County Located: Baltimore County  
Stream: Gunpowder Falls  
Date of Inspection: 14 and 16 December 1977  
Inspected By: Baltimore District, Corps of Engineers

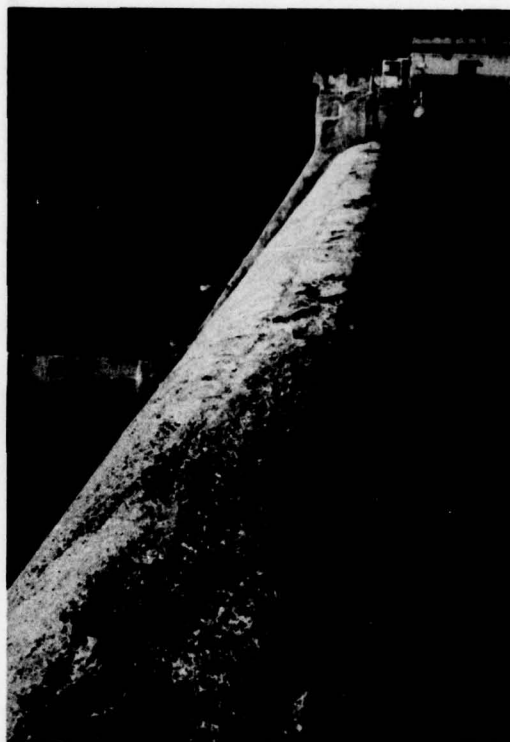
h. Diversion and Regulating Tunnel: The only means of regulation are the selective intakes used for the City of Baltimore's water supply. Two 48 inch low flow by-passes were originally constructed but are not operable; one has been sealed and the other is believed to be silted.

Concrete Deterioration of Face of  
Overflow Section. Note plugged  
48" By-pass on Right Wingwall.
