GEIST STORAGE DAM (SPRINGTOWN RESERVOIR)

PHASE I INSPECTION REPORT
NATIONAL DAM SAFETY PROGRAM

GEIST (CRUM CREEK) STORAGE DAM
DELAWARE COUNTY, PENNSYLVANIA
(NATIONAL I.D. NO. PA-00348)

11 May 1978

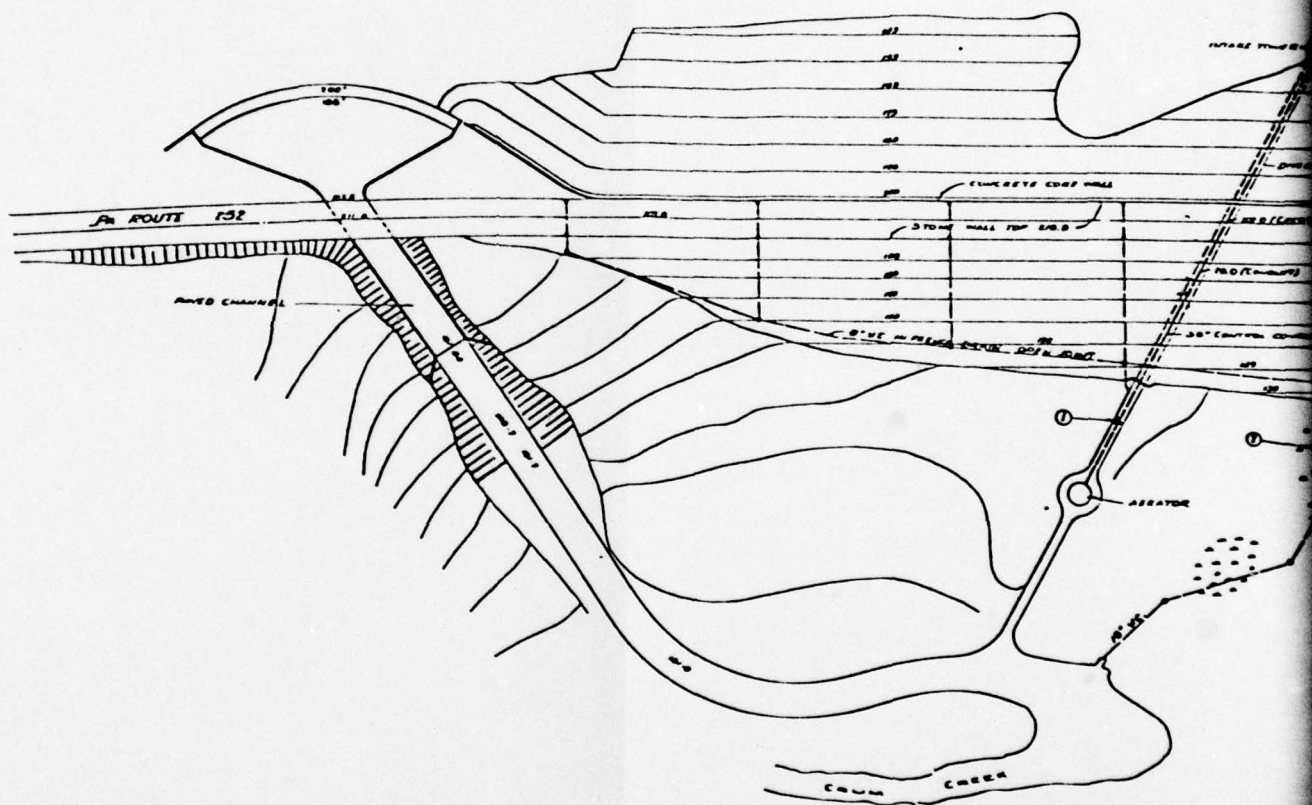
PLATE 3

The survey failed to detect any evidence of distortions in alignment or grade which would be indicative of movement of the embankment or foundation. A careful inspection of the downstream slope and ground surface was conducted to observe any evidence of seepage emergence on or beneath the dam. Because of the porous rock fill mantling the downstream slope, no evidence of seepage was detected on this slope. However, small, clear-running springs were detected at two downstream locations during the inspection. It is understood that the Owner will be installing piezometers near the downstream toe to enable long-term observation of piezometric levels in the areas where there is existing seepage. The location of the springs are shown on Plate 3 and have been identified by previous inspections during 1972-73.
