PHASE I REPORT
National Dam Inspection Program

Keystone Station Dam

Inspection Team - GAI Consultants, Inc.

PHASE I INSPECTION REPORT
NATIONAL DAM INSPECTION PROGRAM
KEYSTONE STATION DAM
ID# NDI PA-275; PENNDR# 3-28

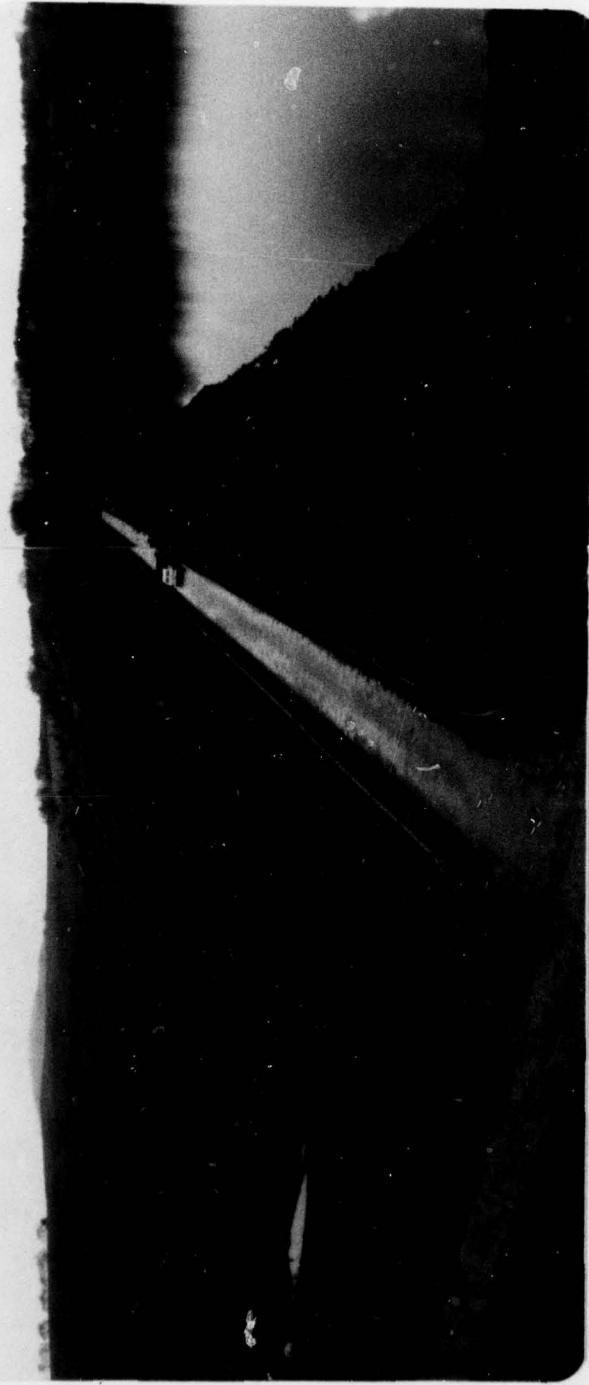
PHOTOGRAPH 2

View from the right abutment showing the crest of the Keystone Station Dam embankment and the area just downstream. The rock toe is visible near the right side of the photograph.
