SPEERS RUN DAM  
NDI Pa - 505 .

PHASE I INSPECTION REPORT,  
NATIONAL DAM INSPECTION PROGRAM. ✓

PHASE I REPORT

Speers Run Dam

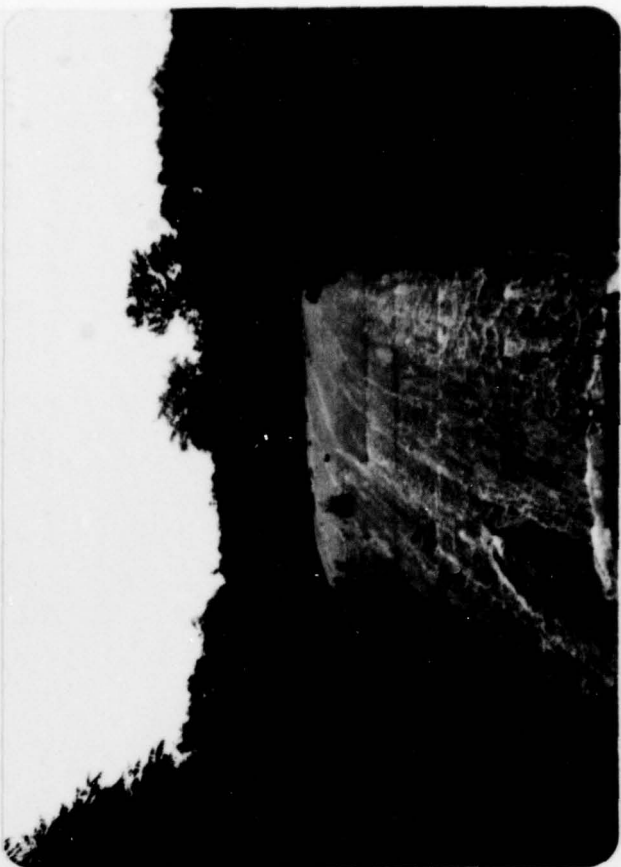
PHOTOGRAPH 4    View of the upstream portion of the  
Speers Run spillway. Note the ogee-  
crested weir in the background of the  
photograph.

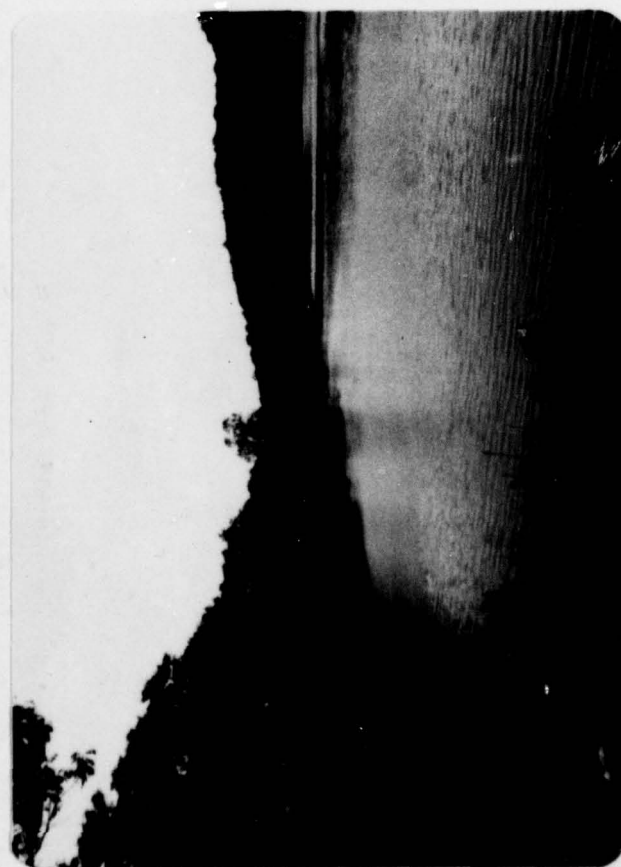
PHOTOGRAPH 3    View of the upstream portion of the  
Speers Run embankment taken from the  
left abutment.

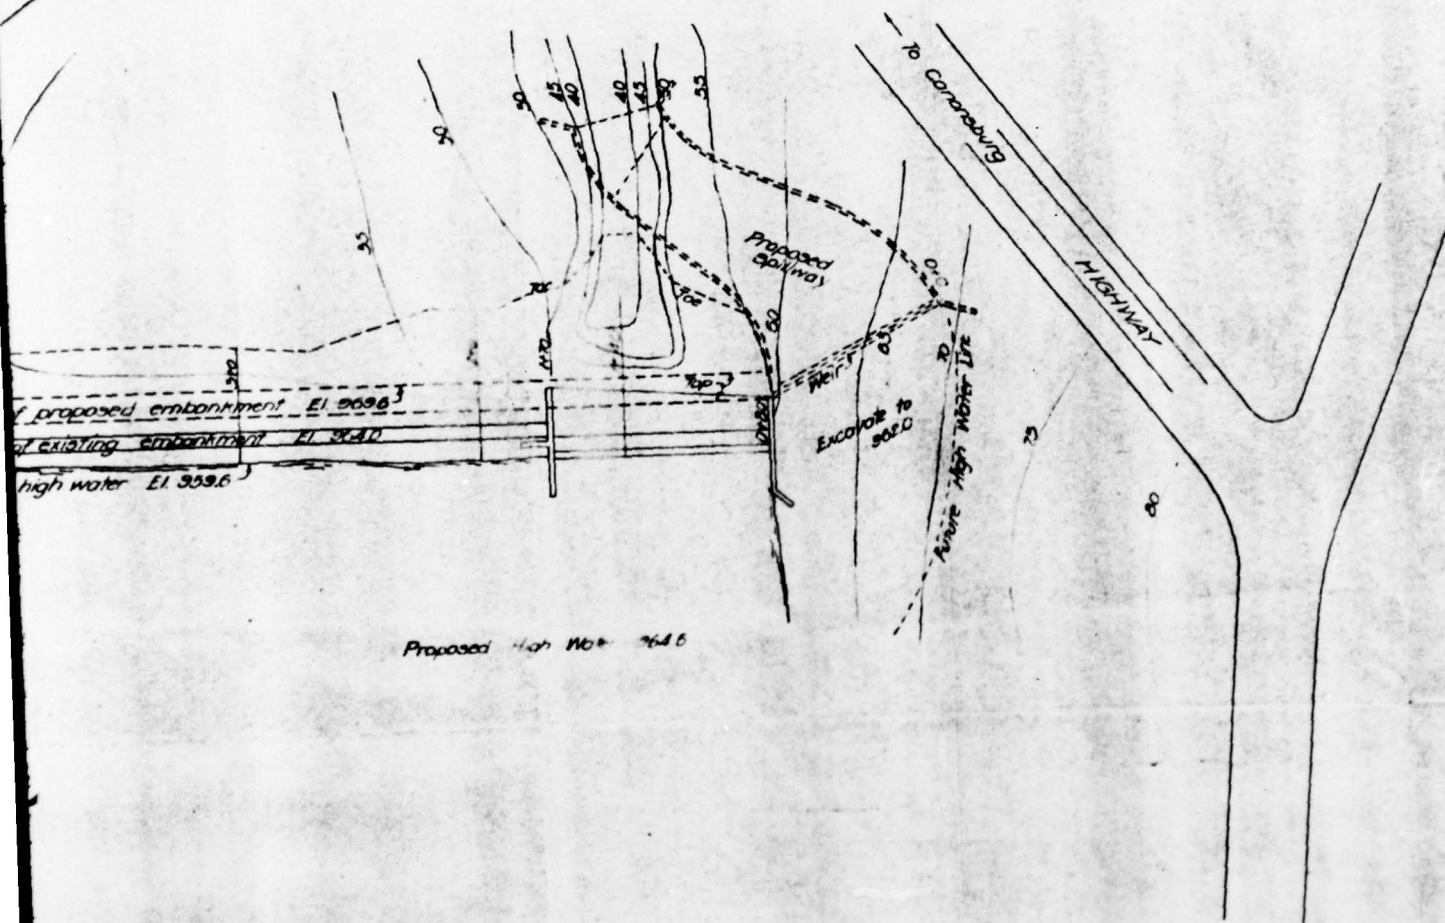
FIGURE 2

Figure 2 of Appendix F shows a plan of the 1927 renovation which included raising the original embankment by 5.6 feet, constructing a new spillway, and raising the intake tower. The top of the embankment as indicated on this drawing was at elevation 964.0 which does not agree with the proposed embankment crest shown on Figure 1 submitted in 1911. Thus, it is possible that the original embankment was not constructed as proposed in Figure 1 or was modified between 1911 and 1927. In addition, the railroad subgrade is indicated on Figure 2 at elevation 965.0+ and the ground contours between the railroad and dam embankment are rather gentle, indicating substantial fill was placed between the two embankments.

Consequently, the railroad embankment and fill act as a massive buttress on the downstream face. As a result, the actual embankment height as presently observed is in the order of 21 feet measured on the downstream side.

According to records supplied by PennDER, the Speers Run embankment is 42 feet high. The field survey, however, indicated a maximum height of 21 feet. This condition has apparently resulted from the construction of the railroad embankment which encroached over a portion of the downstream slope of the dam (see Photograph 2 and Figures 2 and 6).

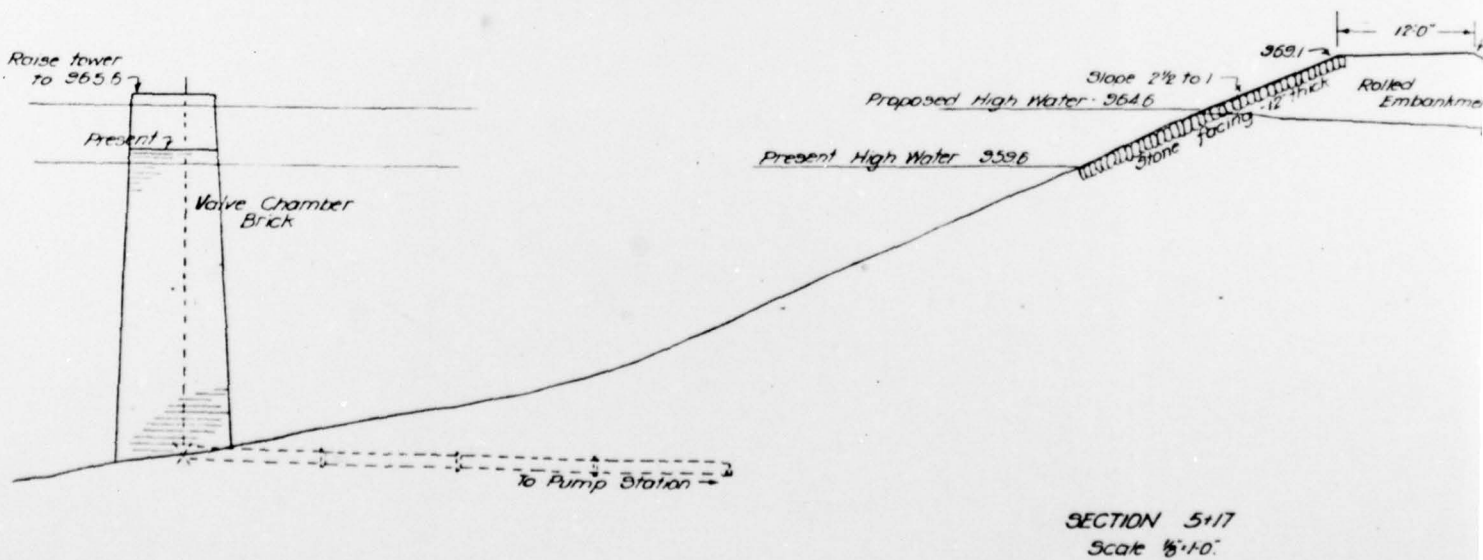
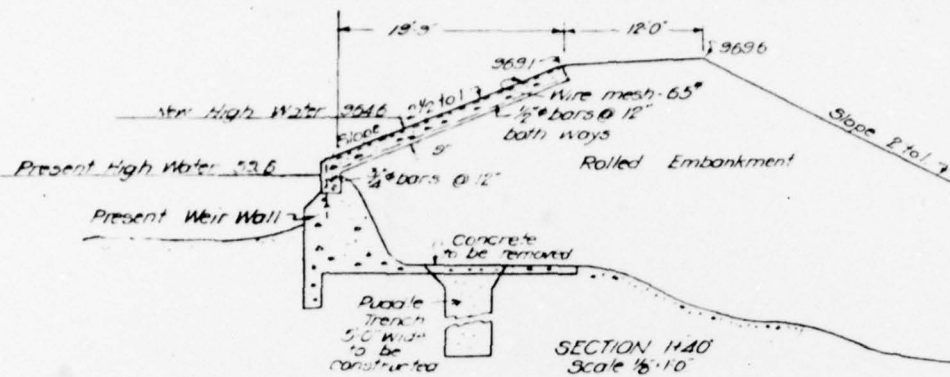
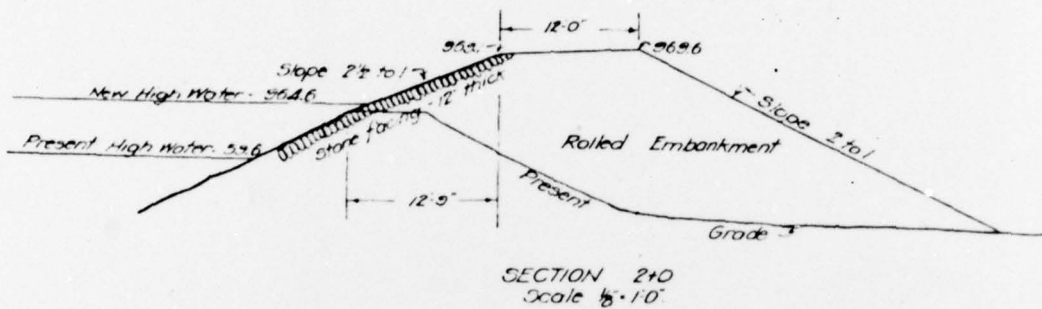
FIGURE 3

Type - One 24-inch blow-off line and one 18-inch  
supply pipe originate at intake (brick valve chamber) as  
indicated on Figure 3. Chamber submerged at time of inspec-  
tion.

The intake structure shown on Figure 3 is submerged and cannot be inspected at the present reservoir level. Outlet appurtenances could not be located and as such pose a potentially hazardous condition, since they are under full hydraulic head beneath the embankment and apparently cannot be closed.

a. The owner enlist the services of a registered professional engineer to inspect and assess the condition of the intake and outlet works and perform those remedial measures deemed necessary to restore their operability including closing the outlet works at their intake ends.
