*Number*  
**WATRES DAM**

**NDS ID NO. PA-00451**

**PHASE I INSPECTION REPORT,**

**(6) NATIONAL DAM INSPECTION PROGRAM.**

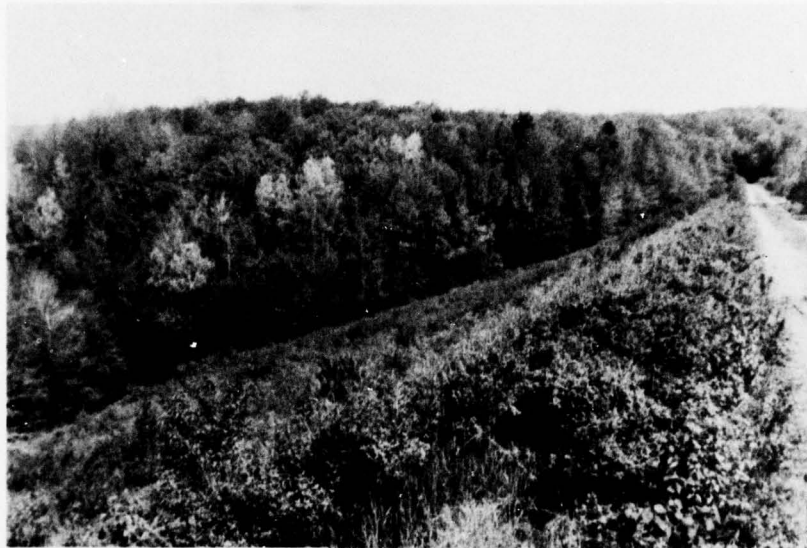
A. Embankment at Right Abutment

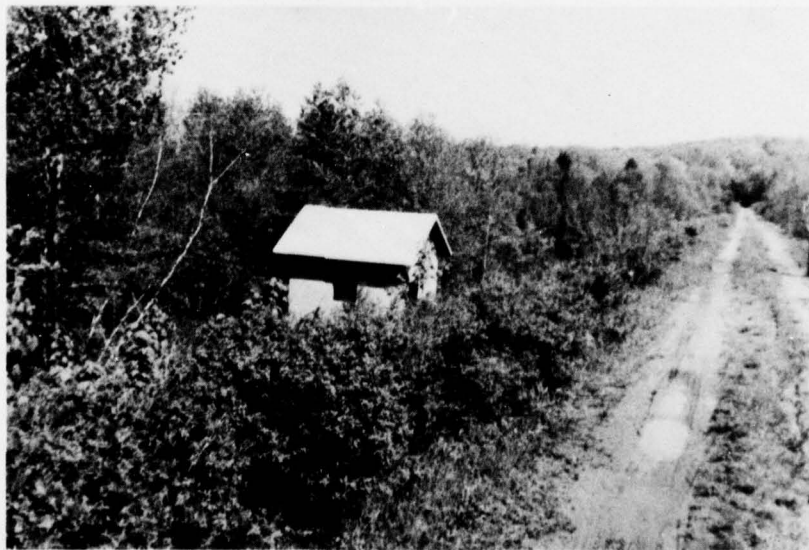
B. Valve House and Top of Dam  
Looking Towards Right Abutment

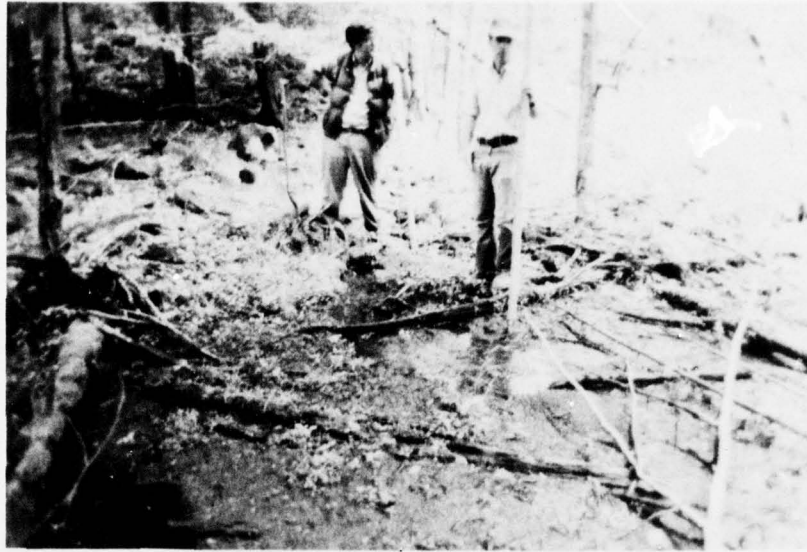
(2) Embankment. Seepage was observed at the toe of embankment and survey data, acquired for this inspection, revealed differences between the existing embankment template and the design template. A detailed description and evaluation of these conditions are in Paragraphs 3.1b. and 3.2a., respectively.

E. Seepage at Toe of Dam

(4) Provide positive drainage and good vehicular access at toe of dam to aid in assessment of seepage. Install at least eight observation wells, or other instrumentation, downstream of the axis of the dam. One well, or other instrumentation, should be located in the vicinity of seepage. The others should be at appropriate locations to determine general water level in downstream embankment. The number of wells, or other instrumentation, will be dependent on the results of the inspection recommended above. Data collected from observation wells or other instrumentation should be utilized in evaluating the stability of the structure and assessing piping potential in the future. Continue to observe wet areas and seepage downstream from dam. If conditions worsen, appropriate action should be taken to control apparent seepage with properly designed drains.

(4) Provide positive drainage and good vehicular access at toe of dam to aid in assessment of seepage. Install at least eight observation wells, or other instrumentation, downstream of the axis of the dam. One well, or other instrumentation, should be located in the vicinity of the seepage. The others should be at appropriate locations to determine general water level in downstream embankment. The number of wells, or other instrumentation, will be dependent on the results of the inspection recommended above. Data collected from observation wells or other instrumentation should be utilized in evaluating the stability of the structure and assessing piping potential in the future. Continue to observe wet areas and seepage downstream from dam. If conditions worsen, appropriate action should be taken to control apparent seepage with properly designed drains.

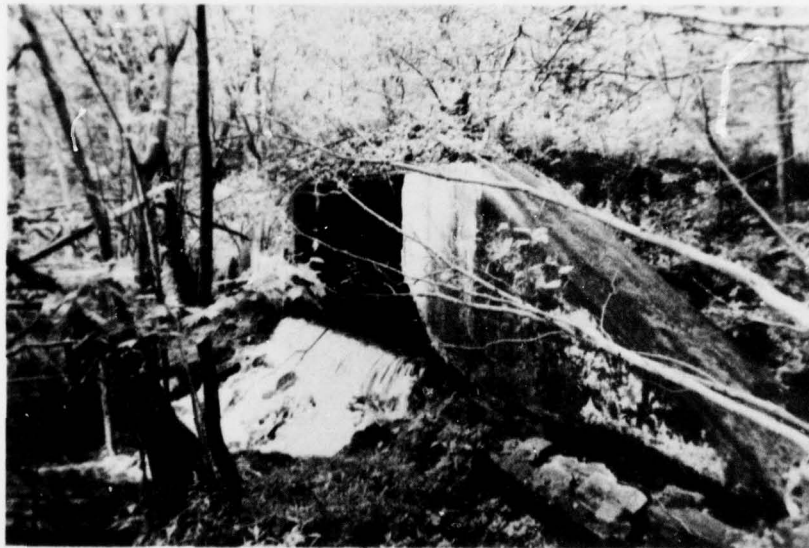
d. Outlet Works. The stem for the floatwell intake valve in the valve house is bowed. The floatwell does not function. The ladder from the valve house which extends down the vertical shaft is rusting. The concrete tunnel lining near the downstream end of the tunnel has 1-inch diameter hole through which water is leaking. The top of the headwall at the downstream end of tunnel is severely deteriorated, with the reinforcing steel being exposed over all the top (Photograph F). The operation of the downstream valve on the left pipe was observed. It required four men 30 minutes to open the valve 8 inches. The Owner requested that the valve not be opened more to avoid getting sediment in the water transmission line on the right. No problems were noted with the valve operation. This valve leaked.

c. Outlet Works. The inoperable floatwell presents no hazard to the dam. However, if operable it would be an aid, in assessing the seepage downstream. The rusting ladder could eventually be a hazard to personnel. The leakage observed in the tunnel presents no significant hazard to the dam. The deteriorated headwall does not present a hazard to the dam.

F. Headwall at Downstream End of  
Outlet Works Tunnel

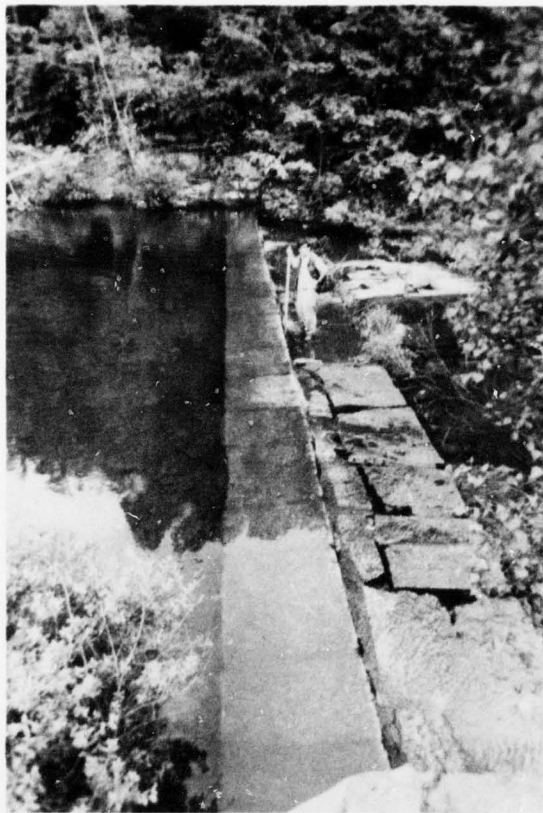
c. Spillway. Mortar is missing for up to a 2-inch depth from some joints in the weir and downstream apron (Photograph G). There is a small amount of vegetation in the channel immediately downstream of the weir (Photograph H). The stream below the spillway channel has dead trees strewn across it (Photograph I). The masonry retaining wall on the right bank in this area has deteriorated mortar, with

b. Spillway. The deterioration of the mortar is not sufficiently serious to be of concern. The vegetation downstream of the weir is too small to create problems at present. The trees in the downstream channel, while not desirable, present no significant hazard to the dam. Trees adjacent to the retaining wall are undesirable. Long-term neglect of the deteriorating mortar could prevent the spillway from acting as a watertight structure.

G. Spillway Crest

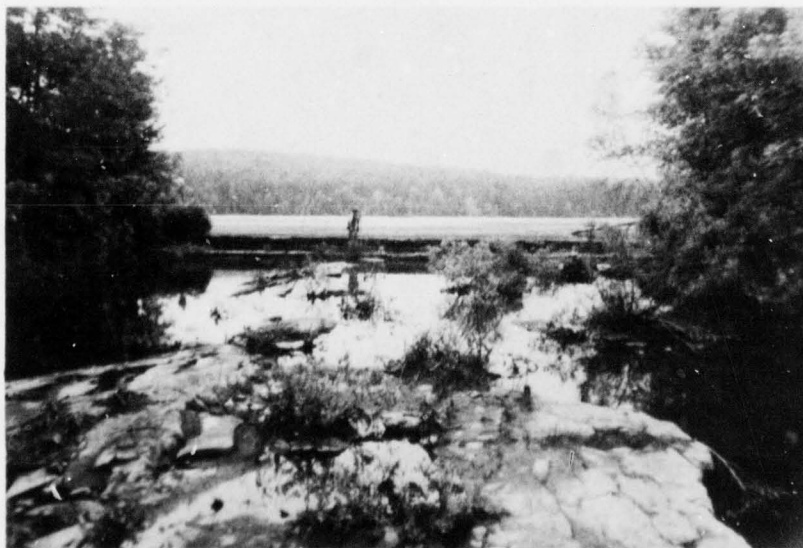
H. Spillway — Looking Upstream

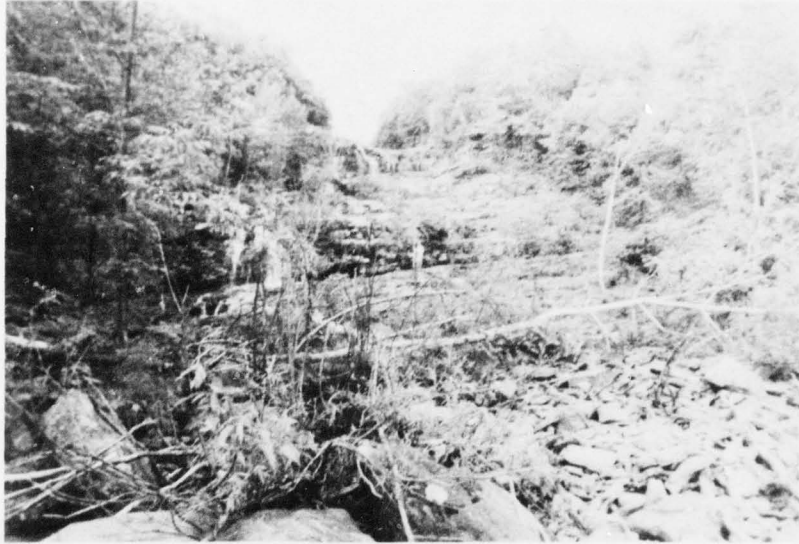
I. Downstream End of Spillway Channel  
Looking Upstream
