SCHUYLKILL RIVER BASIN
FURNACE CREEK, BERKS COUNTY

FURNACE CREEK DAM

PHASE I INSPECTION REPORT
NATIONAL DAM INSPECTION PROGRAM

FURNACE CREEK DAM
BERKS COUNTY, PENNSYLVANIA
NATIONAL I.D. NO. PA 00706

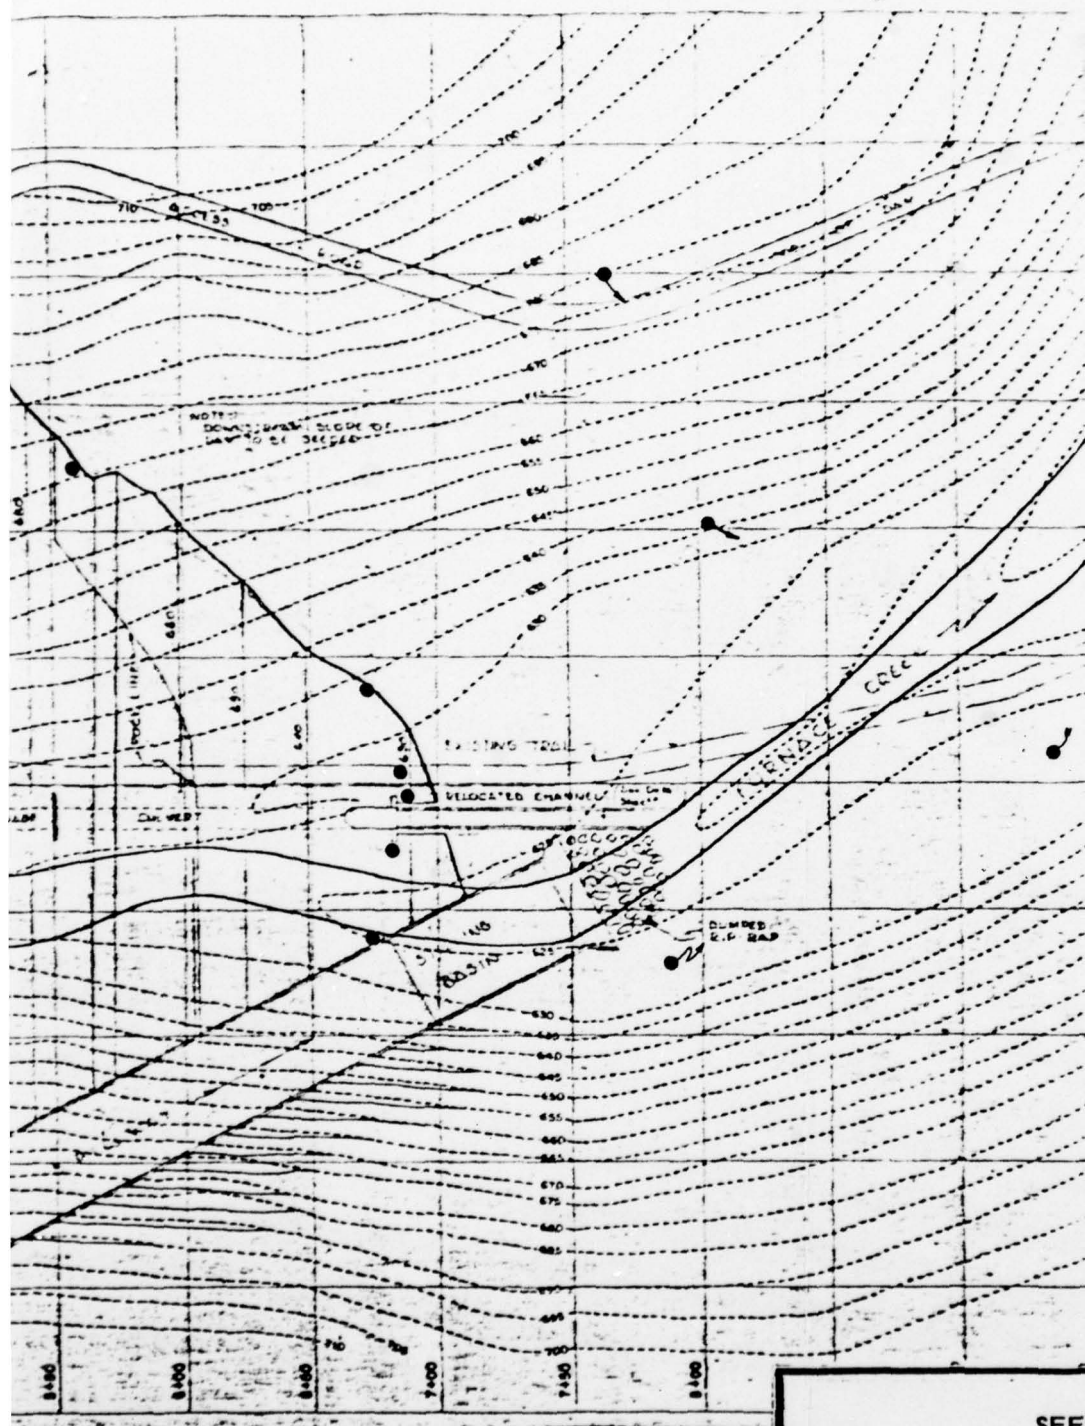
| VISUAL EXAMINATION OF | OBSERVATIONS | REMARKS OR RECOMMENDATIONS |
|---|---|---|
| ANY NOTICEABLE SEEPAGE | Clear water seepage at several locations. Seepage is ponded adjacent to left stilling basin wall with water level 3±' above water level in stilling basin. There are several seeps around discharge culvert and 20' to 30' to left of tunnel. Soft area and seepage at left abutment near valley bottom. Sources of seeps were obscured within rock toe. Volume of individual seeps estimated to be less than 5 gpm since no gauging is installed. Spring observed on access road about 300' from dam. | |

Of less concern is the seepage at the downstream toe of the dam. It is recommended that a program of periodic documented observations be implemented to detect any possible changes in the seepage. Because this dam is virtually unattended throughout the year, a formal program of inspections should be implemented to assure that functional changes in the performance of the structure are noted.

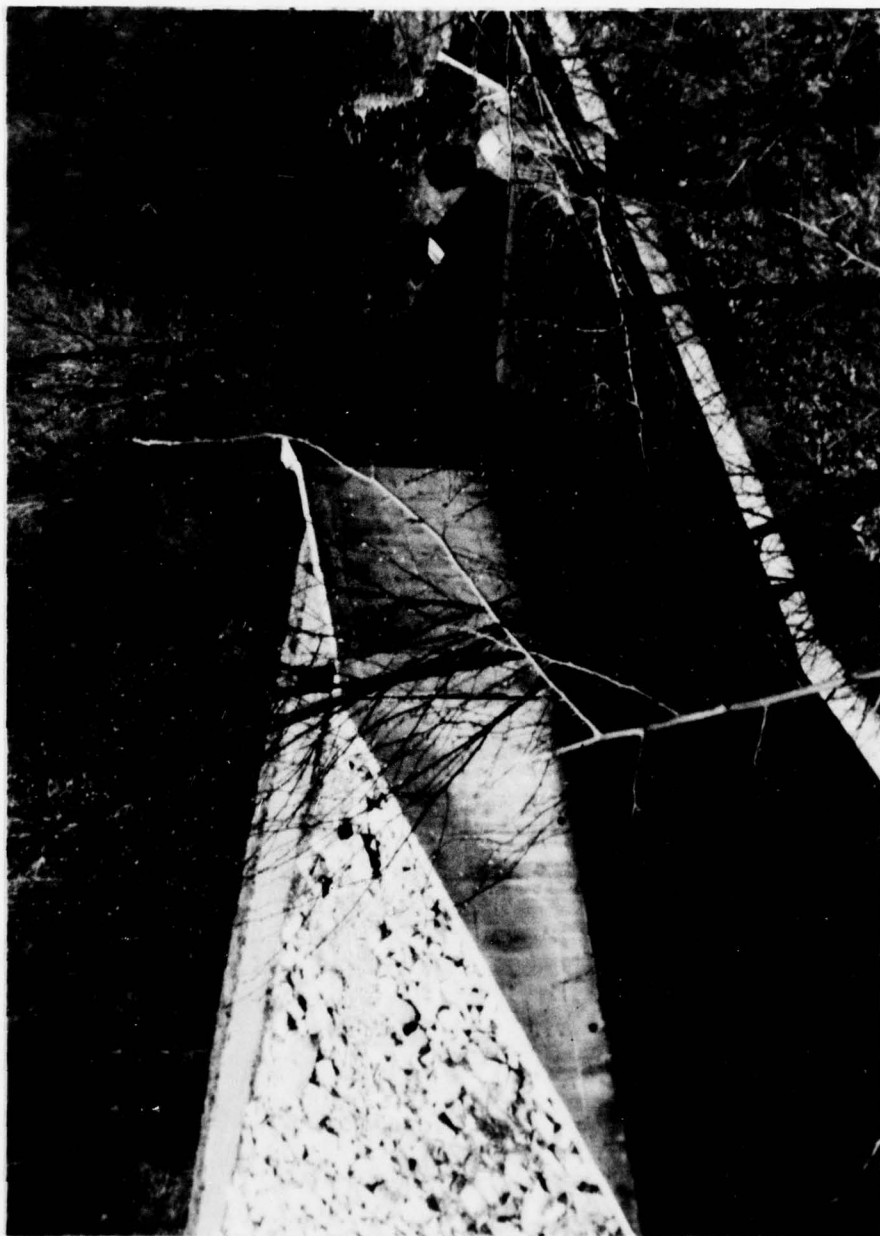
VIEW FROM RIGHT ABUTMENT LOOKING DOWNSTREAM AT SPILLWAY

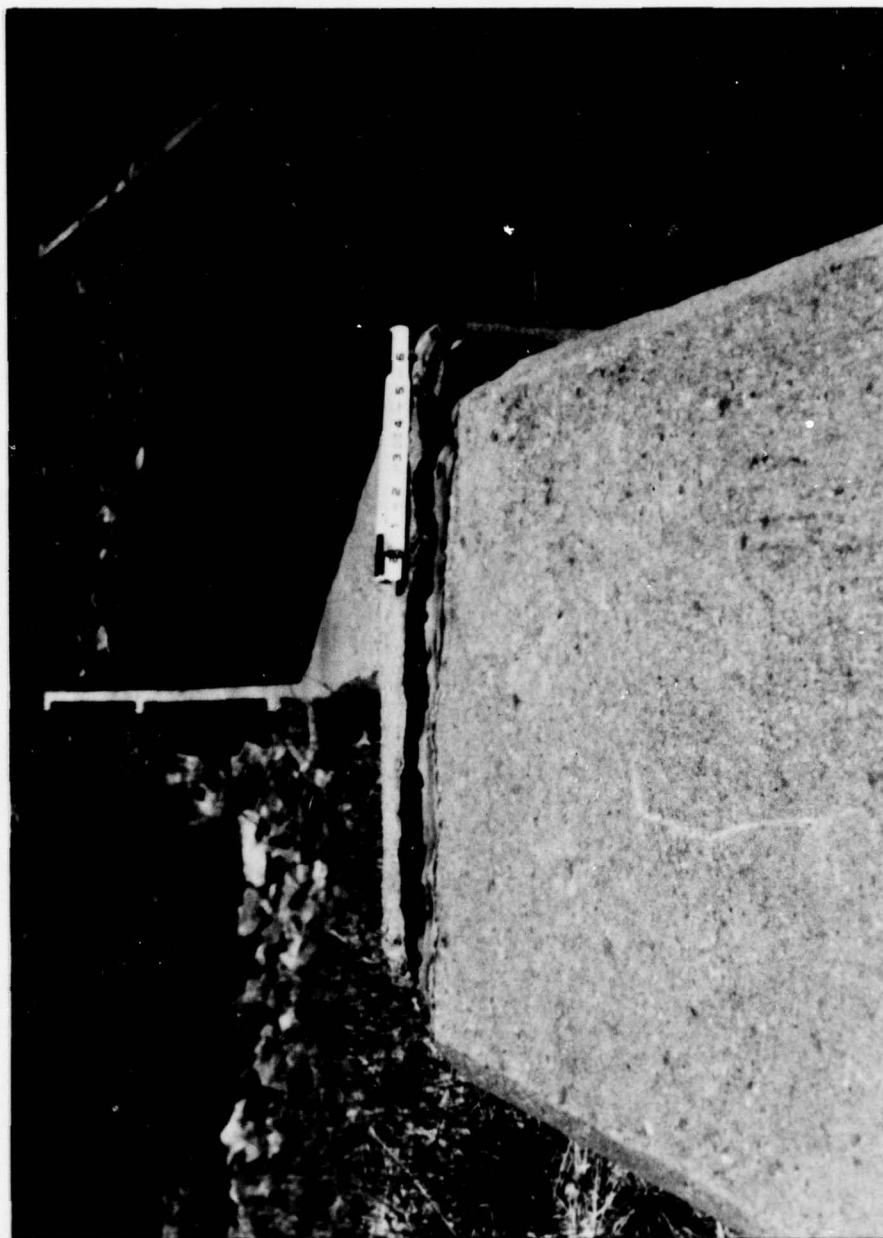
VIEW OF 1.5 INCH DISPLACEMENT OF RETAINING WALL
ON LEFT SIDE OF DISCHARGE CHANNEL

sive stresses have caused structural cracking and separation between the wall and supporting buttresses. It is recommended that the stability of this wall be further evaluated.

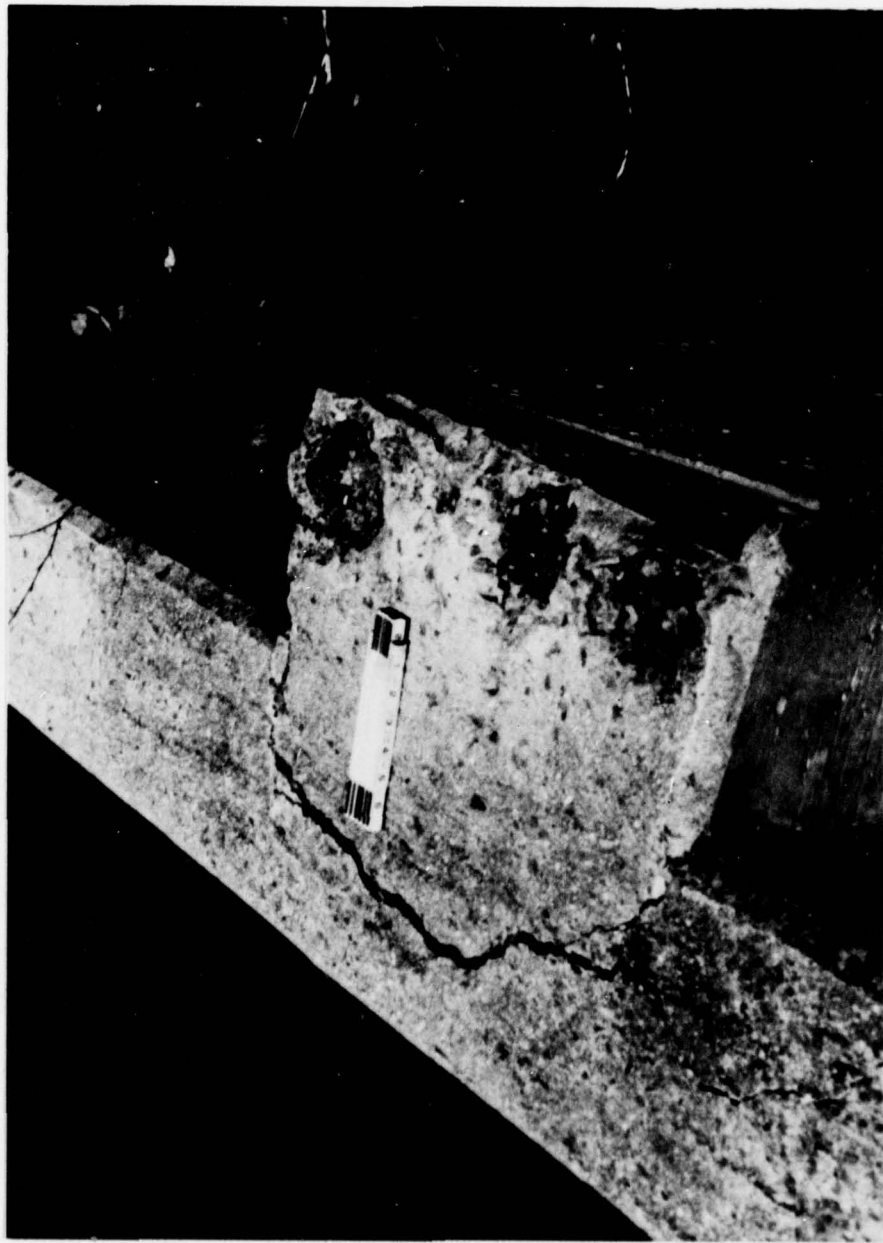
top of the spillway walls. Concrete cracks up to 1/4 inch wide were observed at two of the buttresses on the spillway walls. These cracks appeared to propagate from the re-entrant corners of the buttress and are approximately parallel to the face of the spillway wall.

| <u>VISUAL EXAMINATION OF</u> | <u>OBSERVATIONS</u> | <u>REMARKS OR RECOMMENDATIONS</u> |
|---|---|---|
| APPROACH CHANNEL | Rock cut at right side of channel exhibited loosened and fallen pieces of rock. In right wall of dam crest there is a tension crack propagating from re-entrant corners at buttress and parallel to wall face. (See Photo No. 6) Otherwise, concrete appears in good condition. | |

VIEW OF RETAINING WALL AND BUTTRESS SEPARATION
ALONG RIGHT SIDE OF DISCHARGE CHANNEL.

The cracks in the buttresses should be studied through an analysis of the spillway wall structure. At a minimum, these cracks should be sealed to preclude water intrusion and concomitant seasonal freezing damage. Depending upon the results of further analyses, measures such as installing tie-back anchors might be necessary.

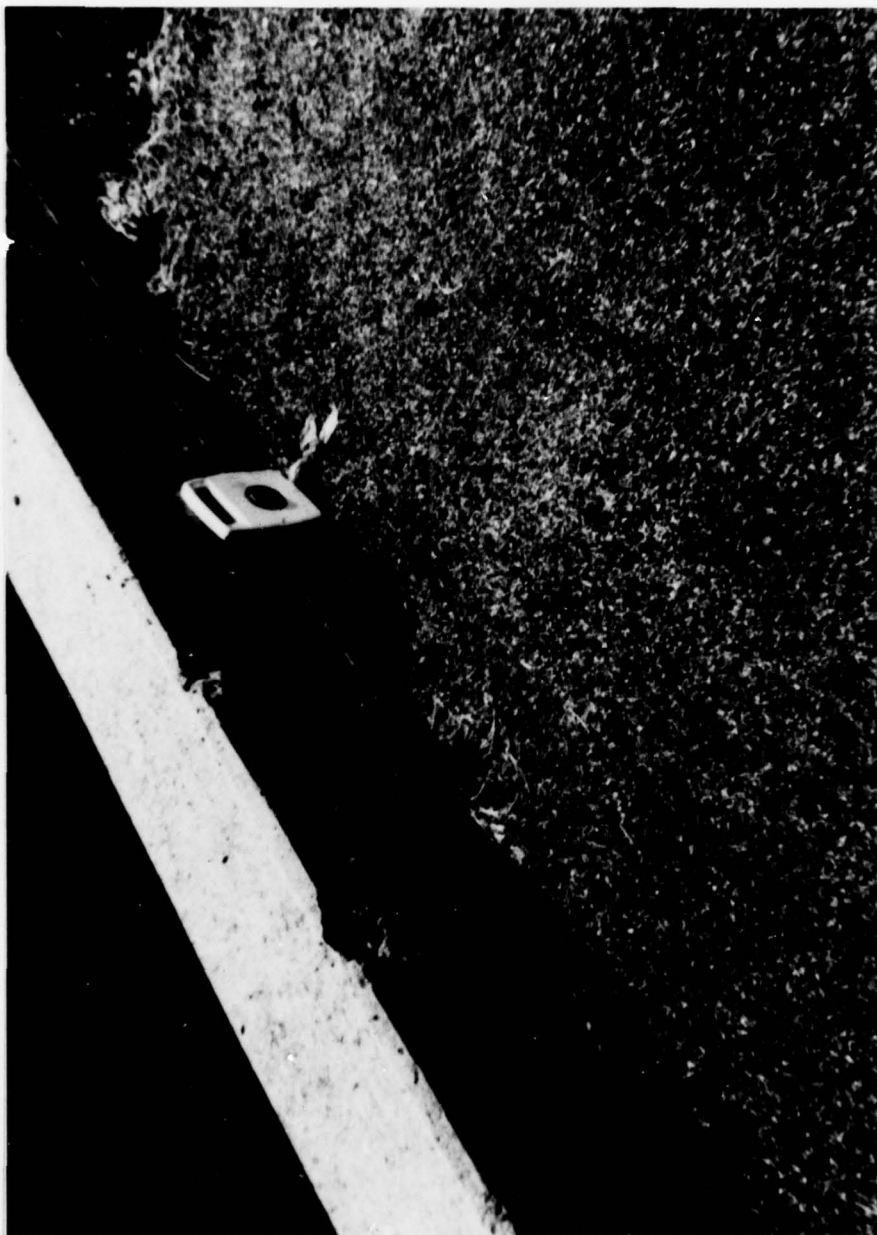
PHOTO NO. 7

It was observed that the crest of the dam was about one foot below the top of the spillway wall. The design drawings indicated the dam crest to be 0.5 feet below the spillway wall so that this observation would indicate about 0.5 feet of settlement adjacent to the spillway. However, the Owner's representative reported that the dam crest was constructed level with the top of the spillway wall so that this observation would indicate about one foot of settlement at this location. Additional observations on the downstream face disclosed a maximum of about one foot of embankment settlement adjacent to the spillway wall.

SETTLEMENT OF DAM CREST AT LEFT SPILLWAY WALL.
PHOTO SHOWS 6 to 12 INCHES OF SETTLEMENT.

As a more feasible means of upgrading the hydraulic capacity of Furnace Creek Dam, it is recommended that the dam crest be raised to the top of the spillway wall. Also, the backfill behind the right spillway wall should be similarly raised. After this work is performed, the spillway is expected to be capable of passing 0.9 PMF. Additional protection against overtopping during the PMF event could be obtained by riprapping or otherwise armoring the downstream slope of the dam.

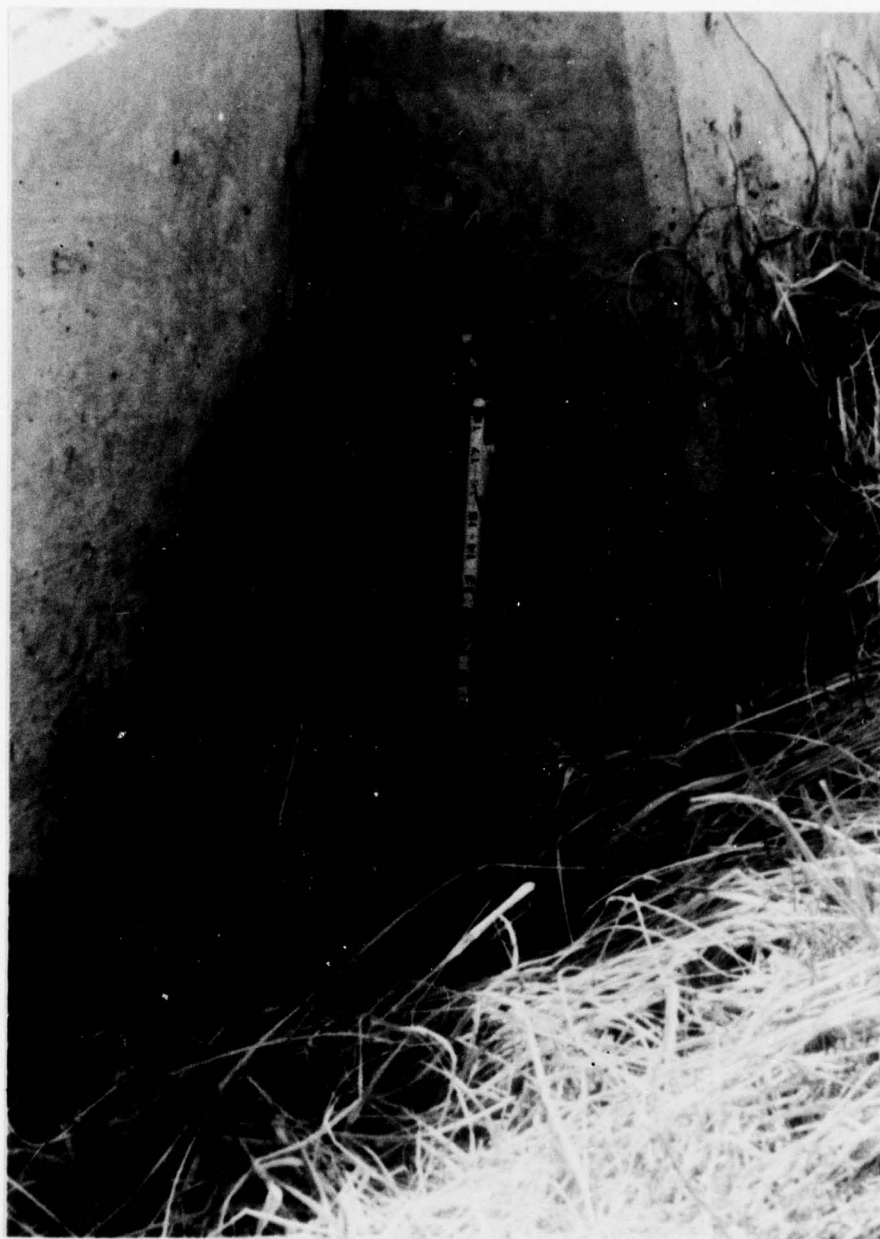
| VISUAL EXAMINATION OF | OBSERVATIONS | REMARKS OR RECOMMENDATIONS |
|---|---|---|
| JUNCTION OF EMBANKMENT AND ABUTMENT, SPILLWAY AND DAM | Settlement of embankment/backfill observed at left spillway wall - 0.5' to 1.0' at dam crest. (See sheet 4, item 4 for explanation). Settlement as much as 1' at first buttress down from crest. (See Photo No. 8) | |

SETTLEMENT OF DOWNSTREAM SLOPE
OF DAM AT LEFT SPILLWAY WALL.
PHOTO SHOWS 12 INCHES OF SETTLEMENT.

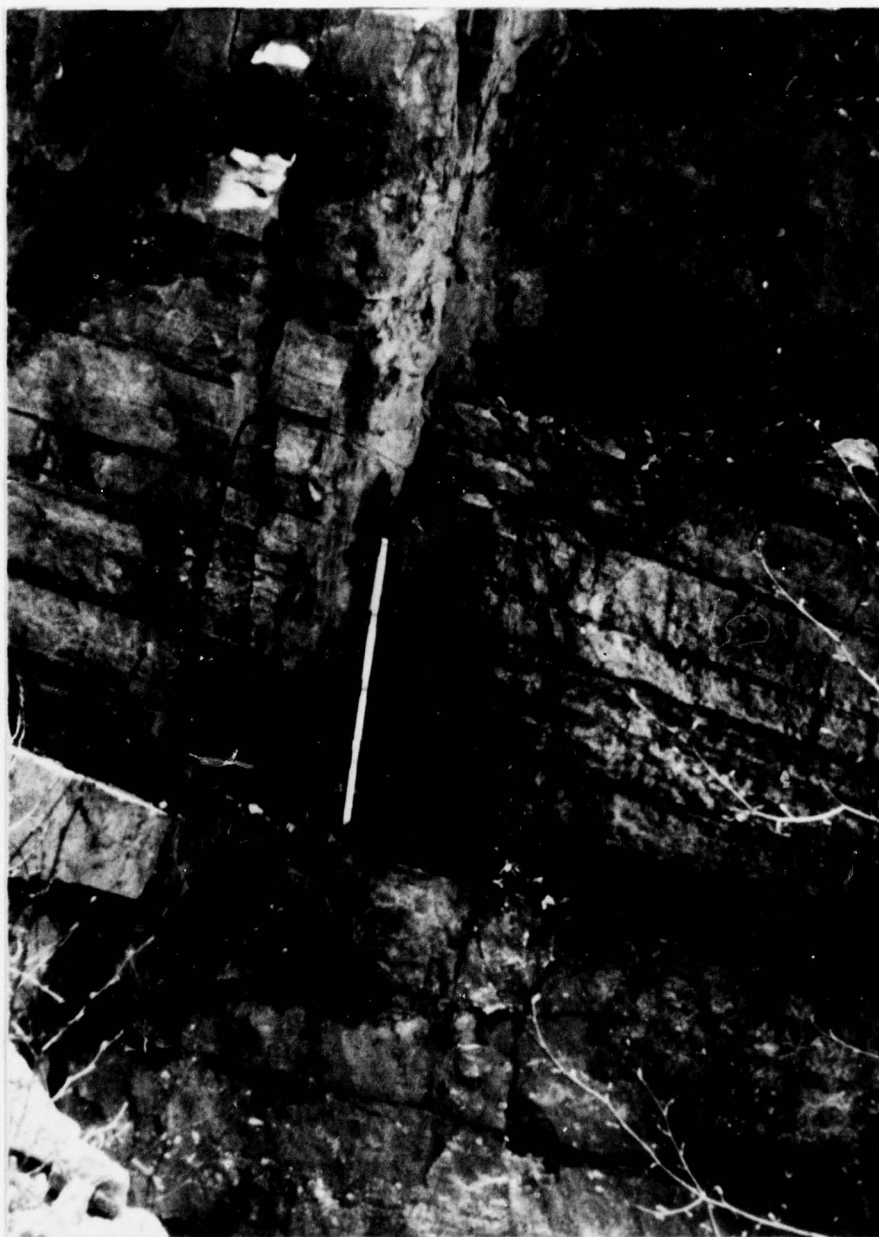
DETAIL OF GRANITE GNEISS EXPOSURE AT
RIGHT ABUTMENT, UPSTREAM
FROM DAM CENTERLINE
