**DELAWARE RIVER BASIN  
WILD CREEK, CARBON COUNTY**

**PENNSYLVANIA  
ID NO. PA.00608**

## **PENN FOREST DAM**

### **PHASE I INSPECTION REPORT NATIONAL DAM INSPECTION PROGRAM**

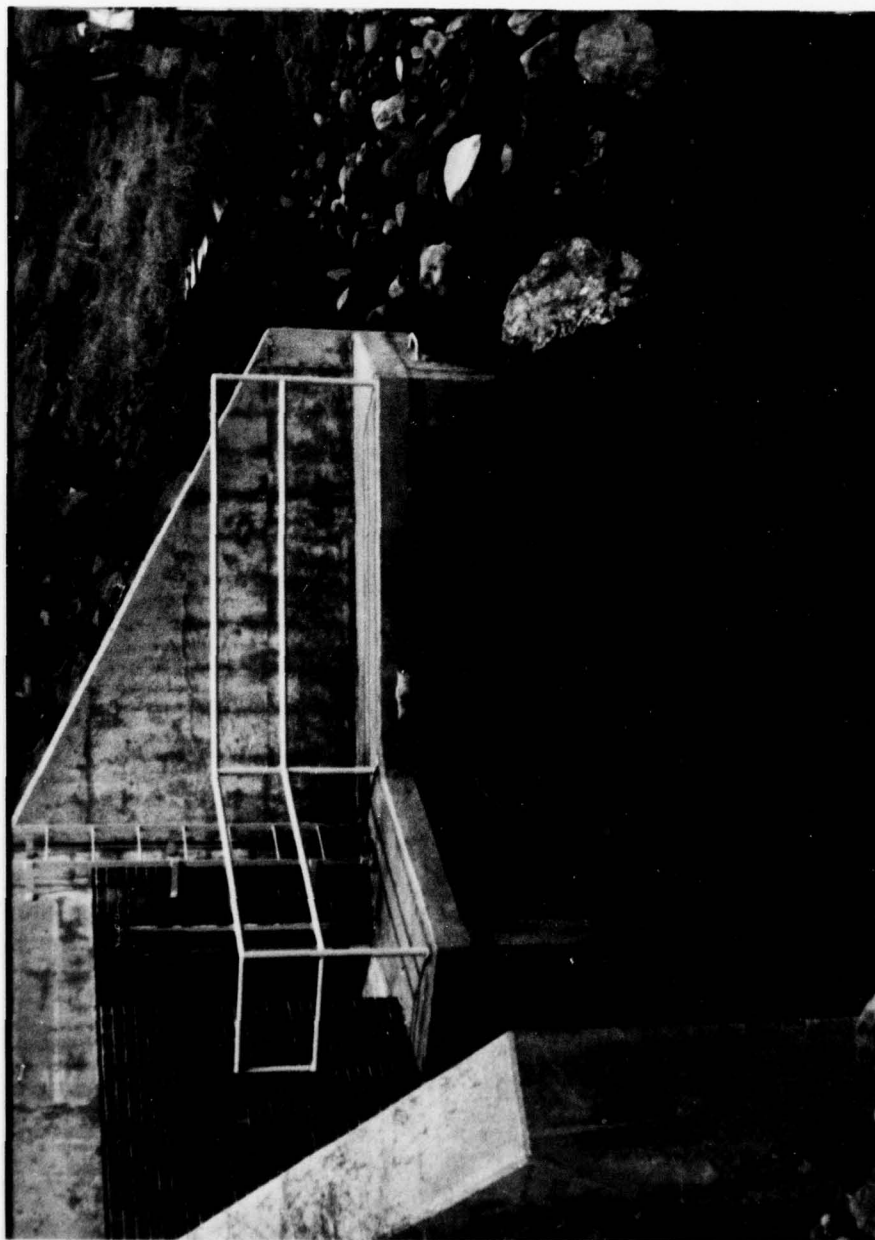
PHOTO NO. 3

DRAWDOWN DISCHARGE STRUCTURE WITH 36-INCH OUTLET PIPE  
(See Photo No. 2 for orientation).

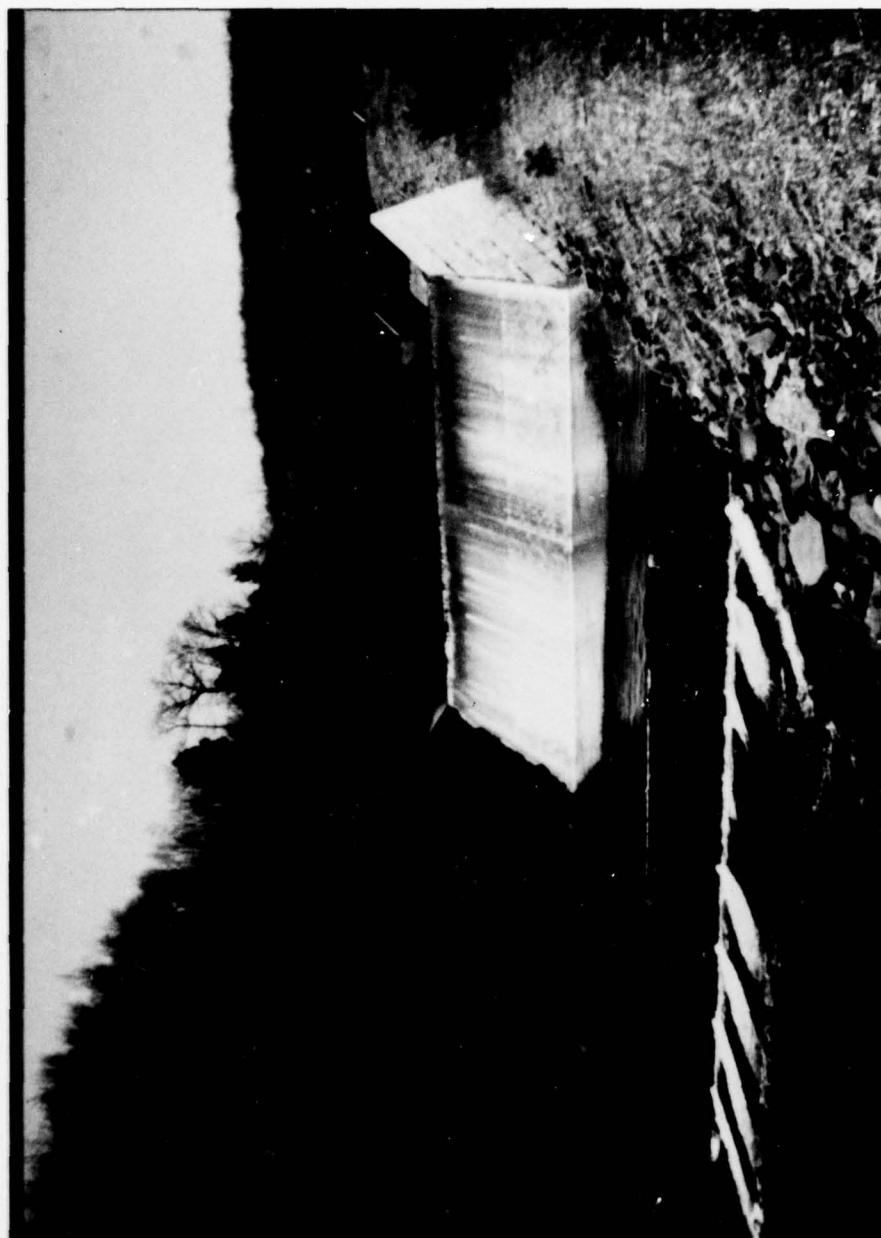
PHOTO NO. 6

VIEW OF STILLING BASINS
