3 OHIO RIVER BASIN  
TUBMILL CREEK, WESTMORELAND COUNTY  
PENNSYLVANIA

2 TUBMILL DAM

(ID NO. PA. 488)

4 PHASE I INSPECTION REPORT  
NATIONAL DAM INSPECTION PROGRAM

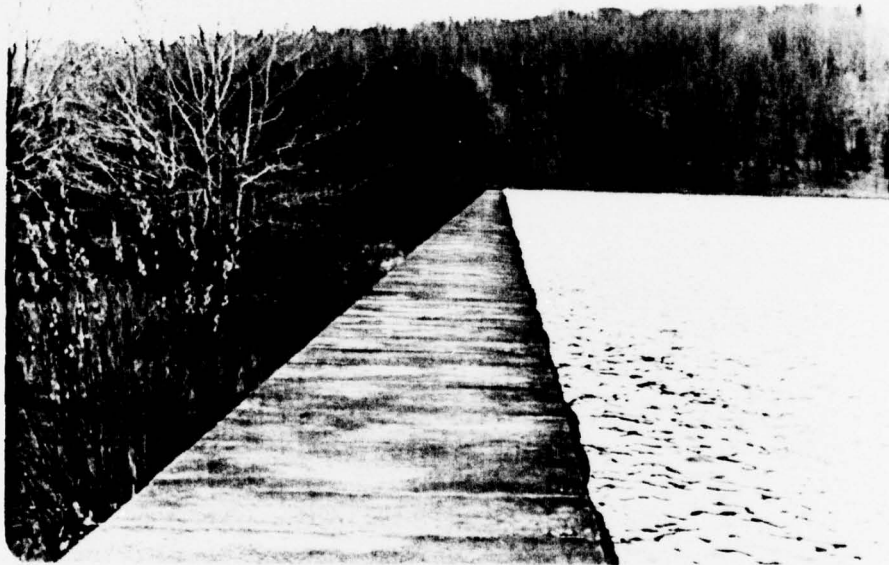
Upstream Face

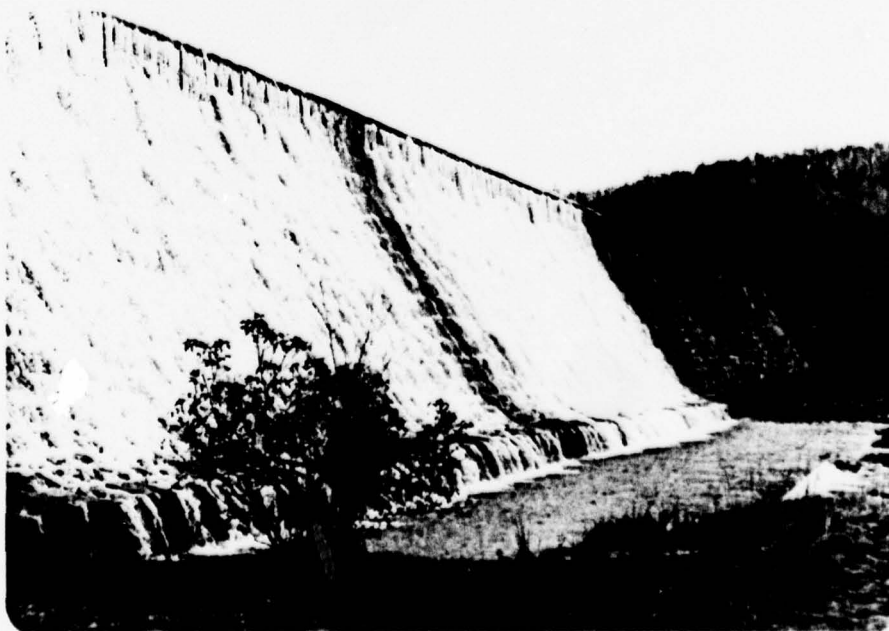
Downstream Face

1. The entire downstream face of the dam was found to be wet. The seeps appeared to be coming from near the top of the dam. No concentrated seeps were observed.
2. Wet areas were observed both on the right and left abutments along the toe of the dam. A sewer pipe discharging along the left abutment toe appeared to be contributing significantly to the wetness on that side. No flow away from the wet areas was found.
3. Two wet areas and one concentrated seepage area was found on the right abutment approximately 150 feet downstream from the dam. One wet area was located on a terrace on the right abutment, but no water was

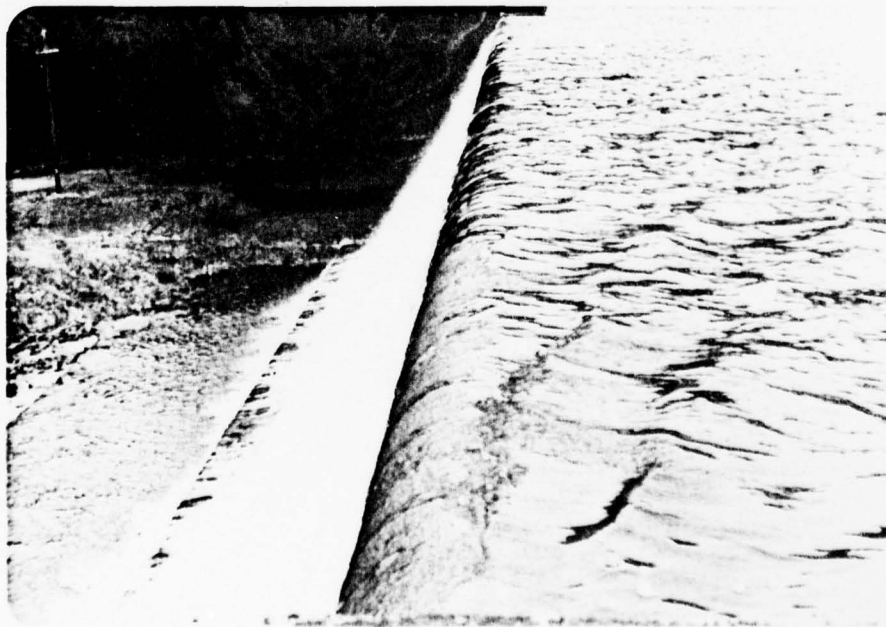
c. Appurtenant Structures. The spillway crests and plunge pools were examined for deterioration or other signs of distress and obstructions that would limit flow. No signs of apparent distress or erosion were observed.

Photograph No. 2  
Spillway.

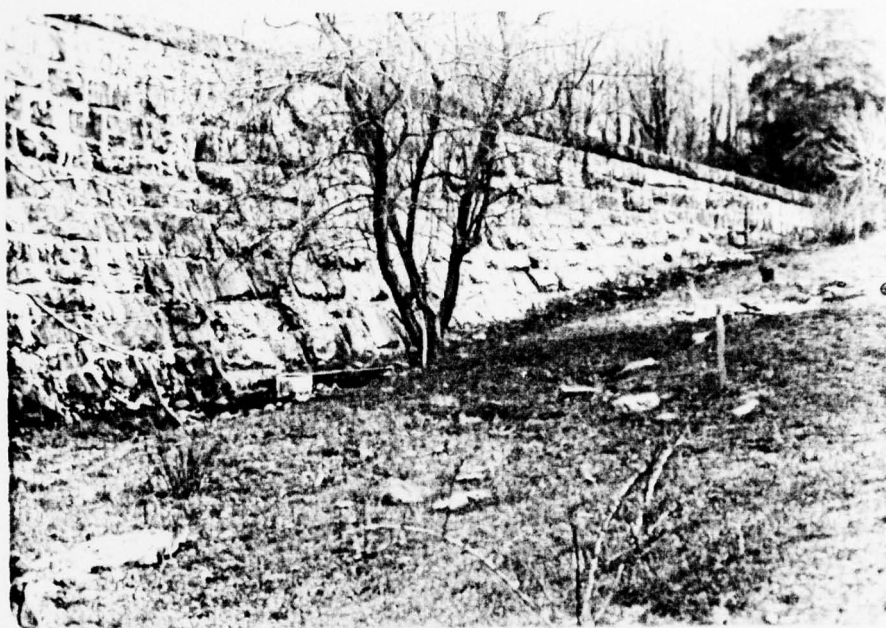
Photograph No. 3  
Left abutment (looking west).

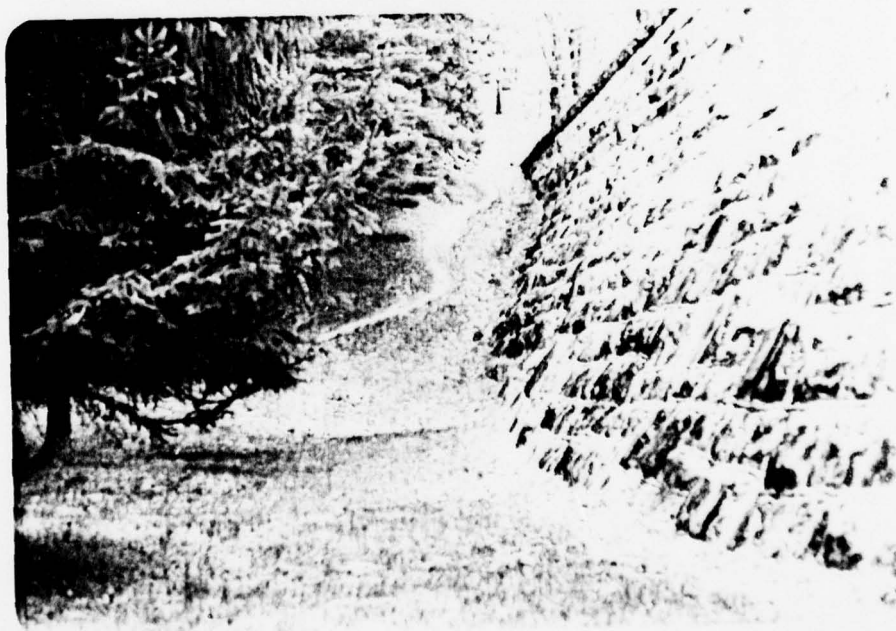
Photograph No. 4  
Right abutment (looking east).

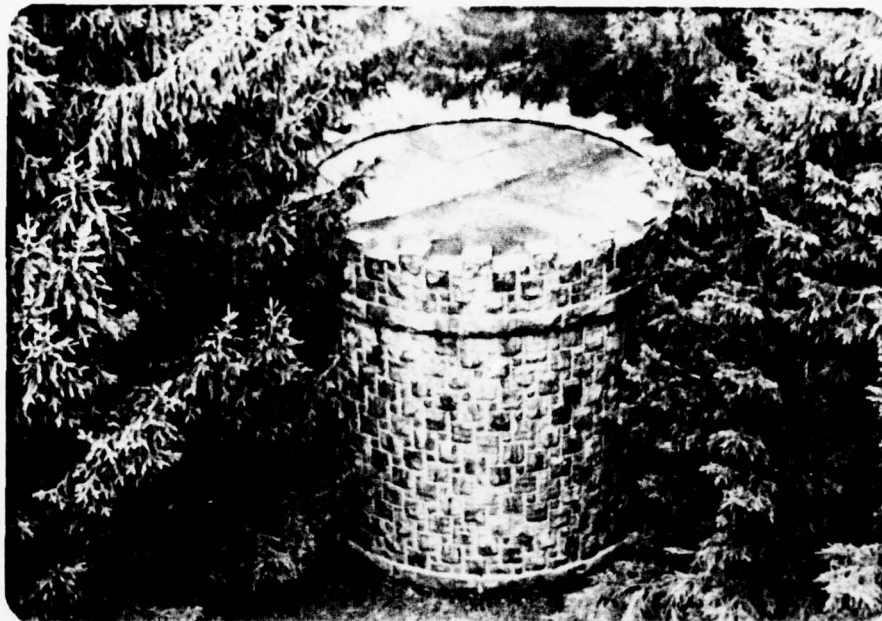
Photograph No. 5

Gate house.

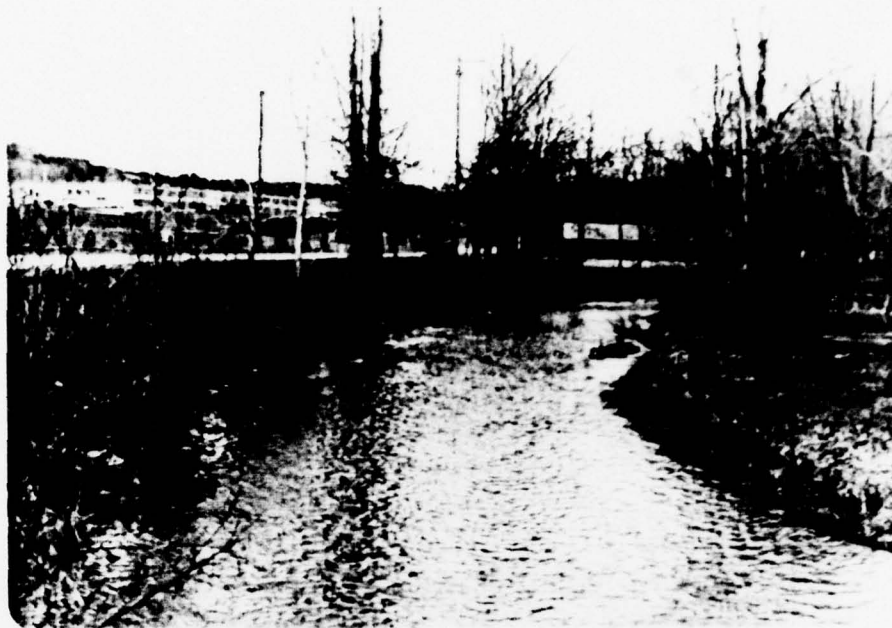
Photograph No. 11

Flood plain along Route 711. (Note high school in left upper corner.)

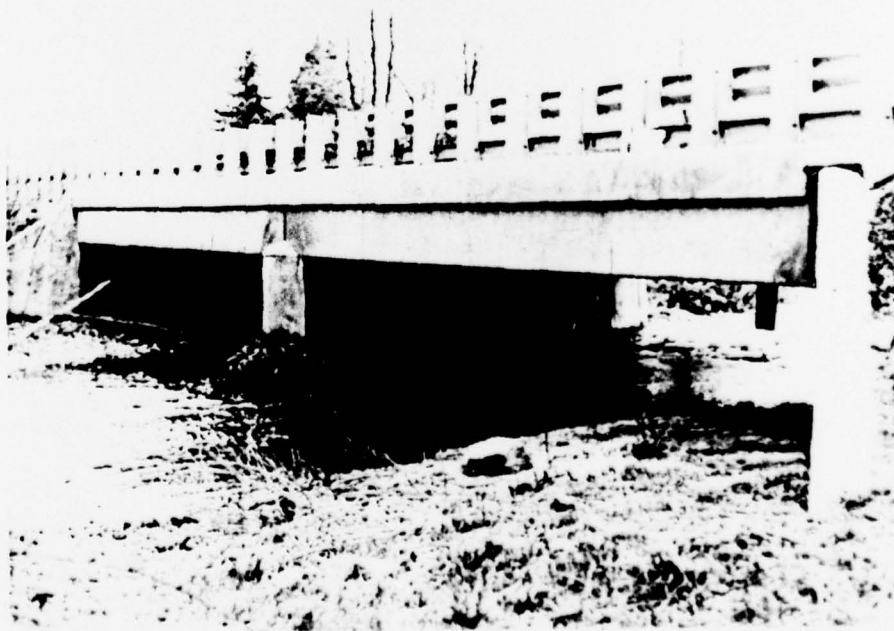
Photograph No. 12

Bridge on Route 711.
