2 QUEMAHONING DAM

(NDI I.D.NO: 740)

PHASE I INSPECTION REPORT  
NATIONAL DAM INSPECTION PROGRAM

1275p D'APPOLONIA CONSULTING ENGINEERS  
10 DUFF ROAD  
PITTSBURGH, PA. 15235

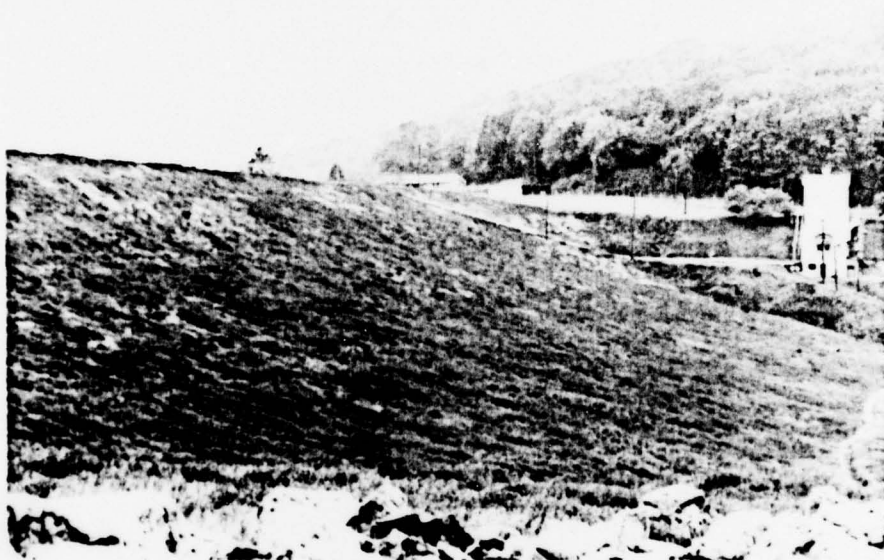
Downstream Face

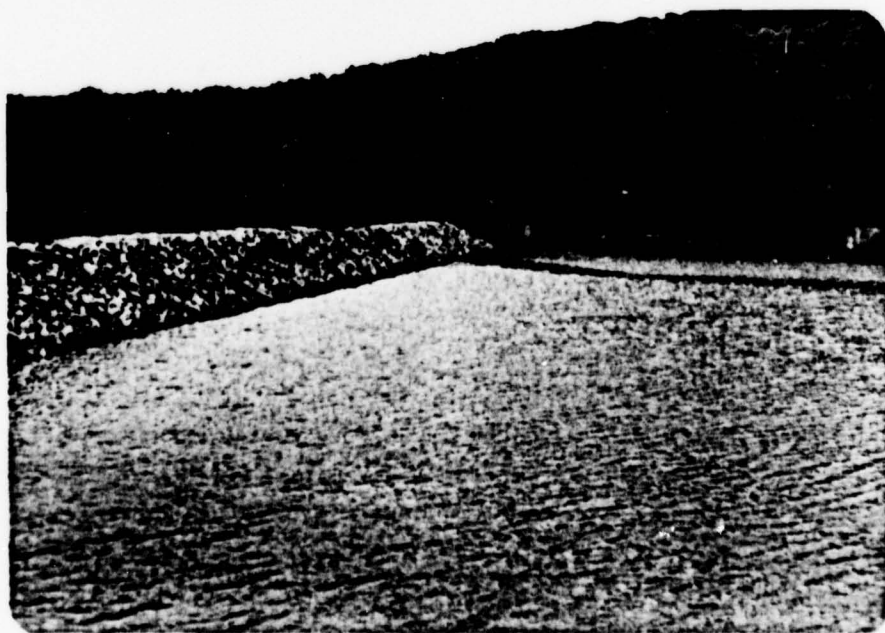
Upstream Face

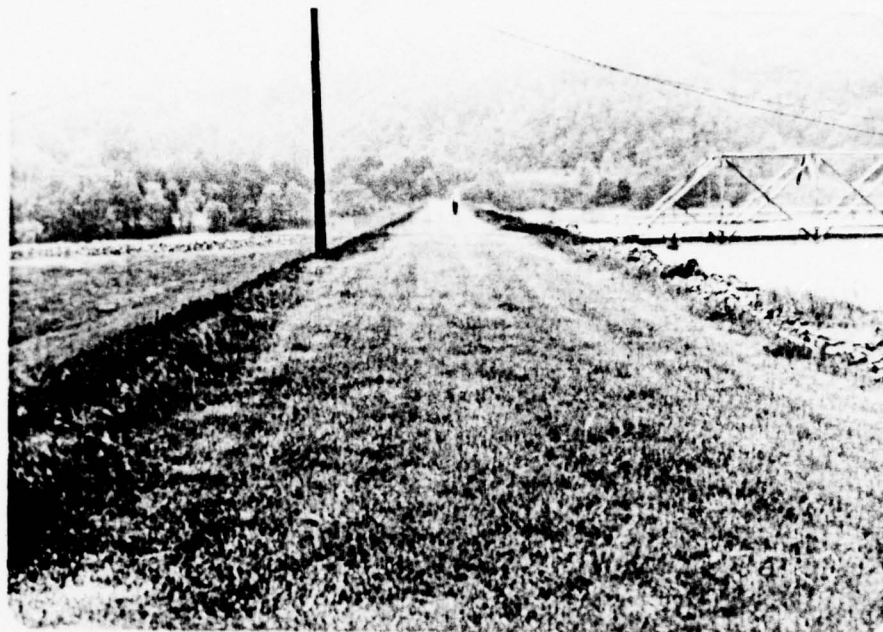
Photograph No. 1  
Crest (looking east).

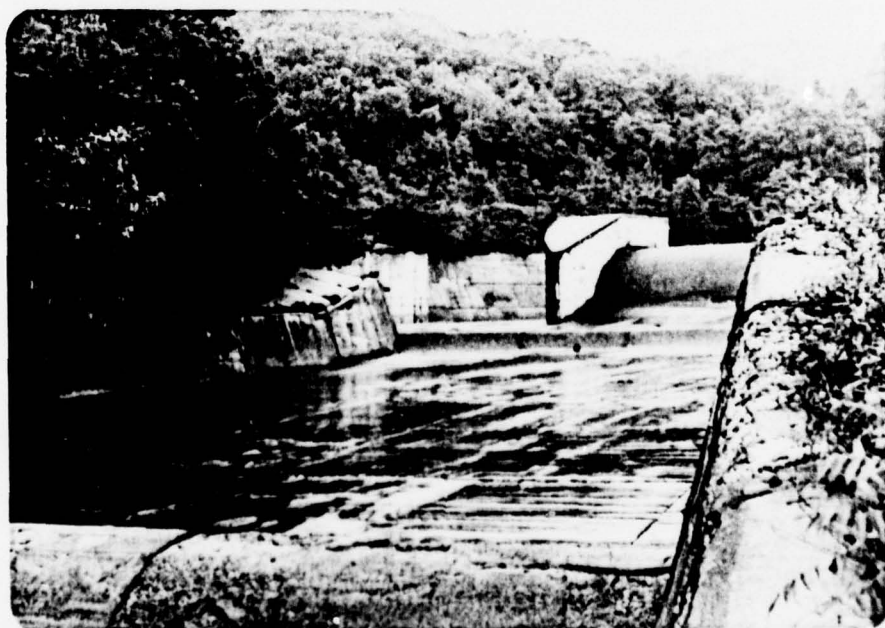
Photograph No. 2  
Spillway discharge channel.

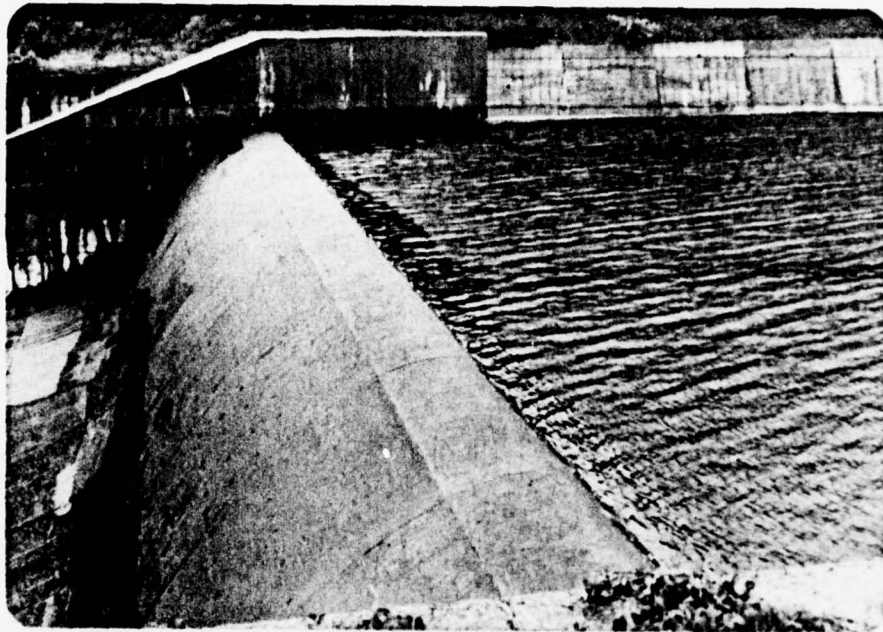
Photograph No. 3  
Primary spillway crest.

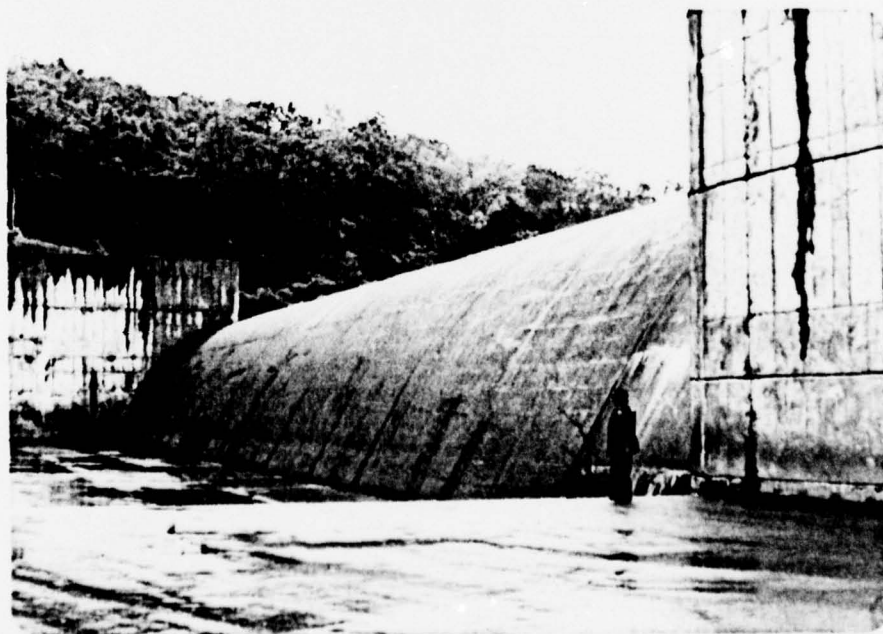
Photograph No. 4  
Side channel spillway crest.

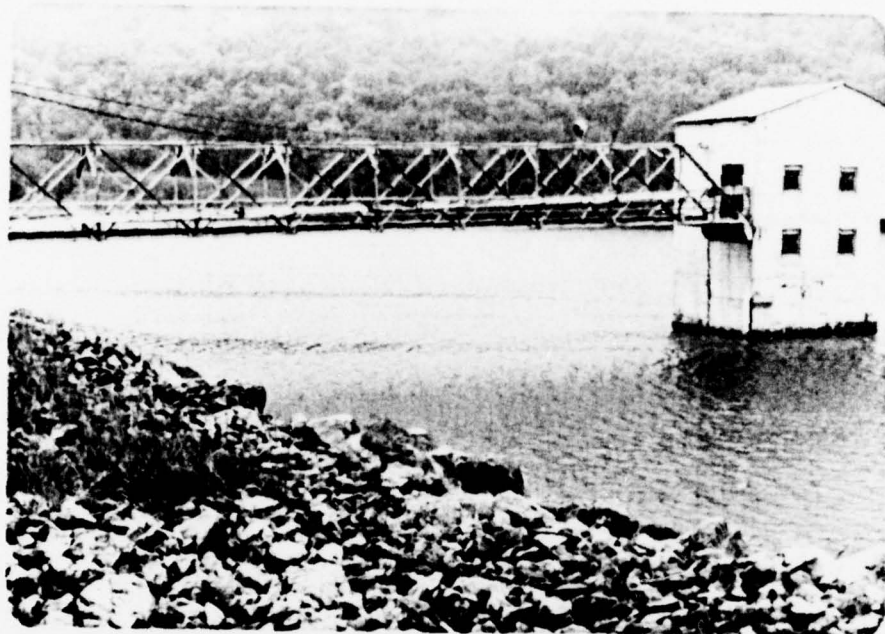
Photograph No. 5  
Intake tower.

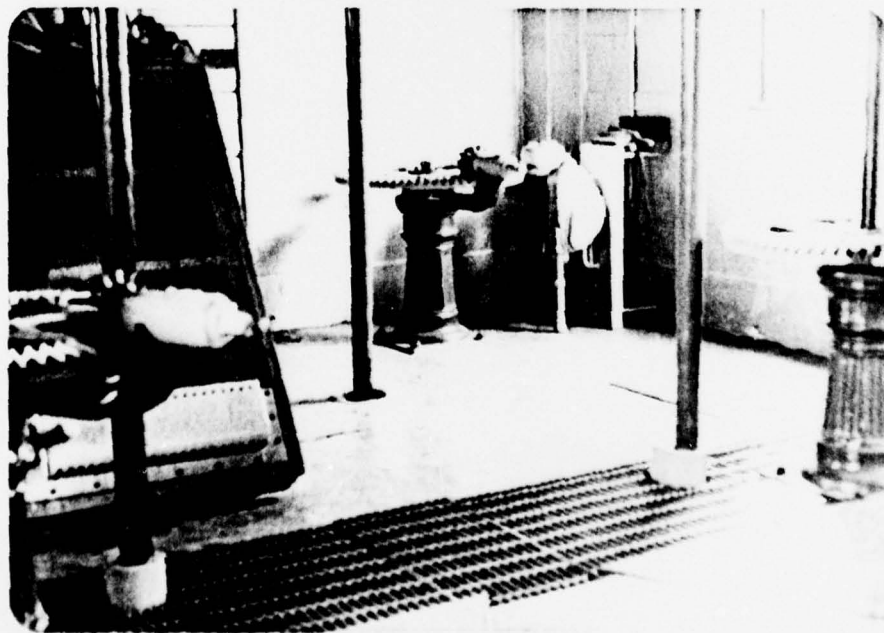
Photograph No. 6  
Valve controls in intake tower.

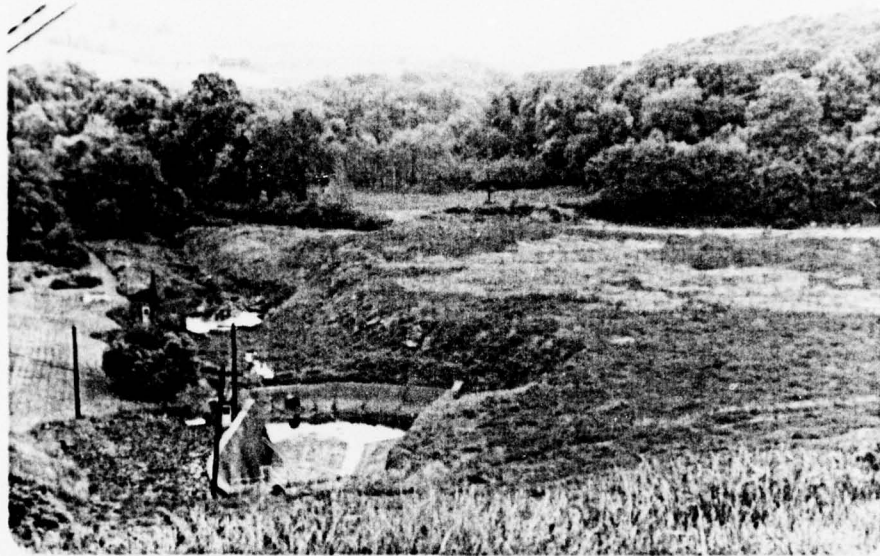
Photograph No. 7

Toe area (lake "blow-off" plunge pool; supply line "blow-off" valve house in background).

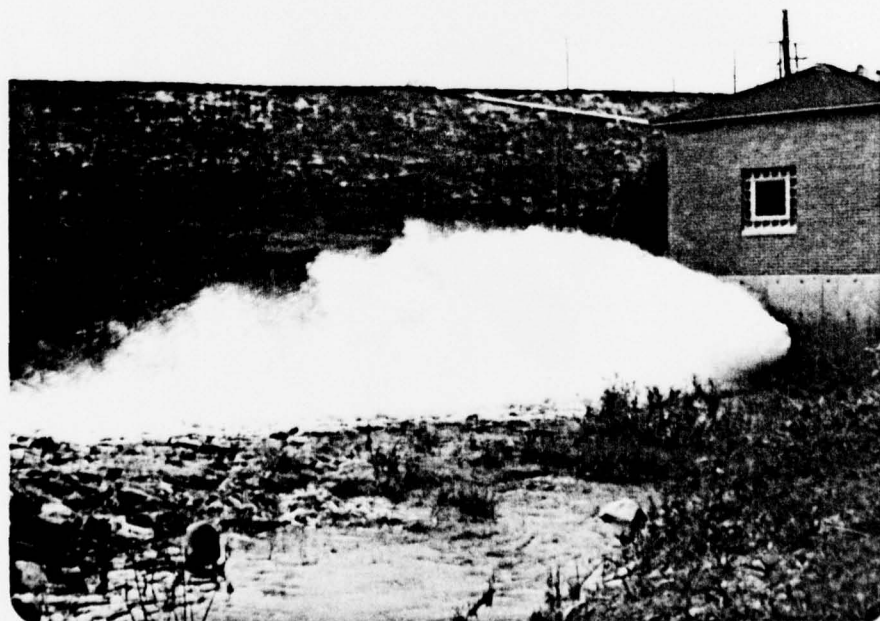
Photograph No. 8

Supply line "blow-off" operating.

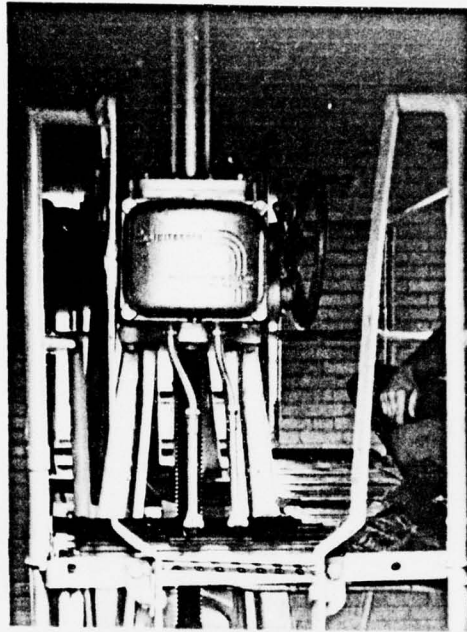
Photograph No. 9  
Supply line "blow-off" valve.

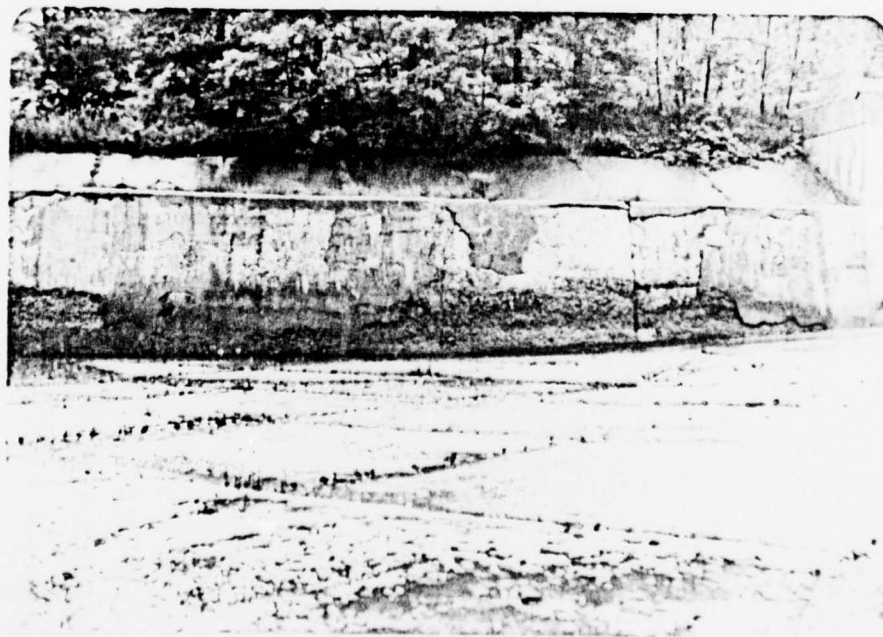
3.2 Evaluation. In general, the condition of the dam is considered to be very good. Some significant concrete spalling was observed in the spillway discharge channel. The spalling does not appear to have caused structural damage. However, repair measures should be taken to avoid further deterioration of the concrete.

VISUAL EXAMINATION OF	OBSERVATIONS	REMARKS OR RECOMMENDATIONS
CONCRETE WEIR	GOOD CONDITION.	
APPROACH CHANNEL	LAKE	
DISCHARGE CHANNEL	CONCRETE SPALLING AT VARIOUS LOCATIONS.	
BRIDGE AND PIERS	NONE

Photograph No. 10  
Spalling in spillway discharge channel.

1. It is recommended that the owner should locate the piezometers installed in 1961 and monitor and record the water levels within the embankment.
2. It is recommended that appropriate repairs should be made to stop concrete spalling at various locations along the spillway discharge channel to prevent structural damage.
3. It is recommended that the dam and appurtenant structures should be inspected regularly and any unusual condition should be reported to the appropriate authorities.
4. It is recommended that the owner should develop a formal warning system to alert the downstream residents in the event of emergencies.

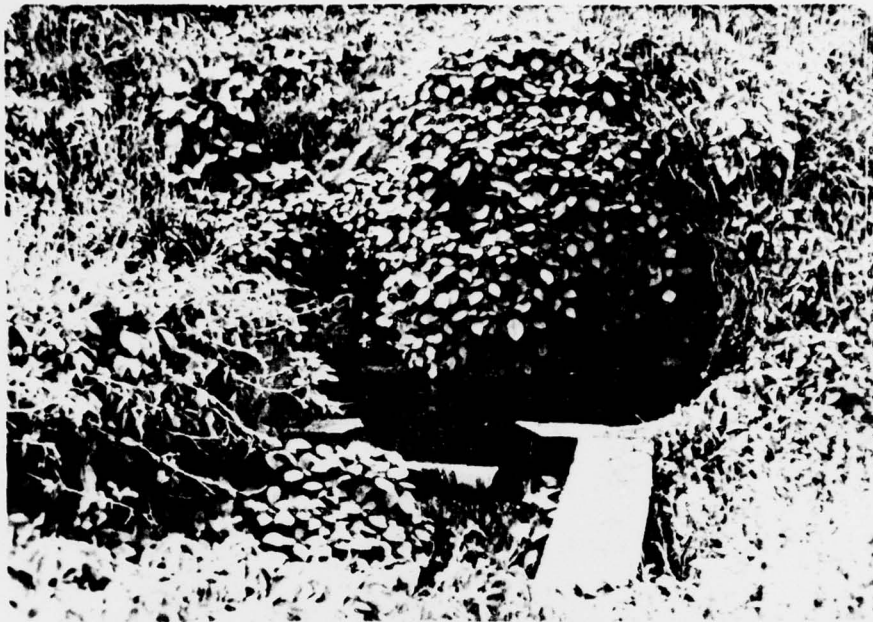
Photograph No. 11  
Seepage weir on left abutment.

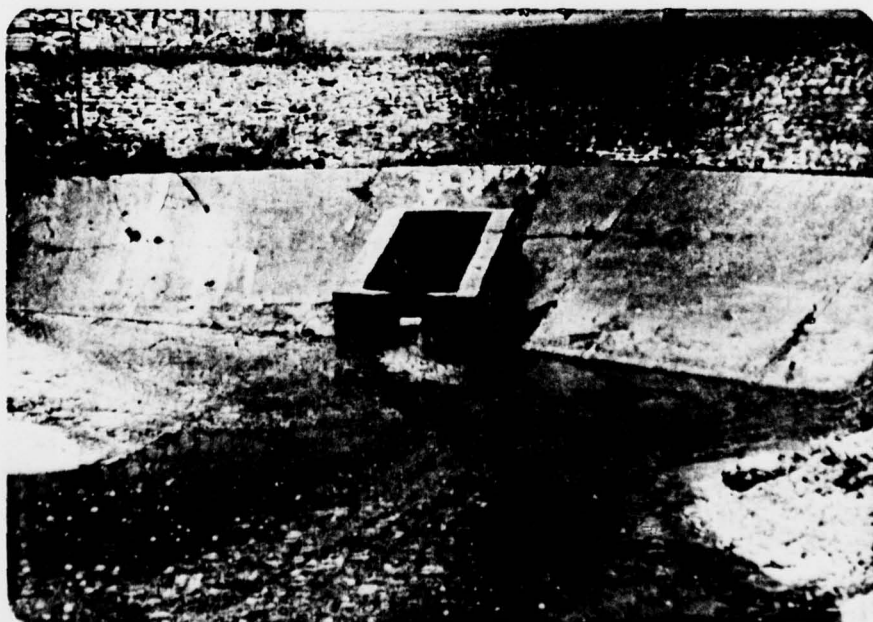
Photograph No. 12  
Seepage weir in lake "blow-off" plunge pool.

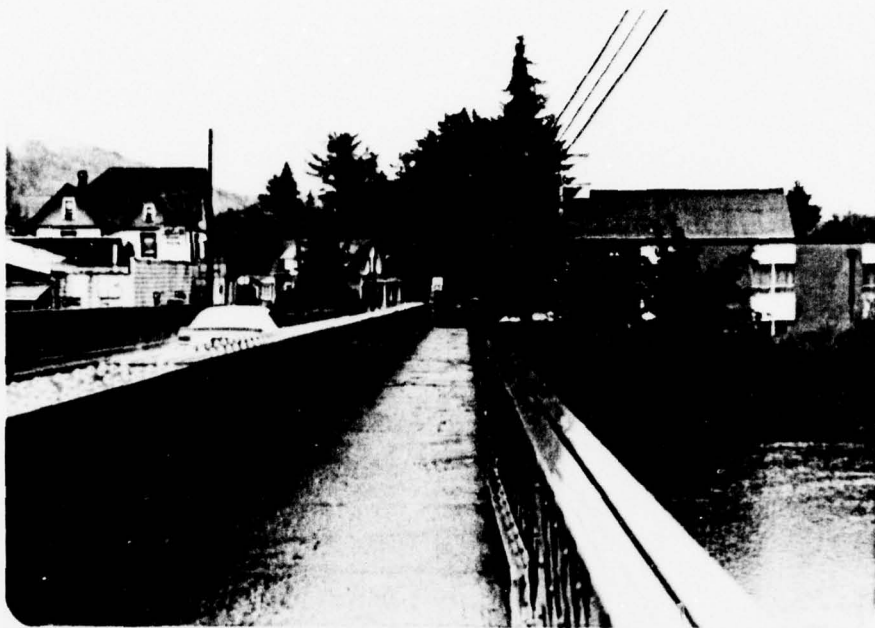
Photograph No. 13  
Bridge at Benson (looking east).

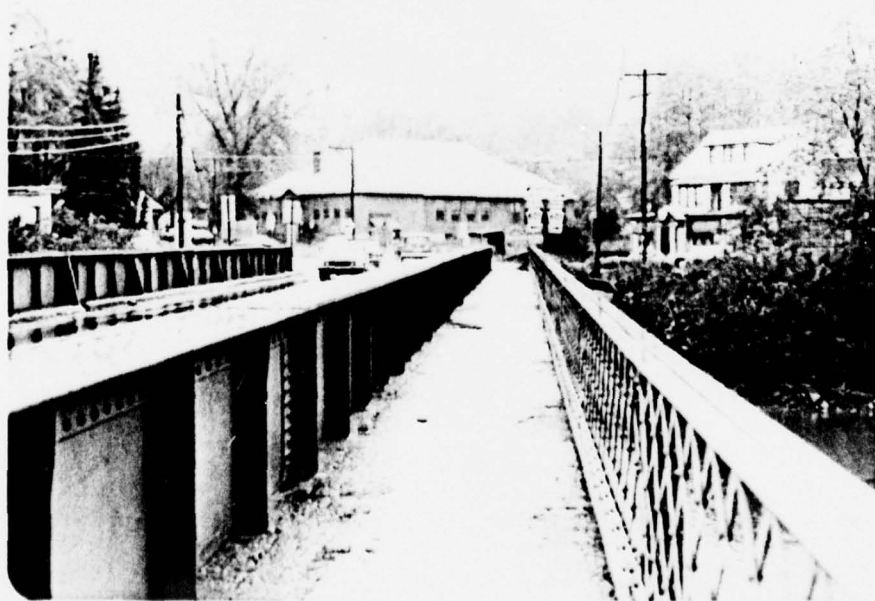
Photograph No. 14  
Bridge at Benson (looking west).
