2 LAKE STONEYCREEK DAM

(NDI I.D. NO: 227)

4 PHASE I INSPECTION REPORT
NATIONAL DAM INSPECTION PROGRAM

D'APPOLONIA CONSULTING ENGINEERS

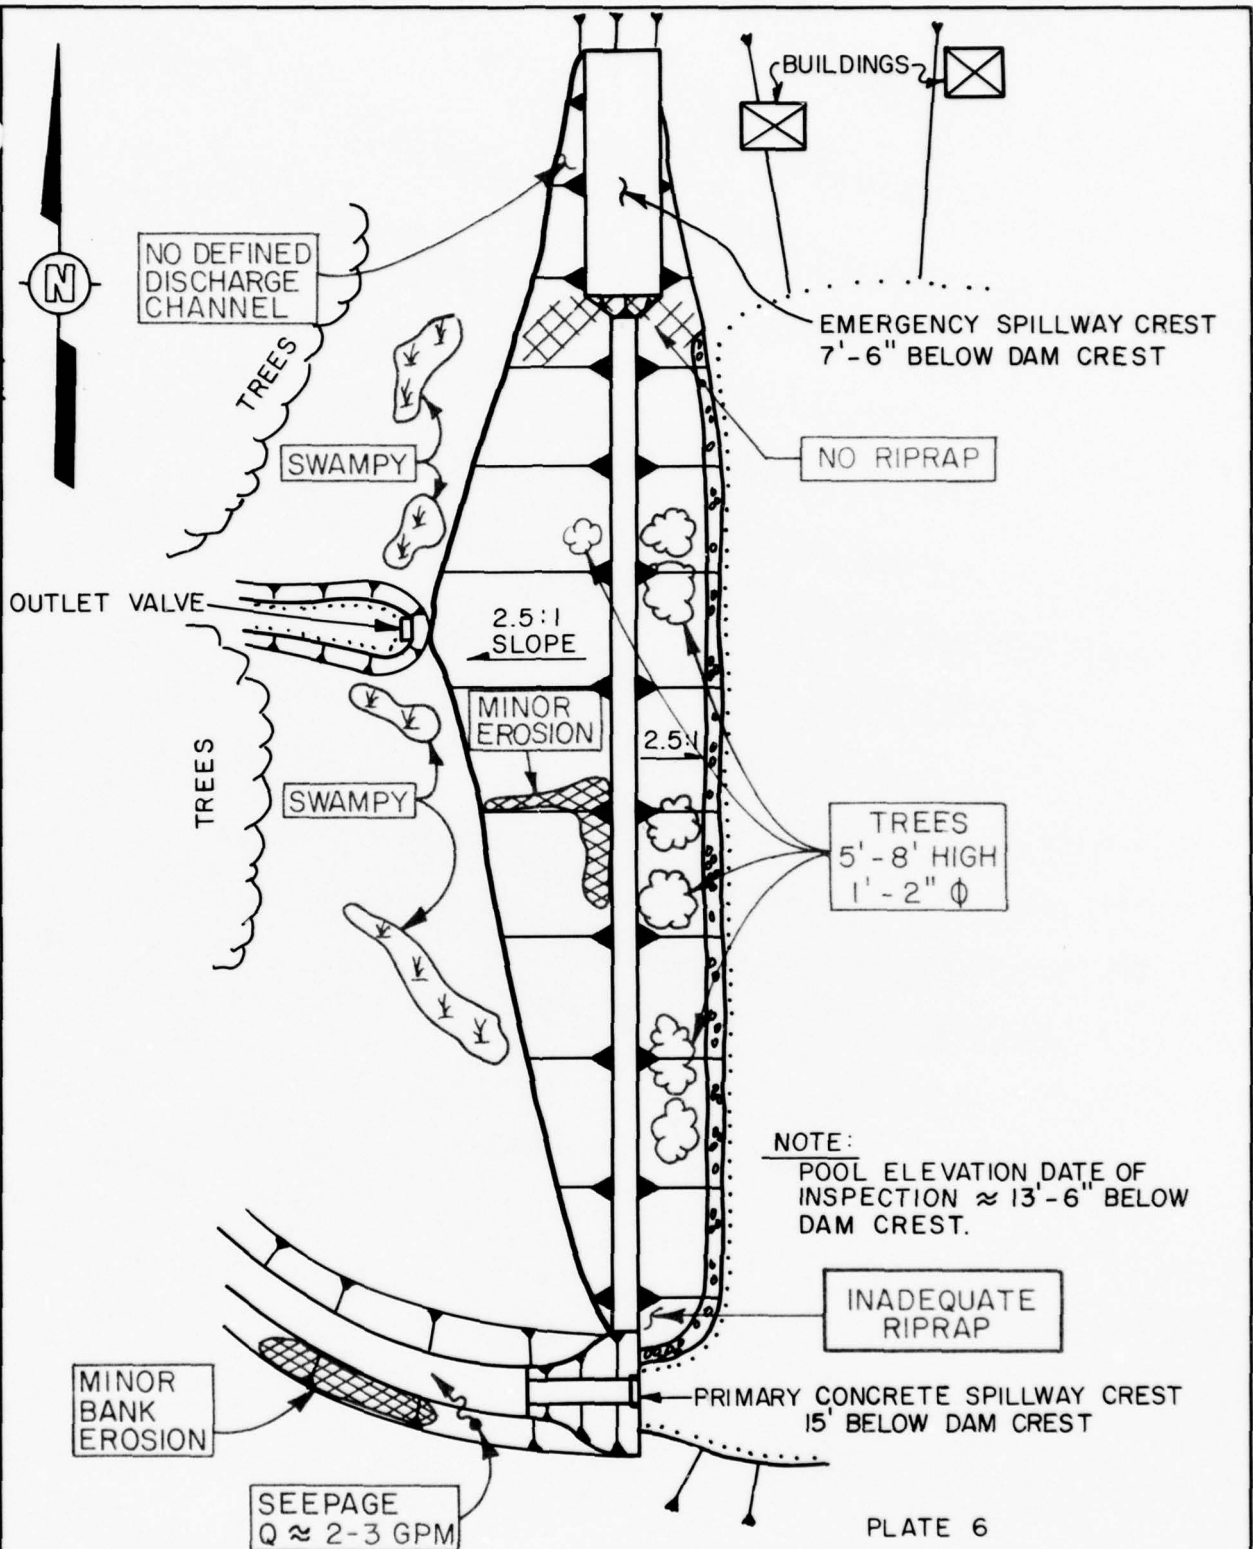
VISUAL EXAMINATION OF	OBSERVATIONS	REMARKS OR RECOMMENDATIONS
JUNCTION OF EMBANKMENT AND ABUTMENT, SPILLWAY AND DAM	NO SIGNS OF DISTRESS OR SEEPAGE	
ANY NOTICEABLE SEEPAGE	SOME NET & SWAMPY AREAS BELOW TOE SEE PLATE 6 FOR LOCATIONS.	
STAFF GAGE AND RECORDER	NONE	
DRAINS	NONE

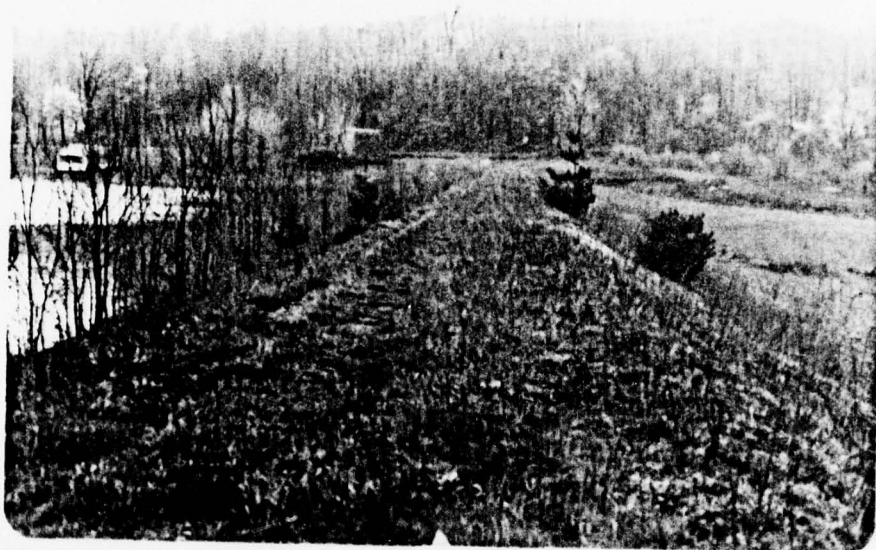
Photograph No. 1
Dam crest.

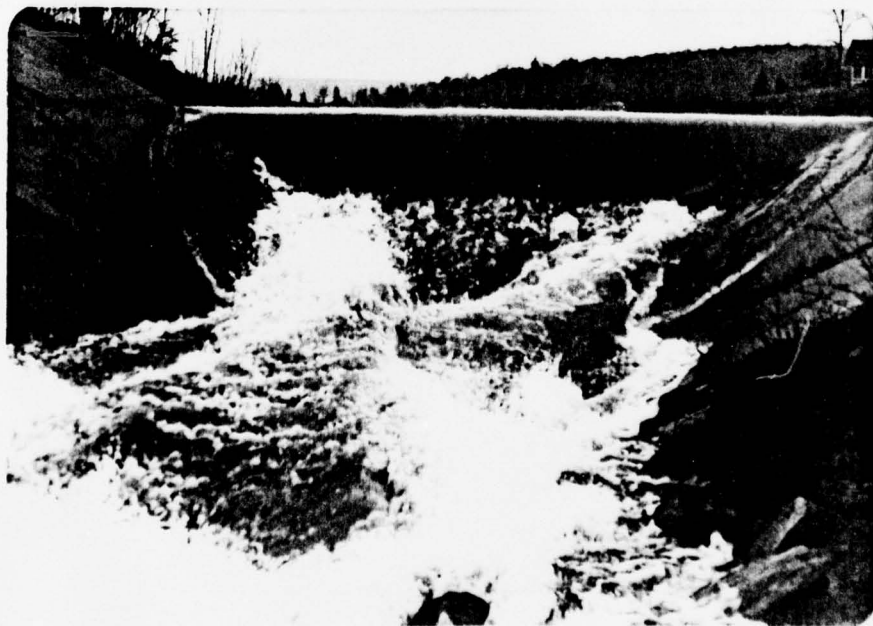
(2) Appurtenant Structures. The structural condition of the primary spillway is considered to be adequate. However, additional riprap on the sides of the approach channel is required to prevent undermining and damage to the concrete sections during high flows.

Photograph No. 2
Primary spillway.

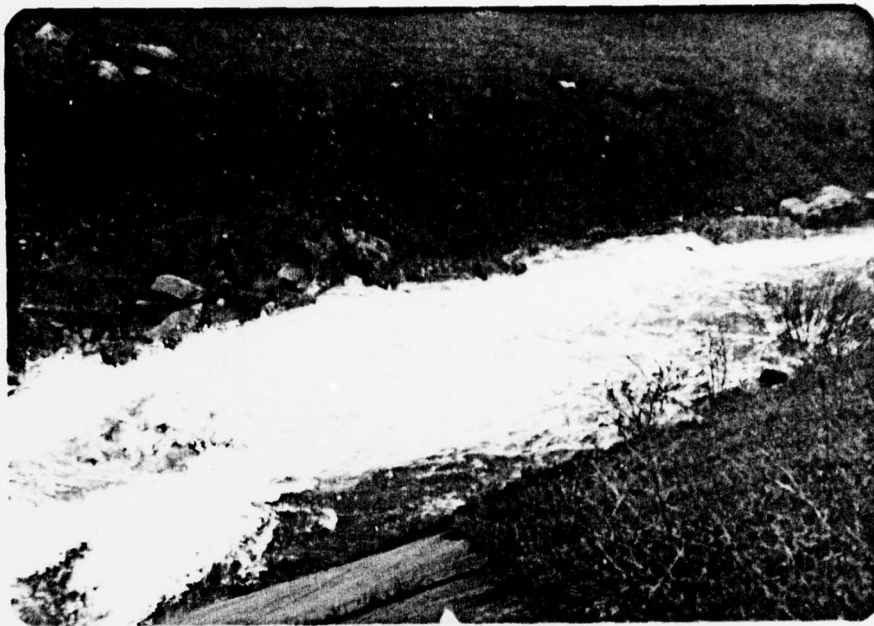
c. Appurtenant Structures. The primary spillway crest and discharge channel were examined for deterioration of the concrete and other signs of distress and obstructions that would limit the flow. The riprap at the approach channel of the primary spillway was considered to be inadequate to prevent undermining of the concrete slabs of the primary spillway. Only minor bank erosion was observed on the discharge channel of the primary spillway.

Photograph No. 5
Erosion in primary spillway discharge channel.

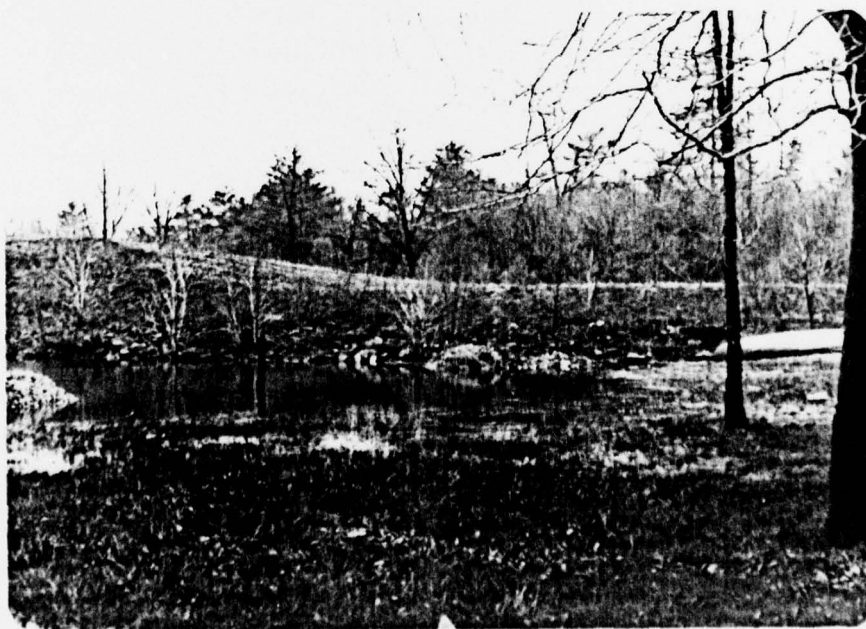
3.2 Evaluation. In general, the condition of the dam is considered to be fair. The most significant condition at the dam is the lack of erosion protection in the emergency spillway channel. This condition is considered to be a threat to the integrity of the embankment in the event of flow over this spillway.

Photograph No. 6
Emergency spillway crest at right abutment.

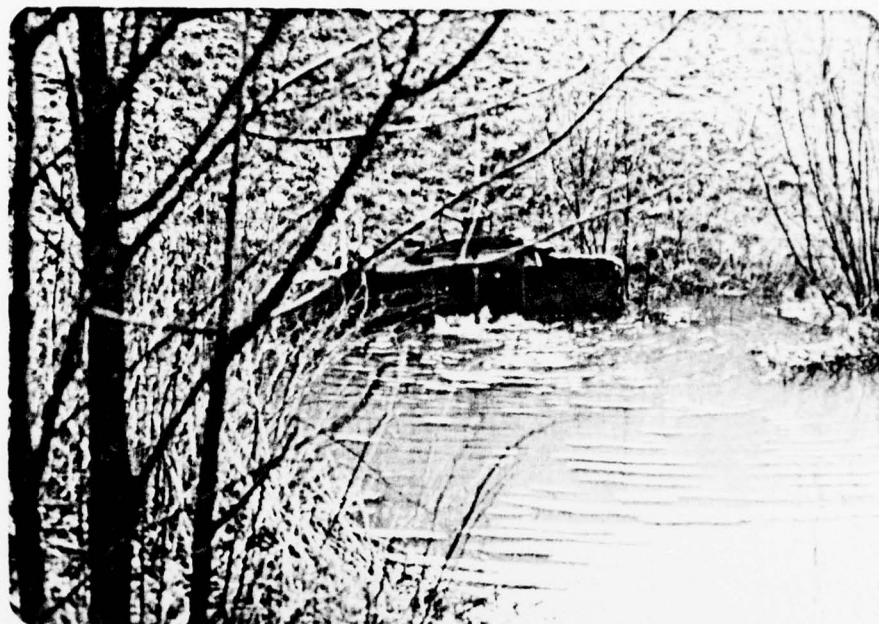
The drainpipe valve was operated and found to be functional. However, significant leakage around the gate was observed, indicating that the sluice gate is not properly seated.

4.3 Maintenance of Operating Facilities. The only operational feature of the dam is the drainpipe gate. On the date of inspection it was operated and found to be functional. However, significant leakage was observed between the gate and gate guide, indicating that the sluice gate is not adequately seated.

Photograph No. 7
Blow-off pipe valve (opened for inspection).

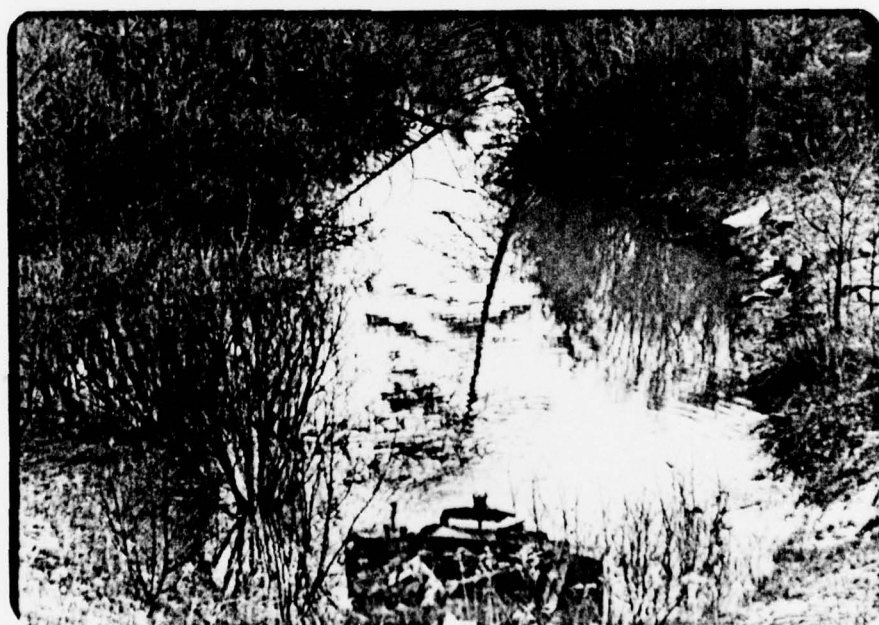
Photograph No. 8
Blow-off pipe discharge channel.

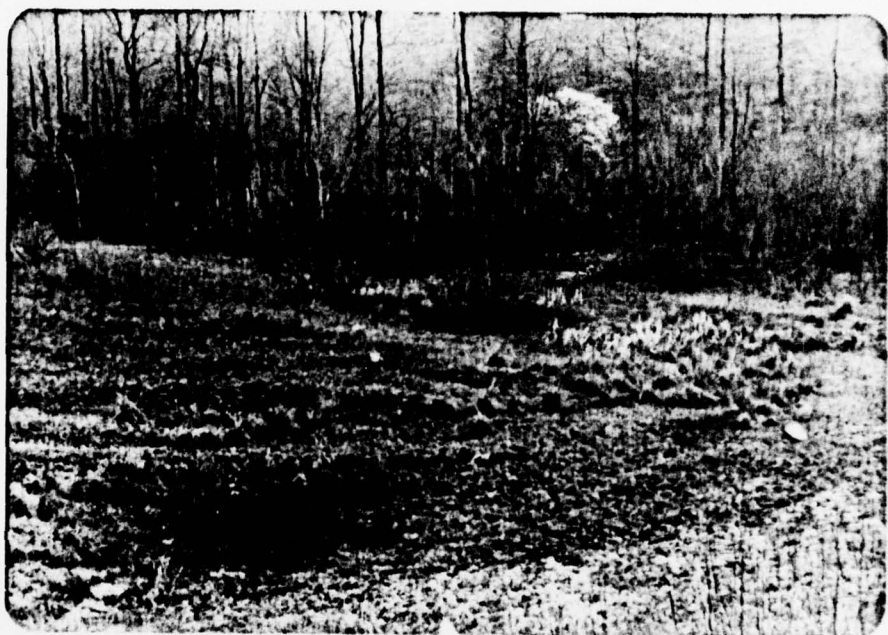
1. Numerous swampy areas were observed below the toe of the dam. No perceivable seepage flow was associated with these wet areas.
2. One concentrated seepage point was found on the slope of the primary discharge channel. Flow was estimated to be two to three gallons per minute.
3. It was observed that the emergency spillway was not built according to the plans. It lacks erosion protection and has no defined discharge channel.
4. The upstream face of the dam was covered with brush and trees five to eight feet high and one to two inches in diameter.

Photograph No. 9
Wet areas below toe.

6. The dam and appurtenant structures should be inspected regularly and any unusual conditions should be reported to the appropriate authorities. During these inspections, special attention should be directed to the wet areas below the toe of the dam to assure that major seepages through these areas are not developing.
