3 OHIO RIVER BASIN
NORTH BRANCH OF LITTLE CONEMAUGH RIVER,
CAMBRIA COUNTY
PENNSYLVANIA

2 WILMORE DAM

NDI I.D. NO: 435

4 PHASE I INSPECTION REPORT
NATIONAL DAM INSPECTION PROGRAM

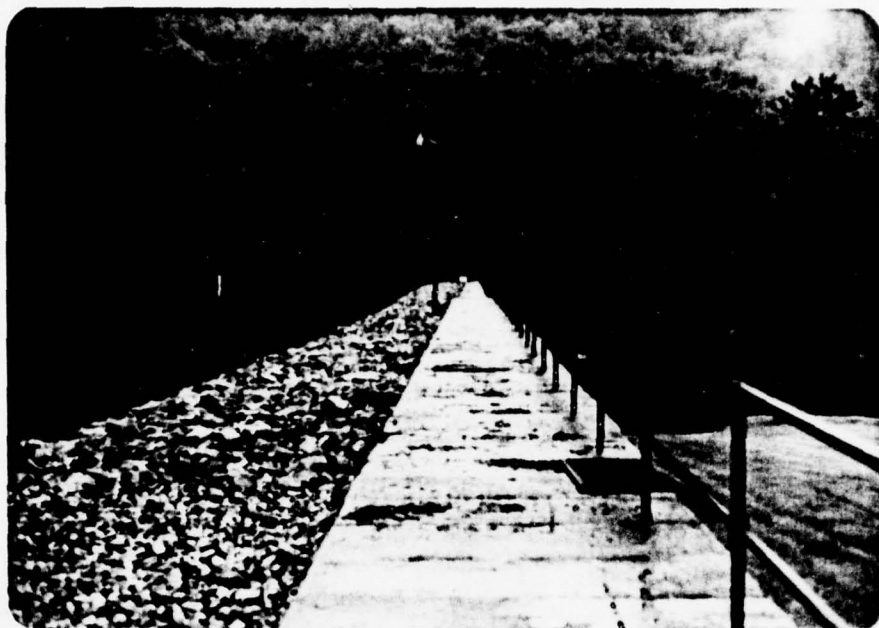
Photograph No. 1
Crest (looking south).

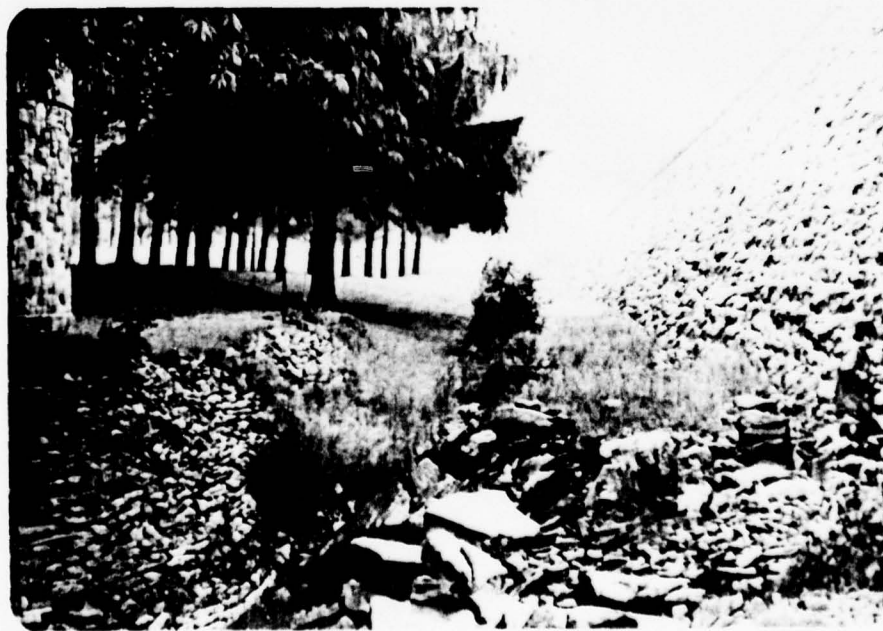
Photograph No. 2
Right abutment.

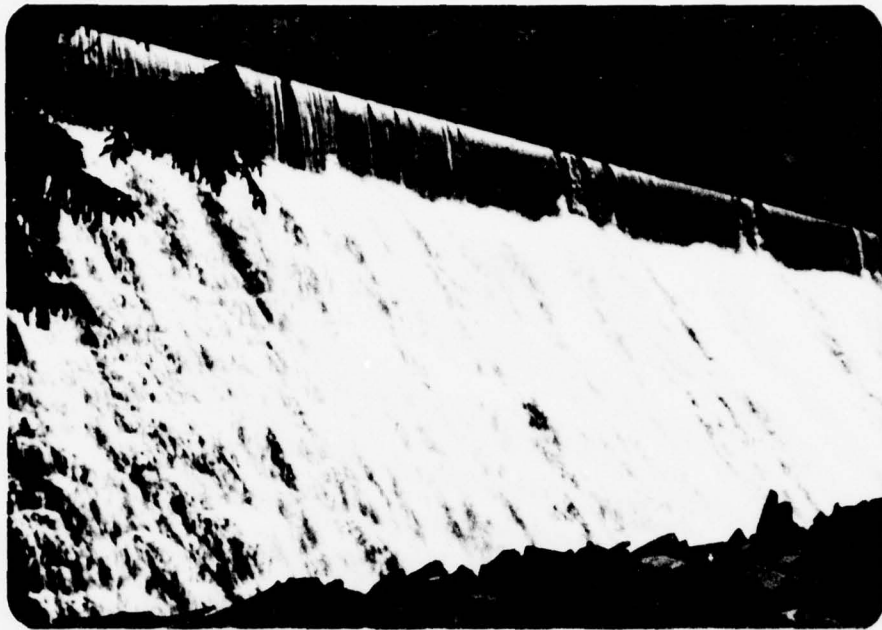
Photograph No. 3
Spillway.

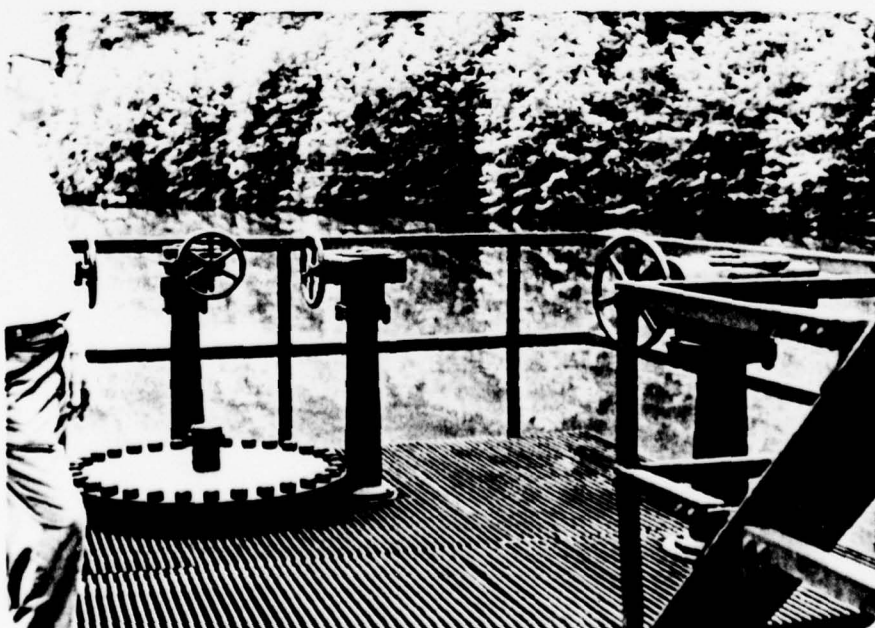
Photograph No. 6
Gate controls at intake tower.

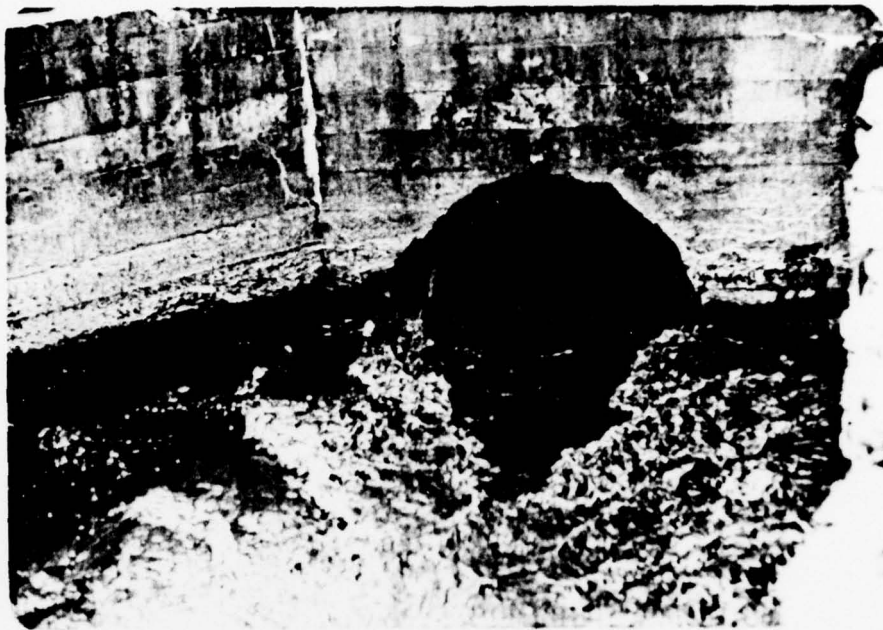
4.3 Maintenance of Operating Facilities. The operating facilities are adequately maintained. On the date of the field inspection, the blow-off valve was operated by water company personnel and was observed to be functional.

Photograph No. 7
"Blow-off" pipe discharging.

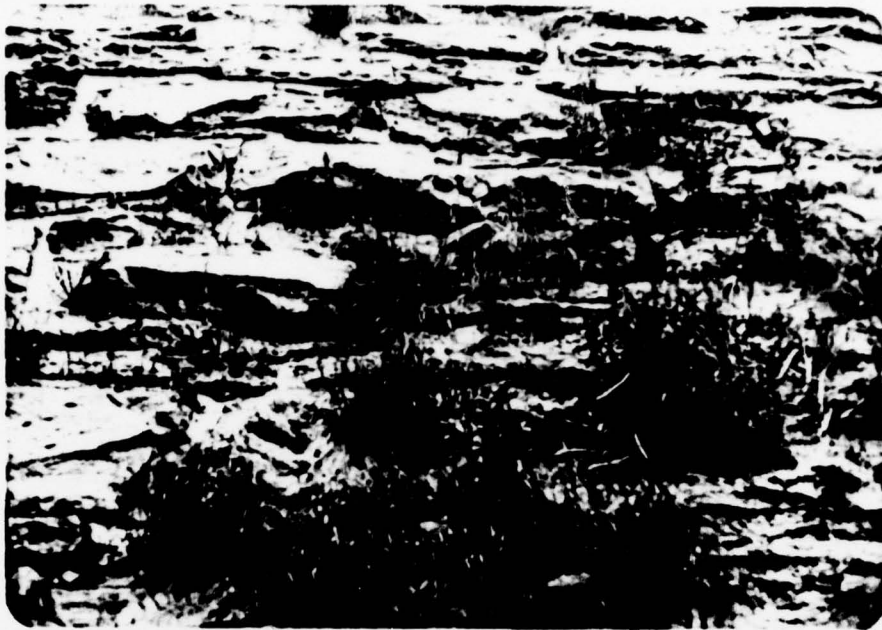
1. Two sections of the downstream face were found to be wet. One area was located on the right end of the secondary spillway over a distance of about 30 feet. No concentrated seeps appeared to be associated with the wet area. The second wet area was located immediately to the right of the primary spillway. Several concentrated seepage points were observed approximately 10 to 13 feet below the secondary spillway crest. The total flow from this area was estimated to be about 4 to 5 gallons per minute.
2. A section of the stream bank along the left abutment apparently has eroded during high flows through the spillway. However, the present extent is not considered to be a threat to the integrity of the dam, and a substantial increase in erosion is not anticipated in the near future.

Photograph No. 9
Typical wet area on downstream face.
