USAFA-TR-78-11

**ENVIRONMENT, DISASTER, AND RECOVERY:
A LONGITUDINAL STUDY OF THE 1970 GEDIZ EARTHQUAKE
IN WESTERN TURKEY.**

WILLIAM A. MITCHELL MAJOR, USAF
Professor

NOV 1978

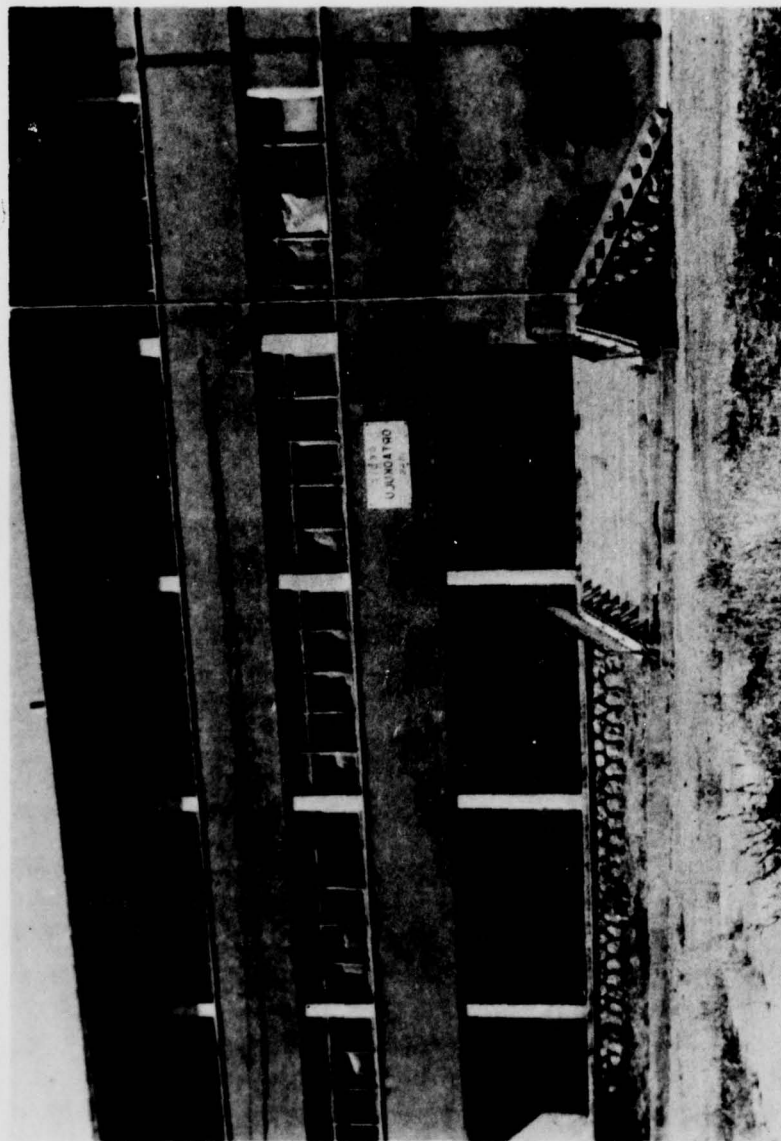
Figure 9

This junior high school suffered structural damage during the earthquake and was abandoned. It is now used to store opium poppy.

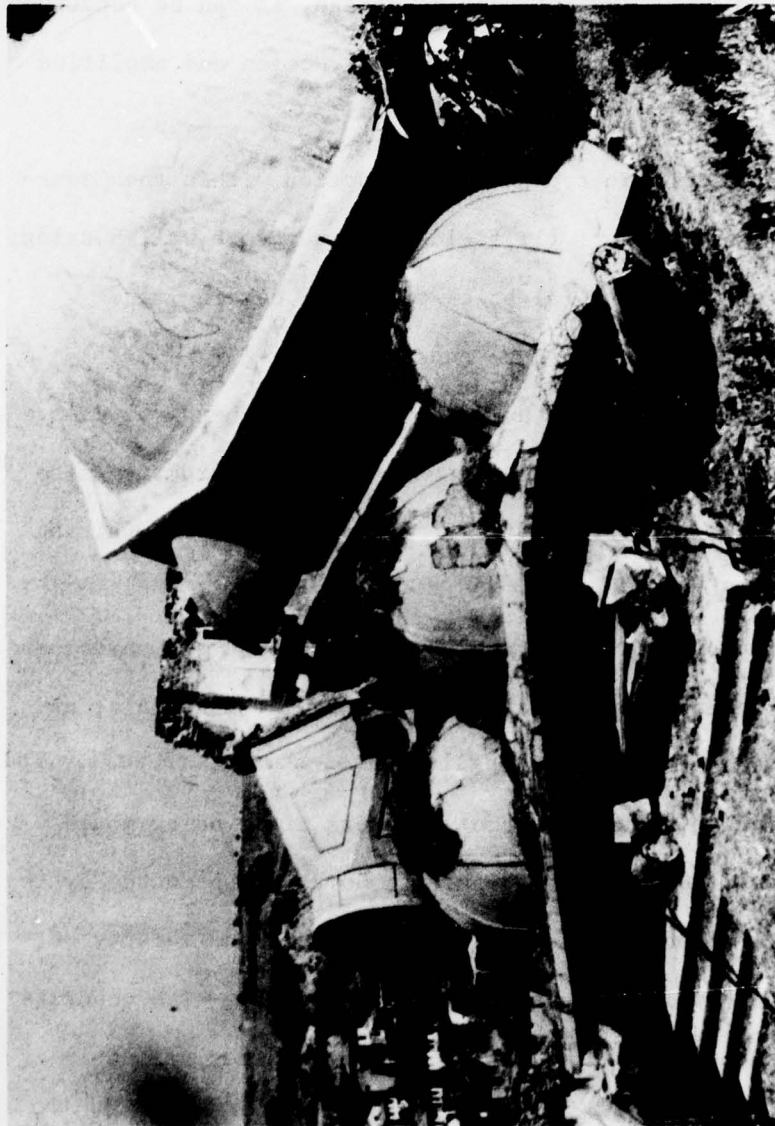
The main causes of such extensive damage were (1) fires and (2) ground shaking from the main shock. Such damage was compounded by poor construction within the area and ground/soil conditions.

Figure 15
A COLLAPSED MOSQUE IN GEDIZ

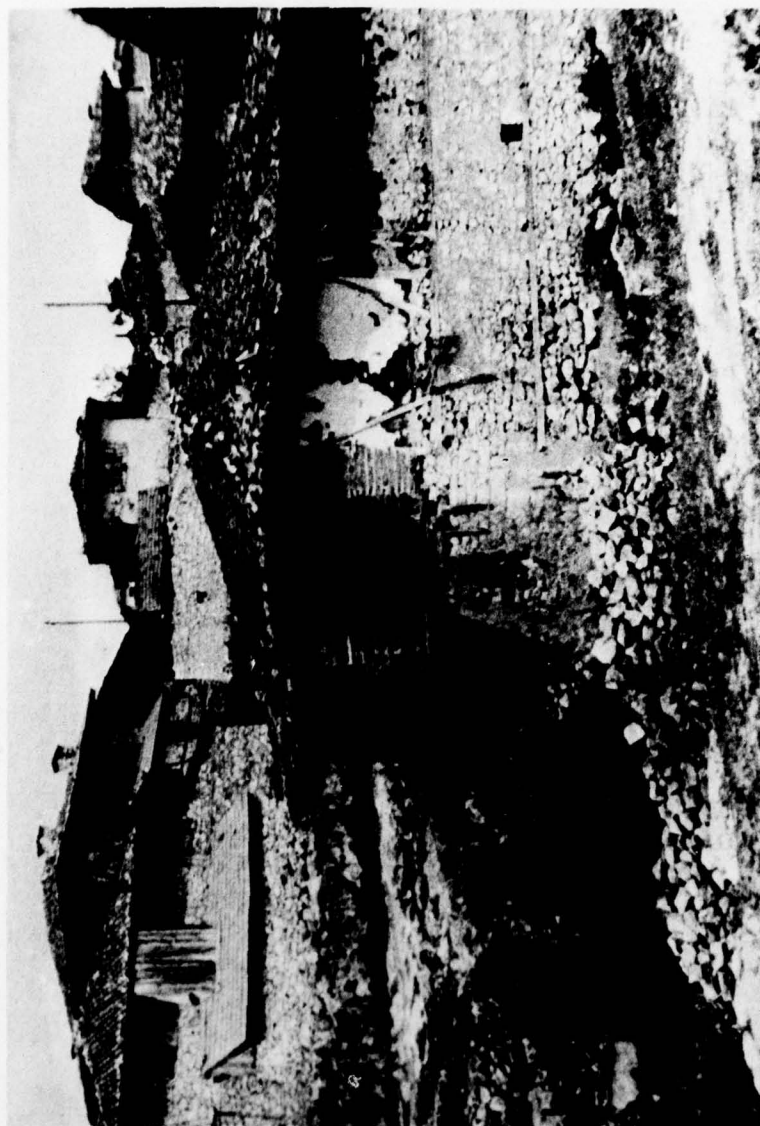
Figure 16

The fieldstone/mud adobe buildings suffered the worst damage of the disaster (Figure 16). Round-post timber construction also received heavy damage with sawn timber frame construction fairing much better (Table 13).

Fieldstone/adobe wall-bearing construction
such as this suffered the greatest damage.

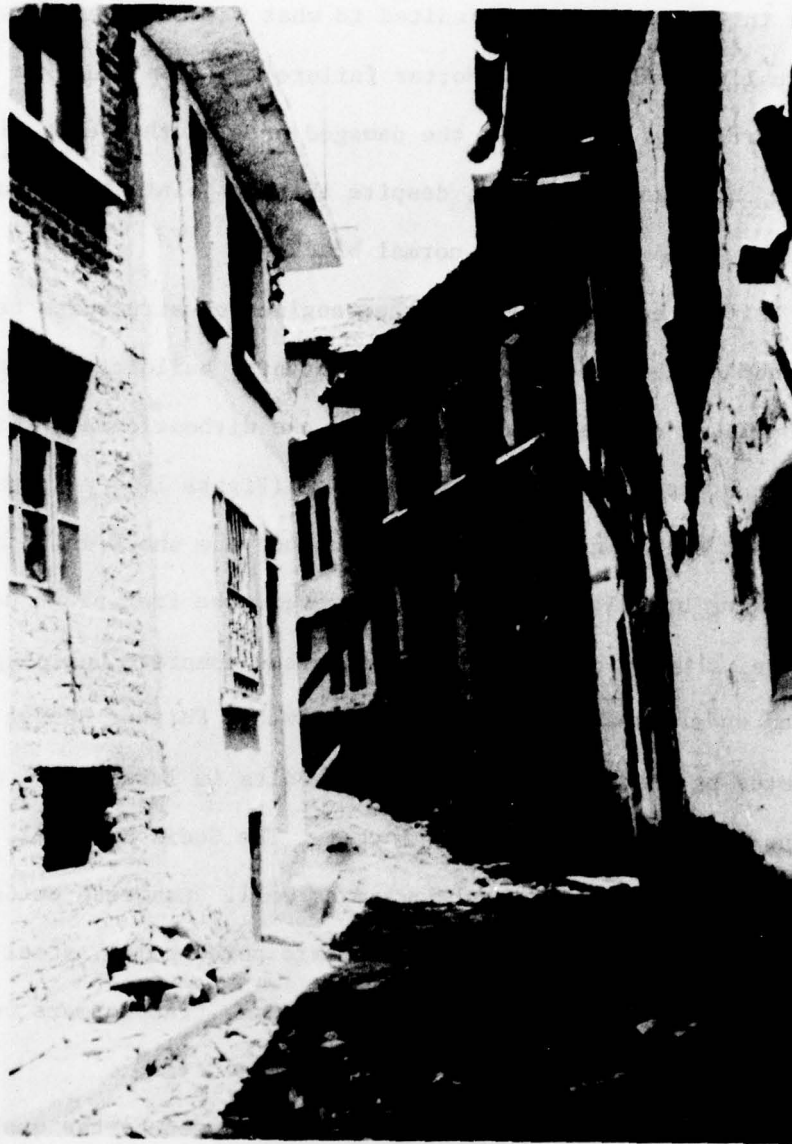
FIGURE 17

Buildings that survived total collapse
were often subsequently temporarily
supported by timber braces.

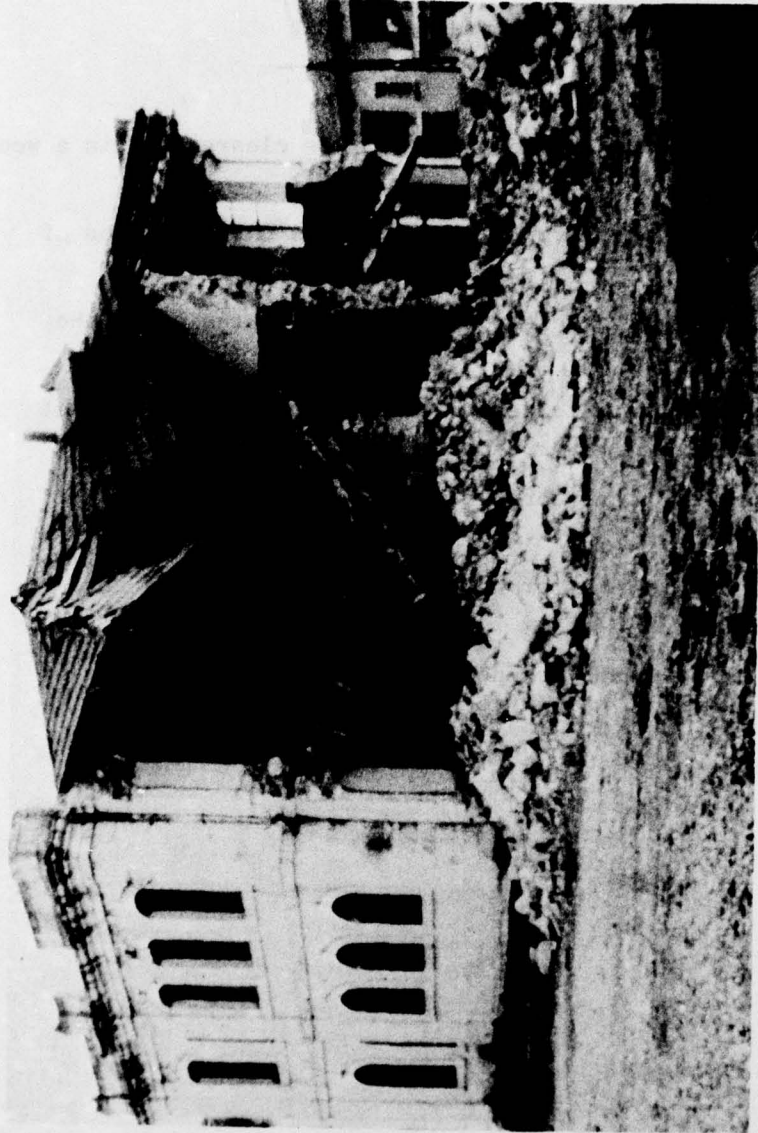
FIGURE A-1
A Destroyed Government Building

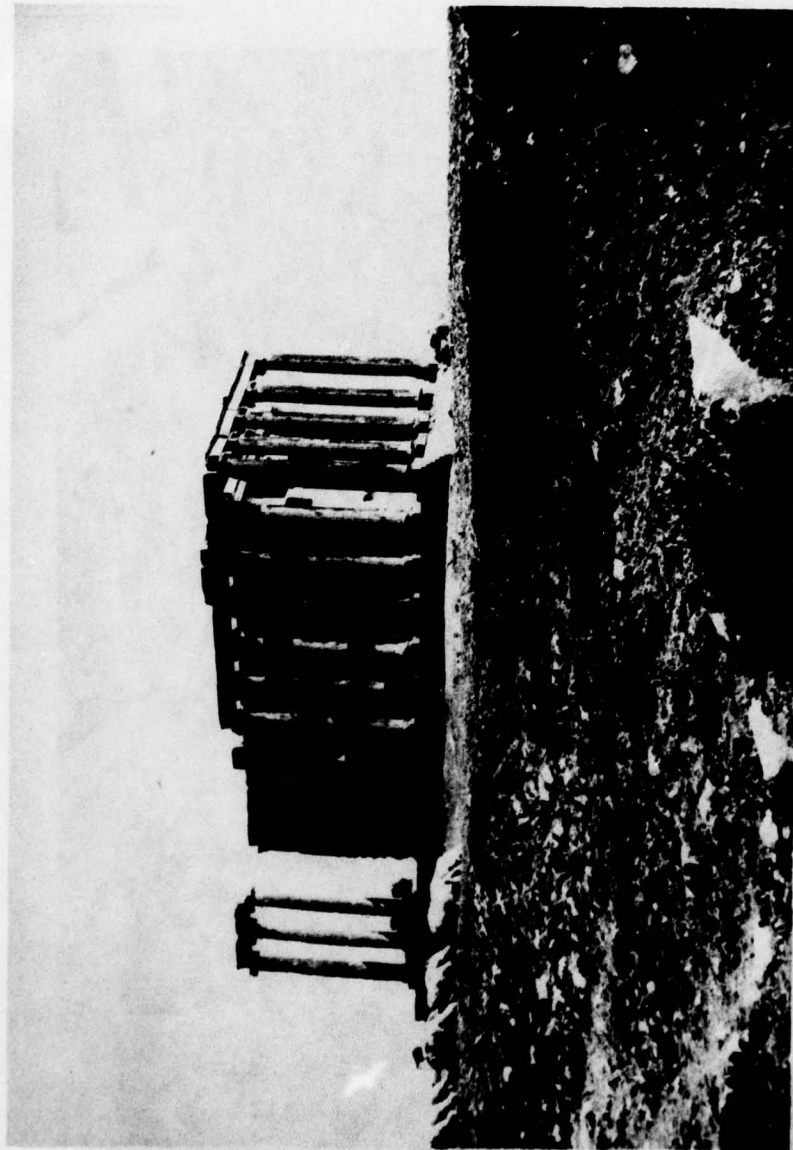
Many cultural structures were also damaged by the quake. Most of the mosques within Gediz and the surrounding villages were severely damaged, including the Gediz Ulu Cami which was built in the 15th Century by Mehmet Çelebi. Columns along the northeast corner of the Temple of Zeus, near Çavdarhisar, also fell (Figure A2).

FIGURE A-2
The Temple of Zeus

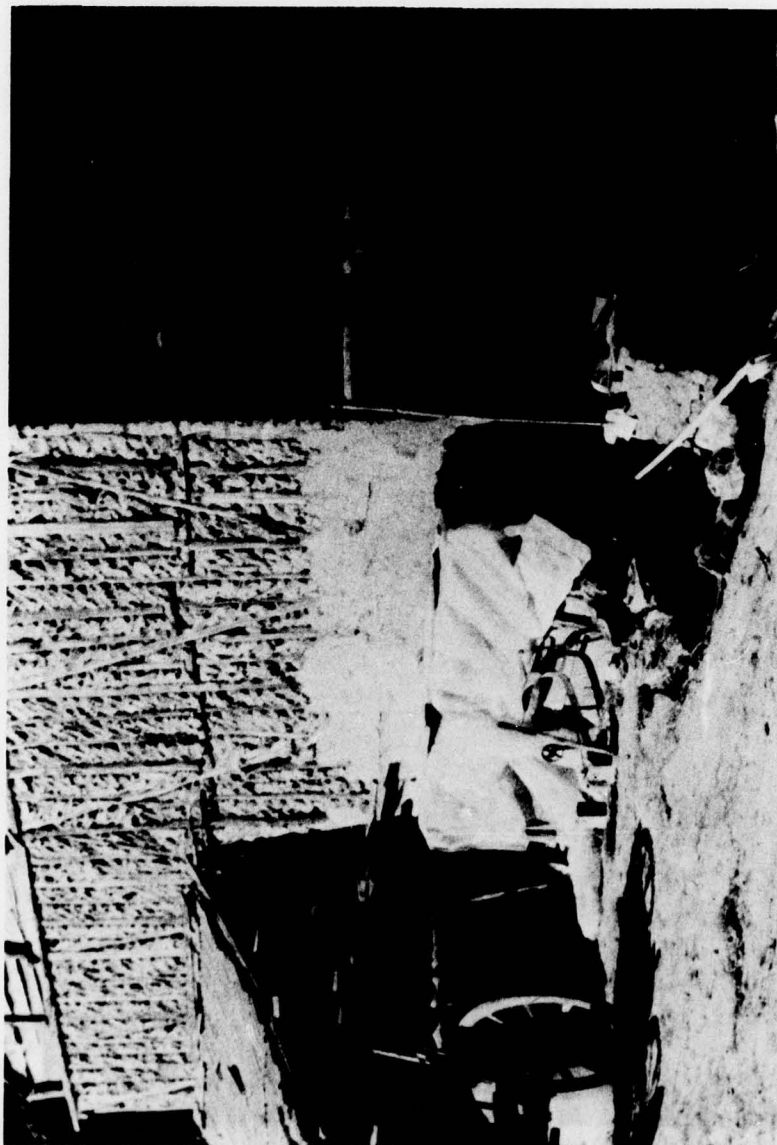
FIGURE B-2

This house in old Gediz was "patched up" after the disaster and is still lived in
