Name Of Dam: HUNGRY MOTHER STATE PARK DAM

Location: SMYTH COUNTY, VIRGINIA

Inventory Number: VA 17309

# PHASE I INSPECTION REPORT

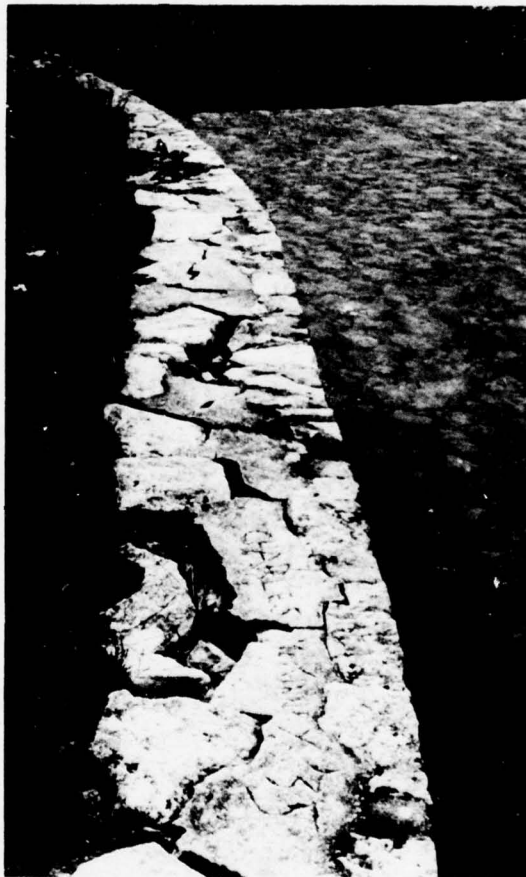
The spillway channel retaining walls consist of hand-placed field stone, laid in a concrete mortar base. The south retaining wall has begun to deteriorate such that the top stones have come loose. The walls appeared to be in good condition near the base.

TOP OF SOUTH WALL OF SPILLWAY SHOWING  
DETERIORATED ROCK SURFACE

| VISUAL EXAMINATION OF | OBSERVATIONS | REMARKS OR RECOMMENDATIONS |
|---|---|---|
| DISCHARGE CHANNEL | Few loose stones in channel bottom. Top of south retaining wall disintegrating along most of lower portion of wall. | |

4.5 Evaluation: Although the maintenance program has kept up the appearance of the dam, it has not kept up with some of the deteriorating conditions which should be attended to. Specifically, the spillway retaining walls are in need of repair, the one gate valve in the gate tower should be repaired, the downstream side slopes immediately after the spillway should be dressed to protect against erosion, and the riprap should be cleared of brush and then reinforced.

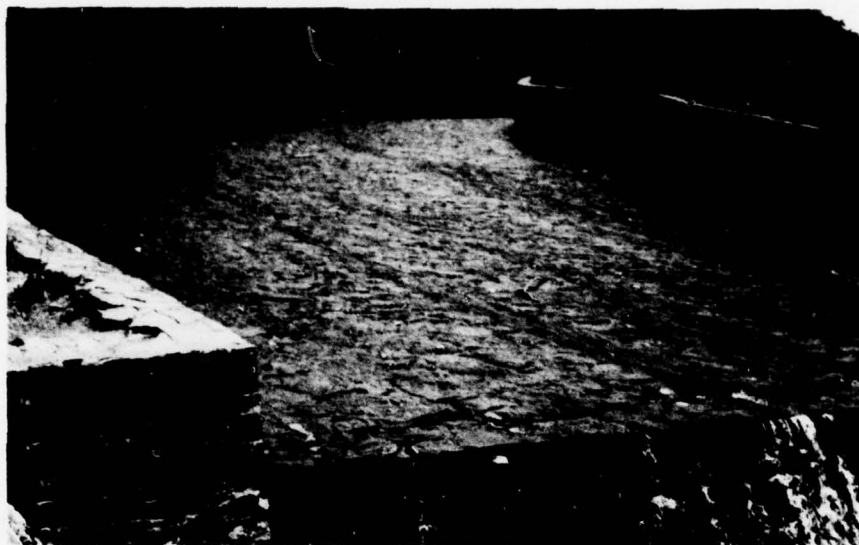
VIEW FROM BOTTOM OF SPILLWAY CHUTE
