Name Of Dam: FALLS MILLS DAM

Inventory Number: VA 18503

PHASE I INSPECTION REPORT

NATIONAL DAM SAFETY PROGRAM

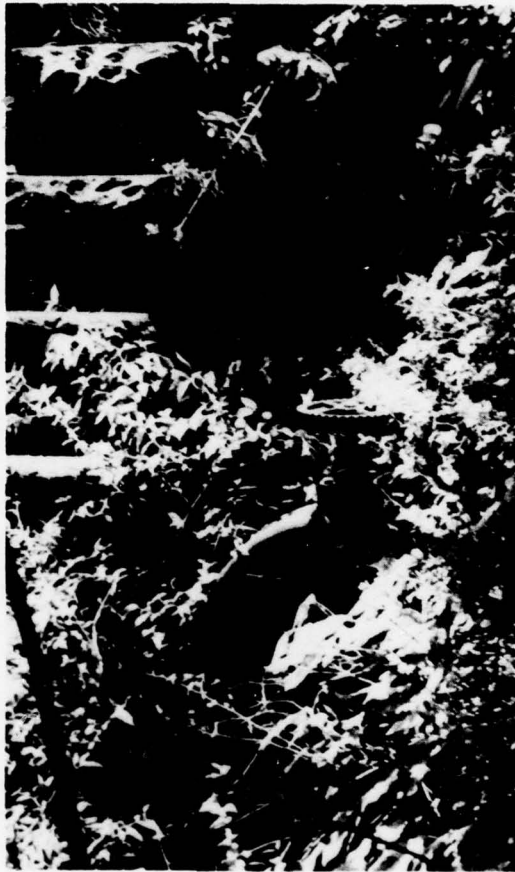
7.1.3 The drain valves did not appear to be operable and therefore cannot be used to lower the reservoir elevation below the spillway crest during emergency conditions.

DETAIL OF DISCHARGE VALVE

7.2.3 It is recommended that at least one of the drain valves be made operable within the next year. It is suggested that because of the depth of sediment, the southerly drain valve may be more effective in lowering the water level at the right abutment.

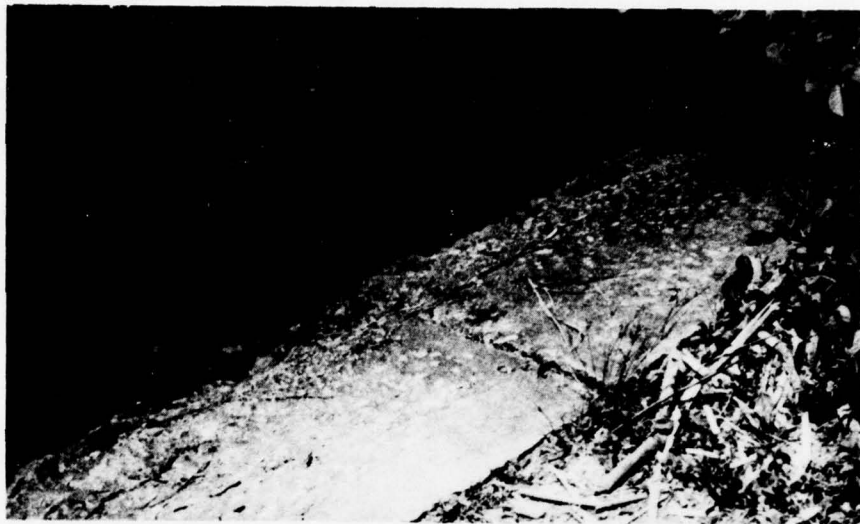
RESERVOIR SLOPE PAVING - NEAR CENTER OF FILL EMBANKMENT

7.2.4 It is recommended that within 30 days the abutment slopes and the fill embankment be cleared of trees, grasses or other acceptable ground cover be established on the upstream and downstream slopes, and areas of disturbed riprap be repaired on the upstream slopes of the embankment.

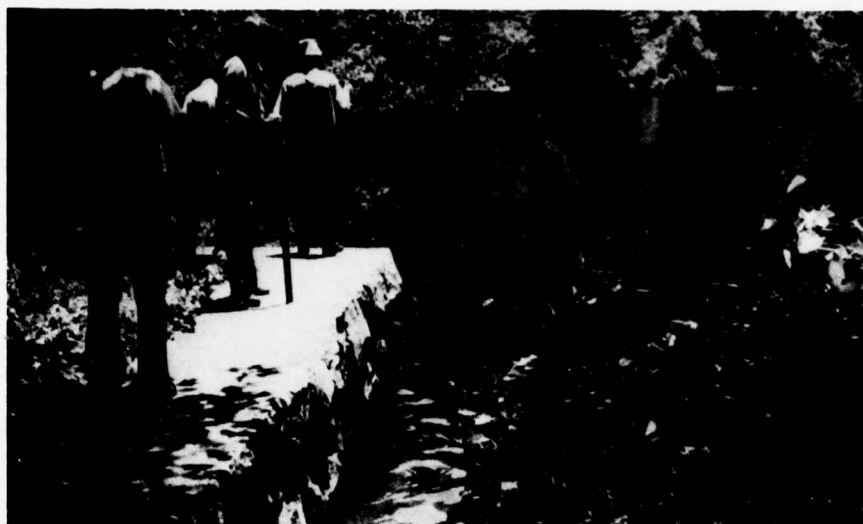
VIEW FROM LEFT ABUTMENT

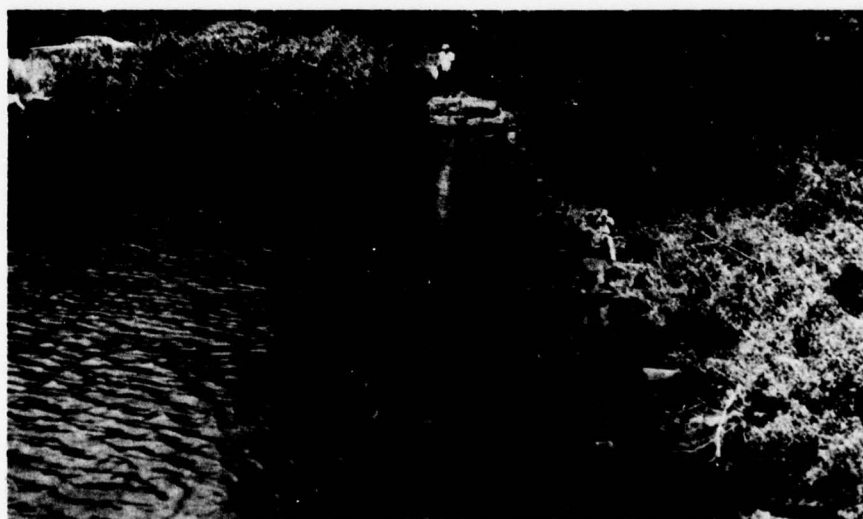
VIEW FROM RIGHT ABUTMENT
NOTE: TOP WIDTH OF DAM

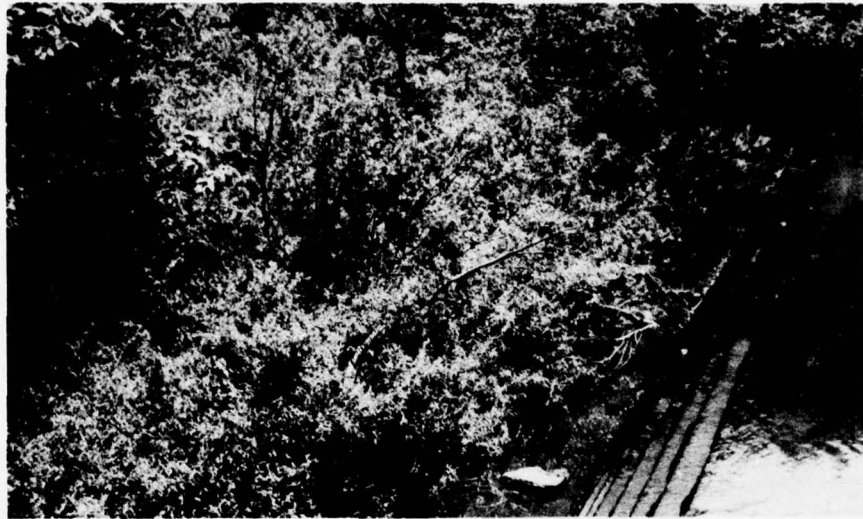
DOWNSTREAM CHANNEL AT TOE OF DAM

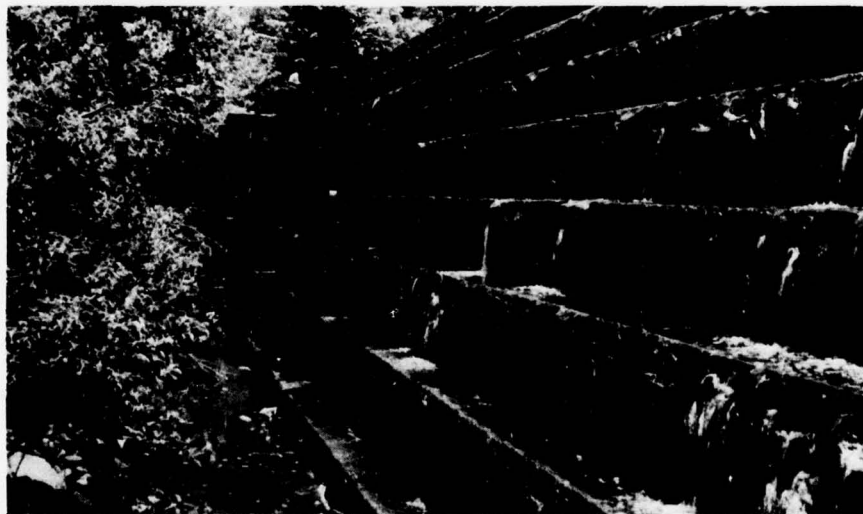
DETAIL OF DOWNSTREAM FACE

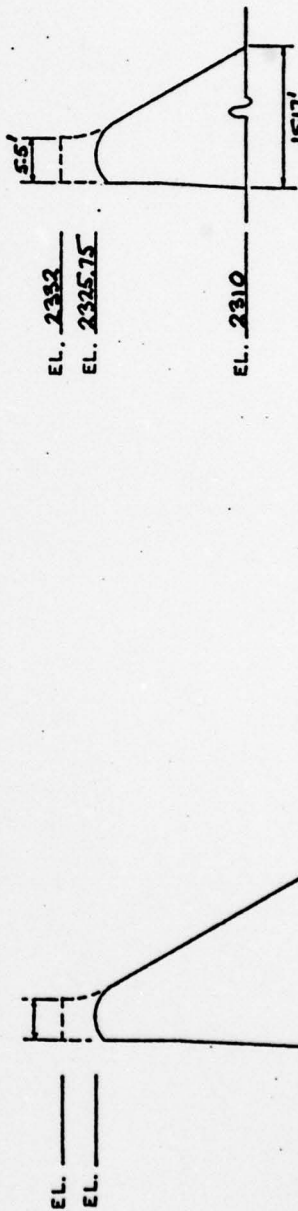
PARTIAL SECTION

The stability calculations performed for the masonry dam indicate the factor of safety for sliding is less than that recommended in Reference 7 of Appendix V and the resultant of overturning forces does not lie within the middle third of the dam as recommended in Section 4.4.4.4 of Reference 7 of Appendix V. These recommendations are for concrete gravity dams, however, it is our opinion that similar guidelines should apply to masonry dams.

NOTES: 50% UPLIFT USED FOR ANALYSIS
FOR SLIDING ANALYSIS $\phi = 37^\circ$
 $S = 2.0$ KSF

7.2.2 A study should be made within 6 months to determine the properties of the fill embankment and its foundation soils, as well as the soft shale, the strength parameters of the critical masonry joint, and methods of providing an adequate factor of safety against sliding and overturning. The results of such a study should be implemented soon after the study. It is suggested that the urgency would be determined during the
