Name Of Dam: OCCOQUAN RESERVOIR SYSTEM
Location: FAIRFAX AND PRINCE WILLIAM COUNTIES
Inventory Number: OCCOQUAN "UPPER" MAIN DAM, VA 15304
OCCOQUAN "LOWER" STORAGE DAM, VA 15305

PHASE I INSPECTION REPORT NATIONAL DAM SAFETY PROGRAM

JULY 1978

PHASE I INSPECTION REPORT
NATIONAL DAM SAFETY PROGRAM
OCCOQUAN RESERVOIR SYSTEM

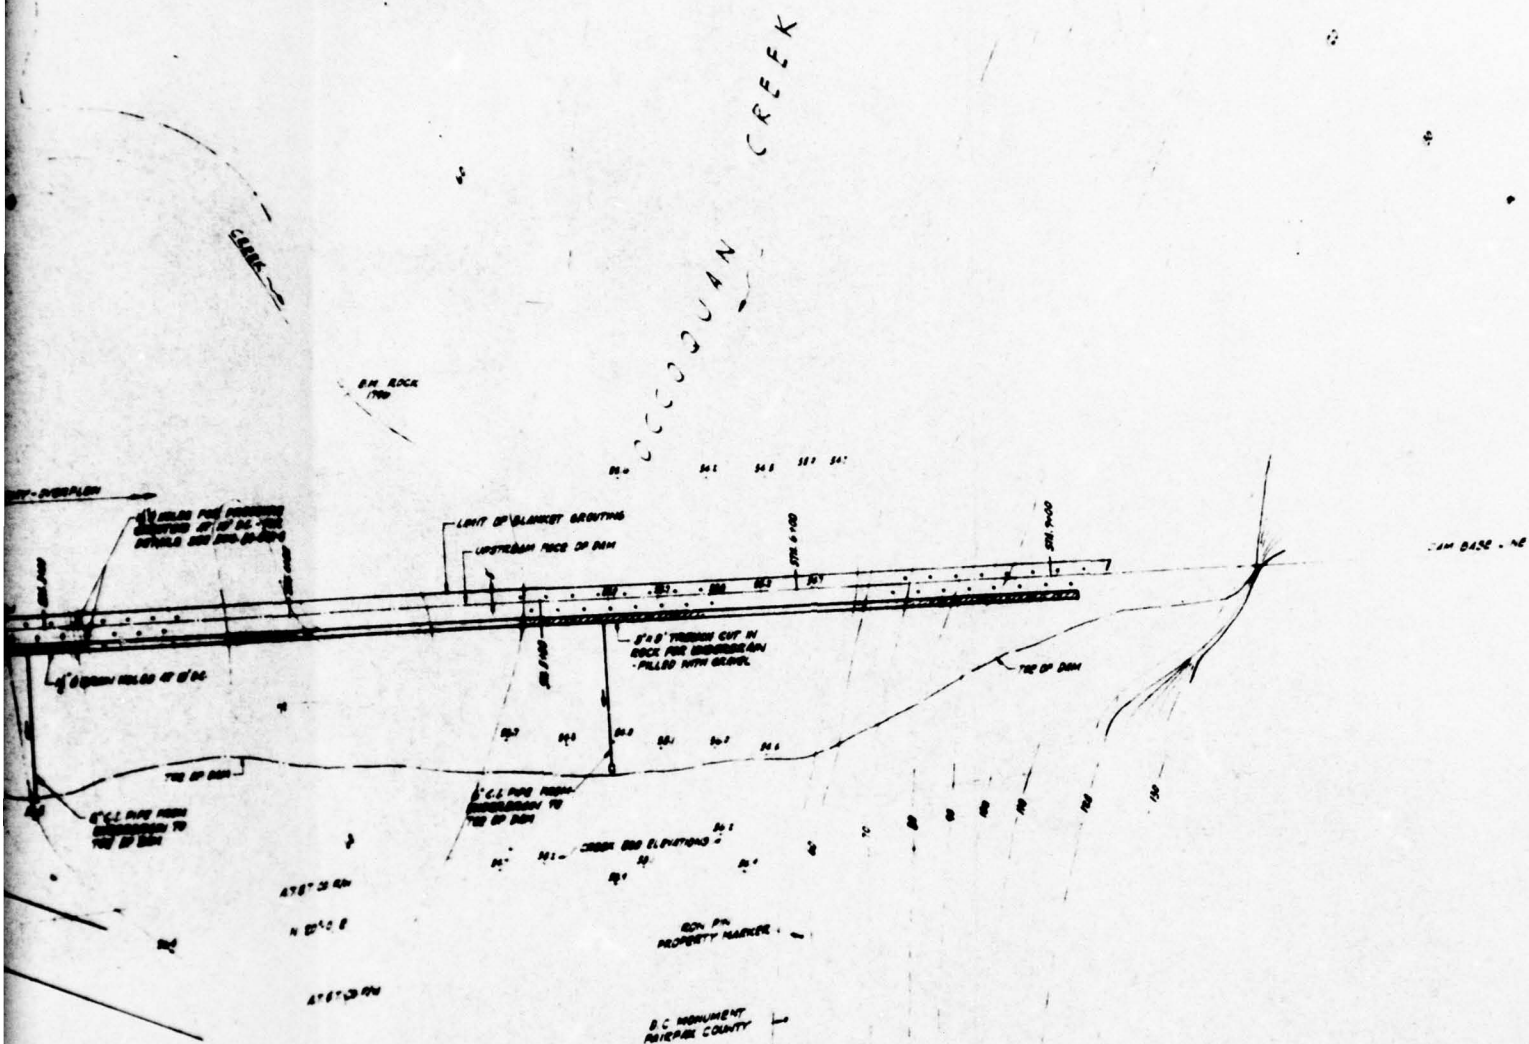
84-640-4
PLATE 6

6.1.2 Foundation and Abutments Conditions: The geology of the dam site and site preparations are documented in Report 1 and 2 of Appendix E. Refer to Plate 6 of Appendix A for a plan view of the foundation. Remedial measures performed are outlined in the contract documents noted in Section 2.1.

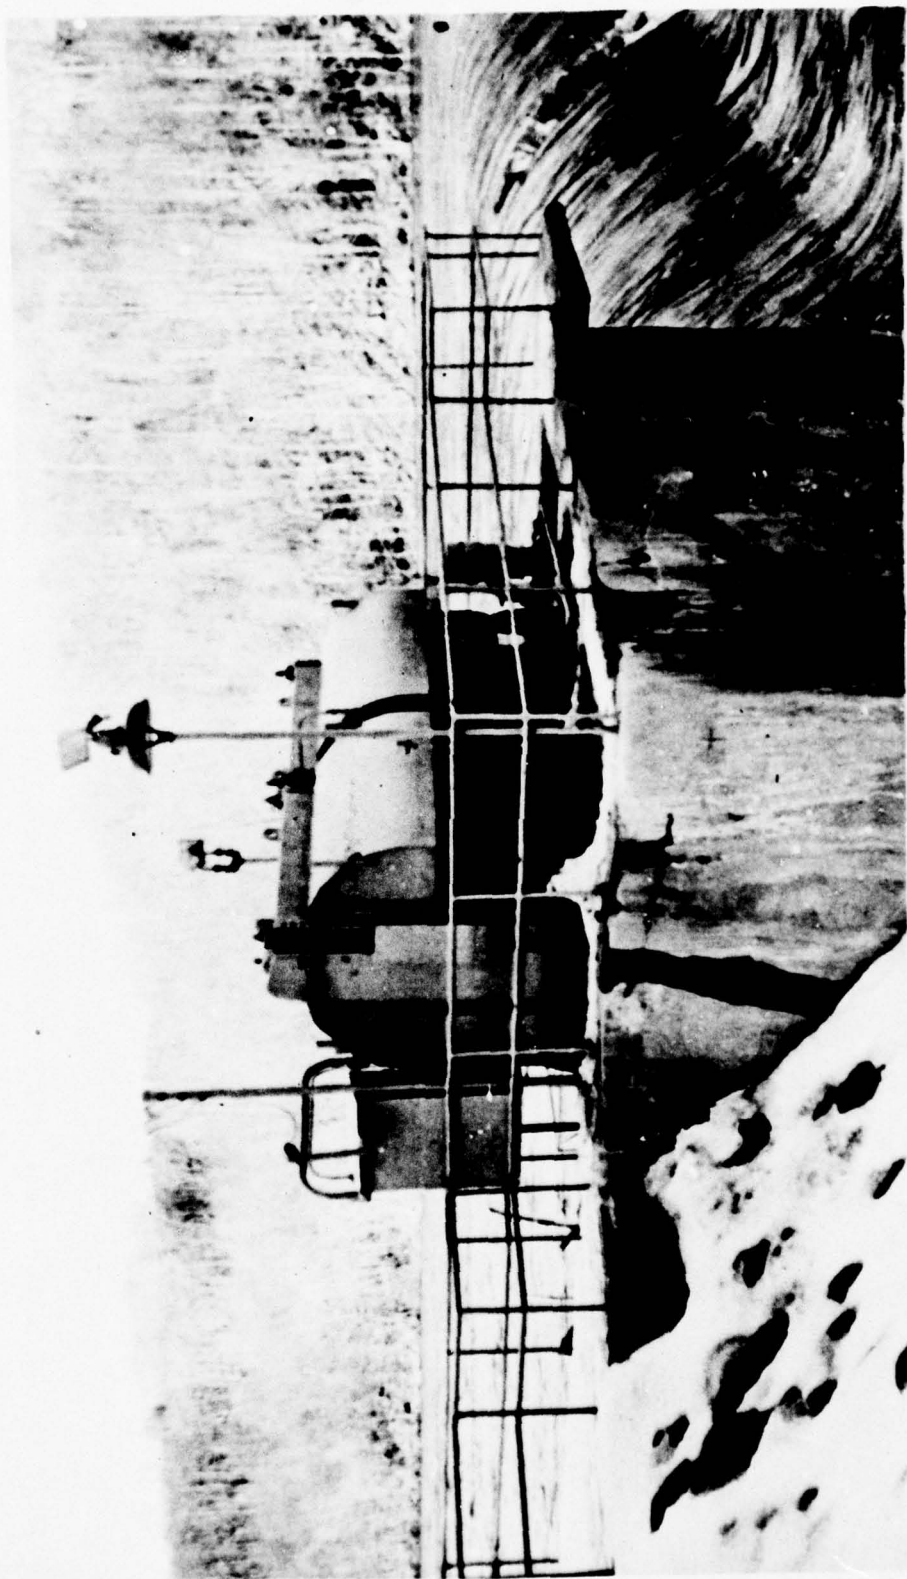
INTAKE STRUCTURE
LOWER DAM

Water was flowing freely over the length of the lower dam. The high water was overtopping the trash screen in the intake structure at elevation 57 MSL. The left abutment could not be directly observed due to wet conditions and difficult access. Based on observation from the right abutment, the left end of the dam was barely visible due to the high flows. It appears to tie into rock. On the right side, the dam ties into the intake structure. A wing wall extends from the intake structure and ties into a riprapped abutment.
