National Dam Safety Program. Cove Dam  
Number 1 (VA 06905), Frederick County,  
Virginia. Phase I Inspection Report.

PHASE I INSPECTION REPORT  
NATIONAL DAM SAFETY PROGRAM

NAME OF DAM: COVE NO. 1

Name of Dam: Cove No. 1  
State: Virginia  
County: Frederick  
Stream: Tributary to Laurel Run  
Date of Inspection: 16 June 1978

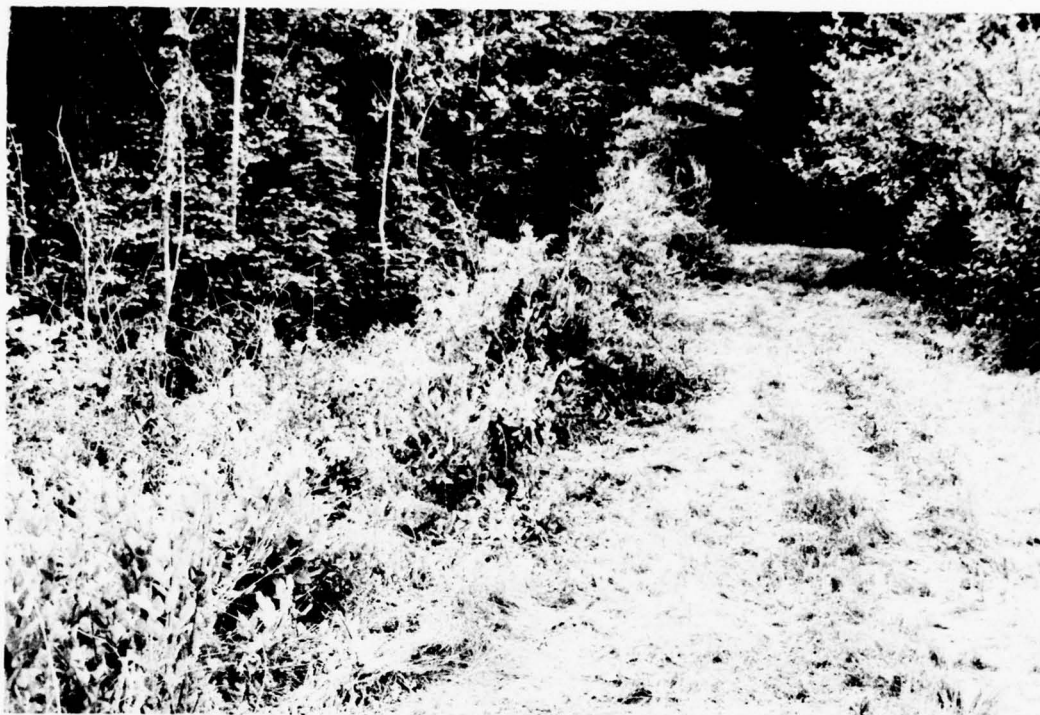
**PHOTO 1**

**Top of Dam at Right Abutment Showing Dense Vegetation**

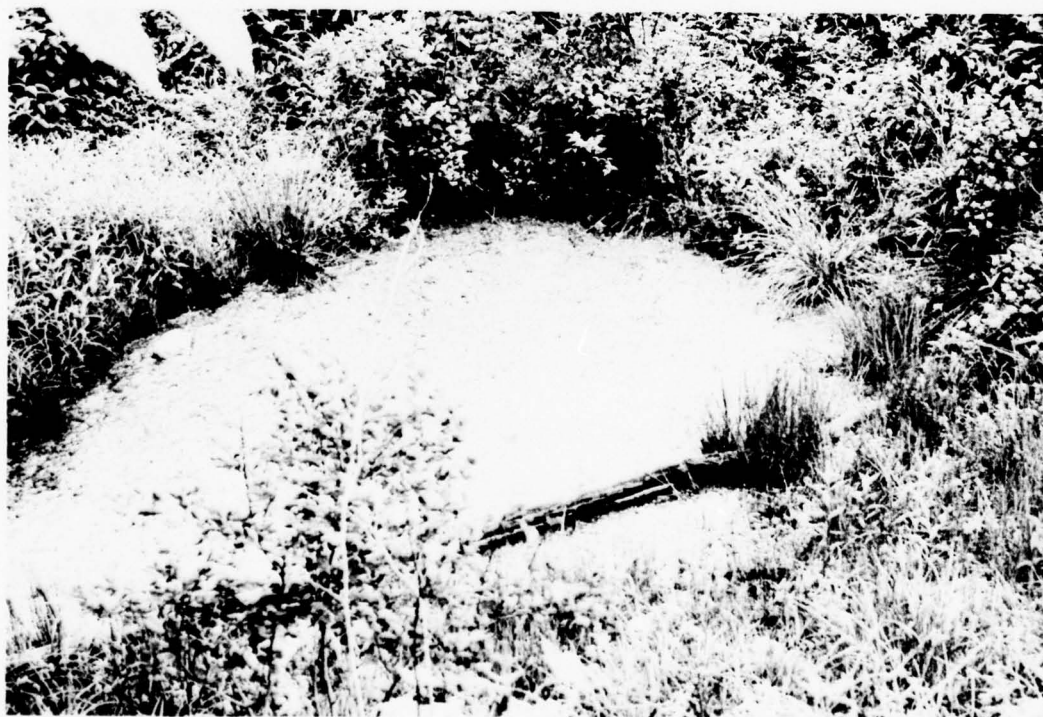
**PHOTO 2**

6.2.1 Visual Observations: No evidence of sloughing or sliding in the embankment, cut slopes or drainage structures was observed. Clear seepage occurs in three areas at the downstream toe of the dam. The seepage from a grouted outlet pipe has formed a small pond with a measured flow of 0.75 g.p.m. (see Photo 2).

**Small Red Pond at Covered Outlet of Sealed 10 Inch Pipe at Downstream Toe Near Middle of Dam**

ANY NOTICEABLE SEEPAGE	Seepage at the downstream toe 100 feet from the right abutment in a 50 feet wide area was not measurable. A 20 feet wide pond of red water (from iron precipitate) (see Photo 2) near the downstream center at the outlet of a 10 inch pipe which was reportedly grouted after it had been damaged. The pipe was not visible--covered with earth. A flow of 0.75 g.p.m. was measured. There is a wet area (100 feet long) from seepage on the left abutment of the embankment toe.	The seepage is of sufficient quantity to warrant close regular inspection and/or piezometers. A siphon drain is scheduled to be installed in the fall of 1978 to replace the 10 inch pipe, according to the owner.
STAFF GAGE AND RECORDER	None	
DRAINS	The owner reported that the downstream toe drain had been constructed by bulldozing scattered sandstone rocks into a pyramid section. There is a cover of soil and topsoil with a vegetative growth which obscures inspection of the rocks. Previously reported seepage occurs at the toe. The engineer's plans called for an embedded four inch tile drainpipe with porous backfill.	The toe drain presently seems to be adequate but the materials appear to be mixed.

- 4.4 Evaluation: The maintenance of the dam is poor with respect to the removal of trees and brush. However, the primary spillway pipe was free of debris and siltation (see Photo 4). The owner should immediately provide a means of draining the lake by repair of the existing, plugged, 10 inch drain or by new construction.

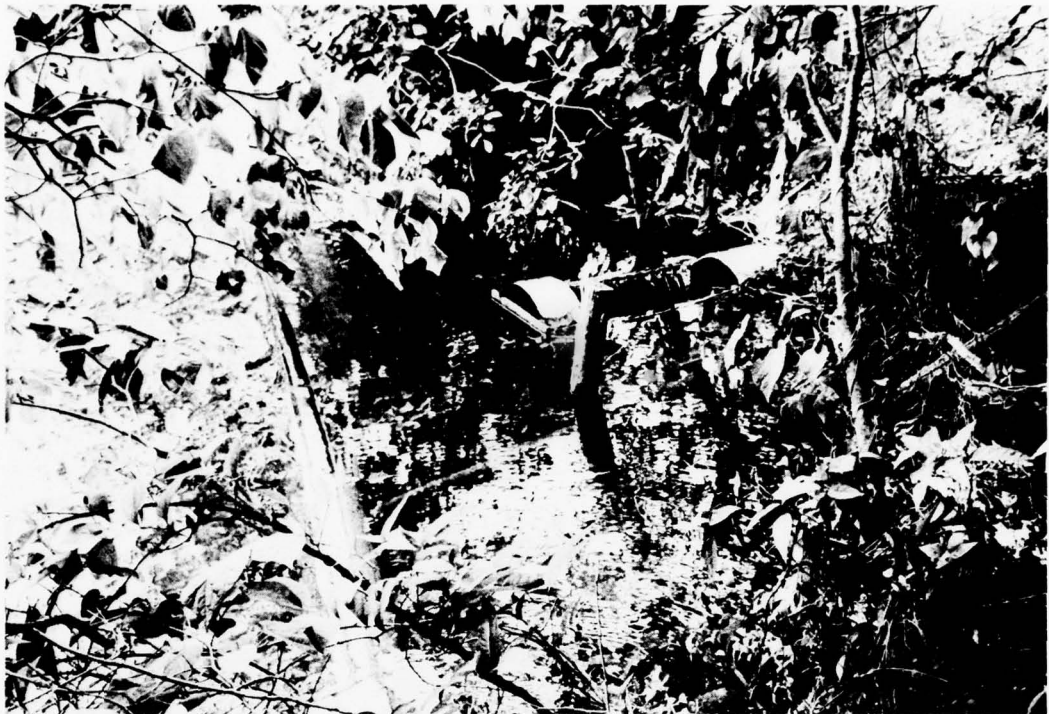
**PHOTO 3**

**Inlet of 24 Inch C. M. P. Principal Spillway Near Right Abutment**

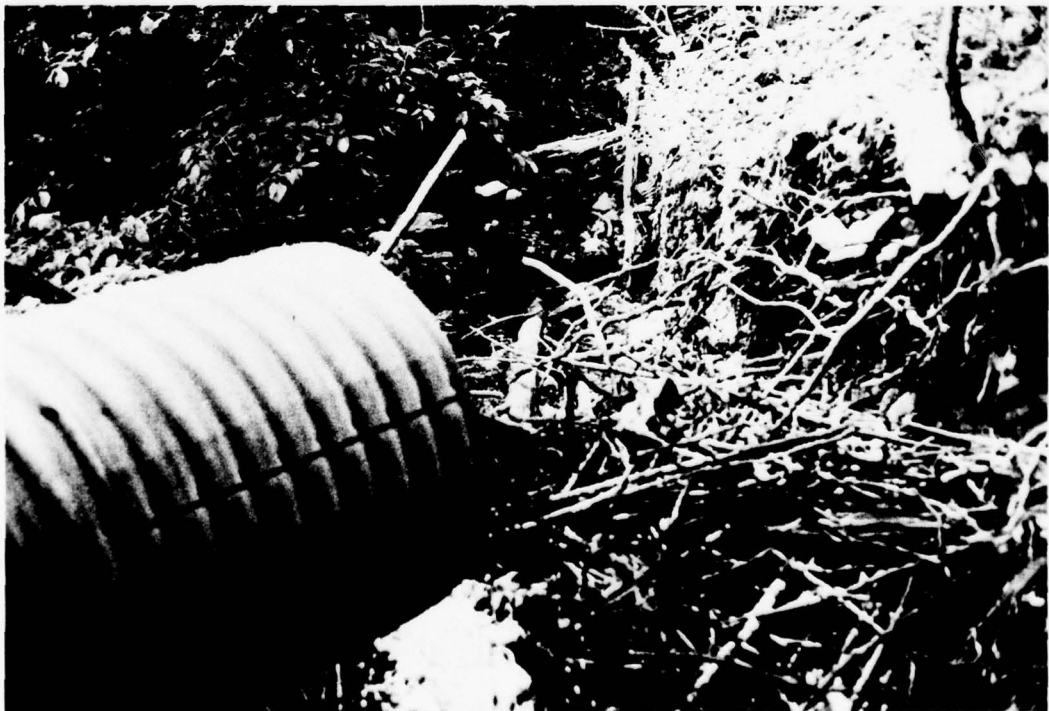
**PHOTO 4**

**Outlet of 24 Inch C. M. P. Principal Spillway Showing Stilling Basin With Trash and Downstream Channel**

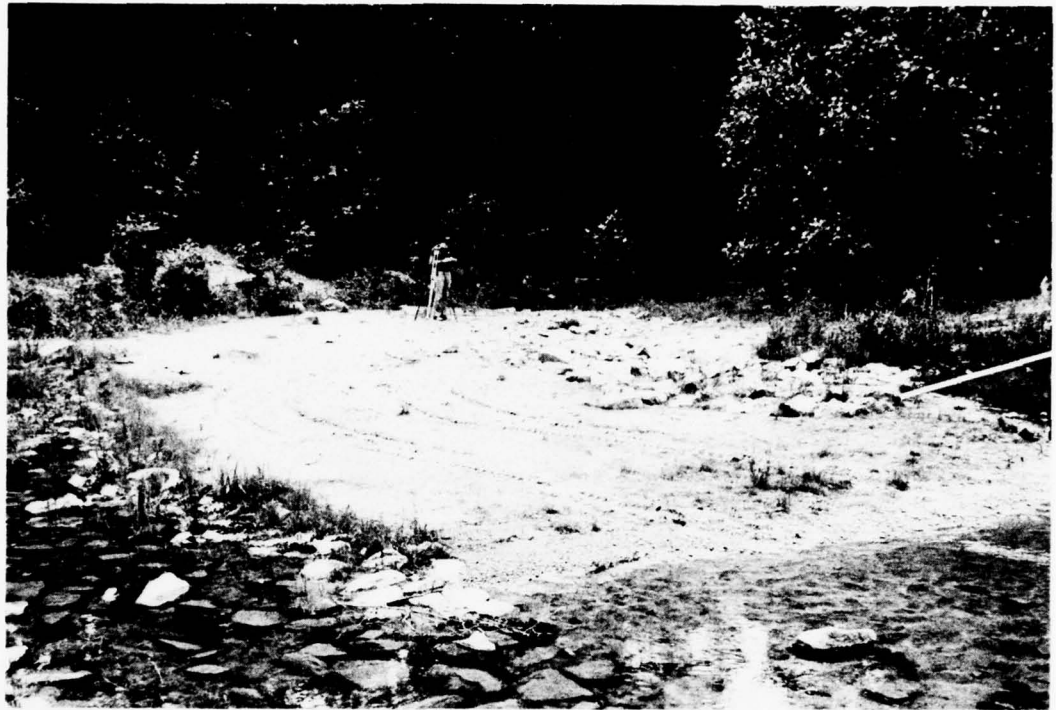
**PHOTO 5**

- 3.1.3 Appurtenant Structures: The approach channel to the emergency spillway has no riprap or other forms of erosion protection.
- 3.1.4 Reservoir Area: No serious deficiencies were observed in the reservoir area.
- 3.1.5 Downstream Channel: The discharge channel of the emergency spillway is poorly defined, with low unprotected banks which may overflow during a flood discharge. Additional grading and riprap placement should be done to confine the flow of the water.

**Approach to Emergency Spillway**

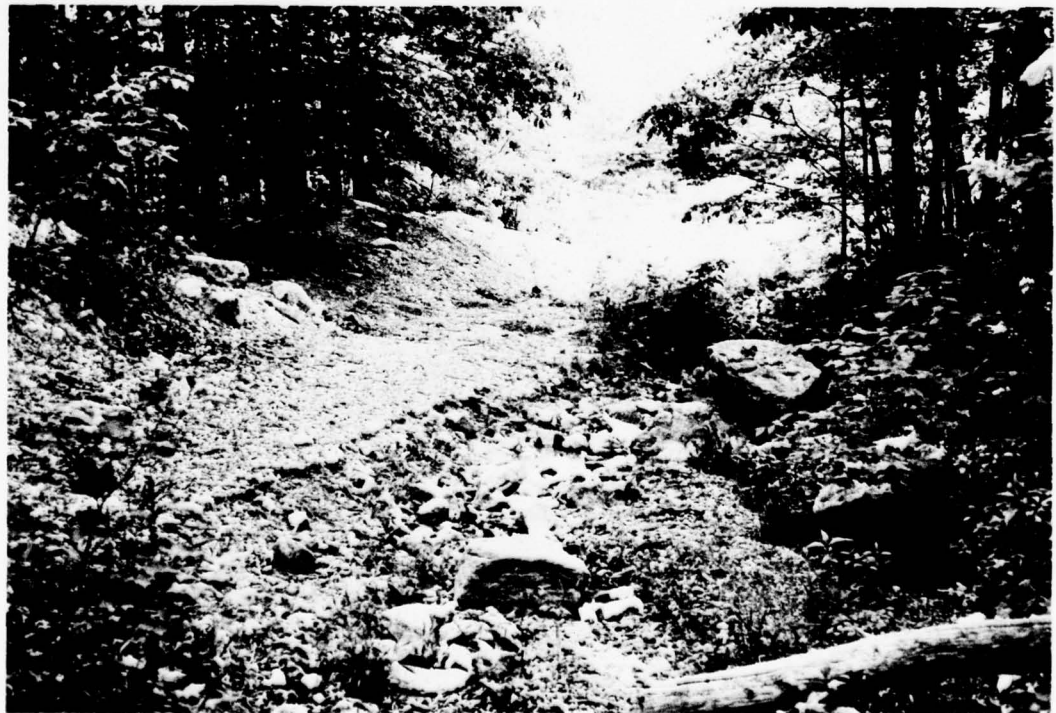
**PHOTO 6**

**Discharge Channel of Emergency Spillway Looking Upstream**
