Name Of Dam: SOUTH RIVER NO. 25

# PHASE I INSPECTION REPORT

## NATIONAL DAM SAFETY PROGRAM

SEPTEMBER 1978

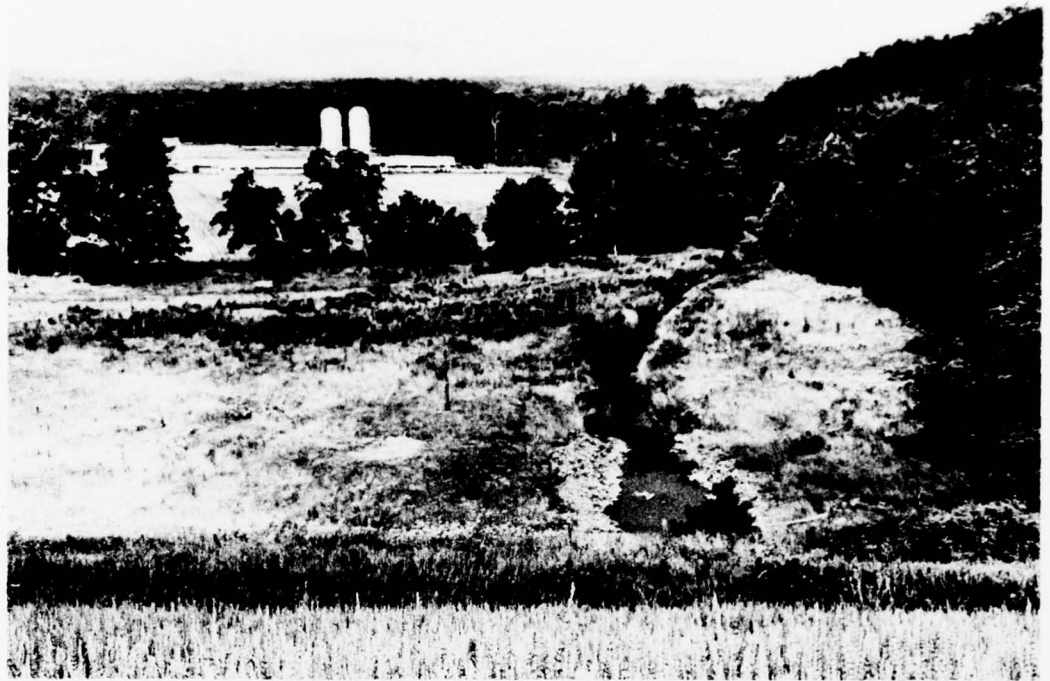
**PHOTO 1. Downstream Channel From Principal Spillway and Farm**

<p>CONDITION (OBSTRUCTIONS, DEBRIS, ETC.)</p>	<p>The channel is in good condition with a bottom of gravel, cobbles and small boulders. No obstructions or debris were observed.</p>	
---	---	--

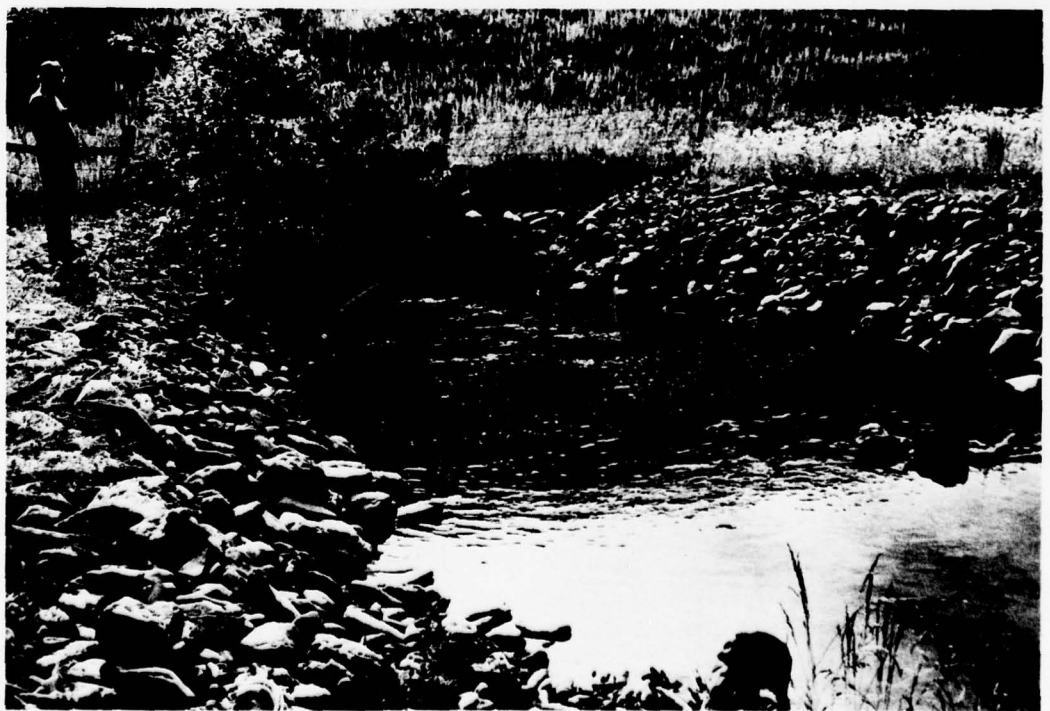
**PHOTO 2. Stilling Basin at Downstream Outlet of Principal Spillway**

STILLING BASIN	The basin is approximately 30' x 50' x 6' deep. The riprap is in good condition.

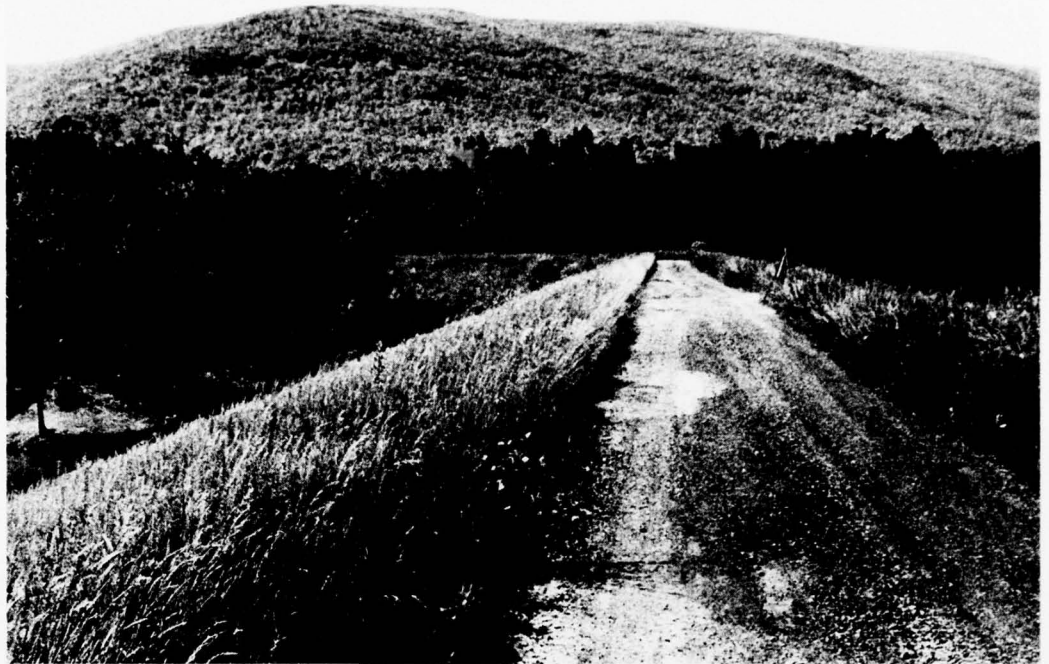
**PHOTO 3. Curve of Dam on Left Side**

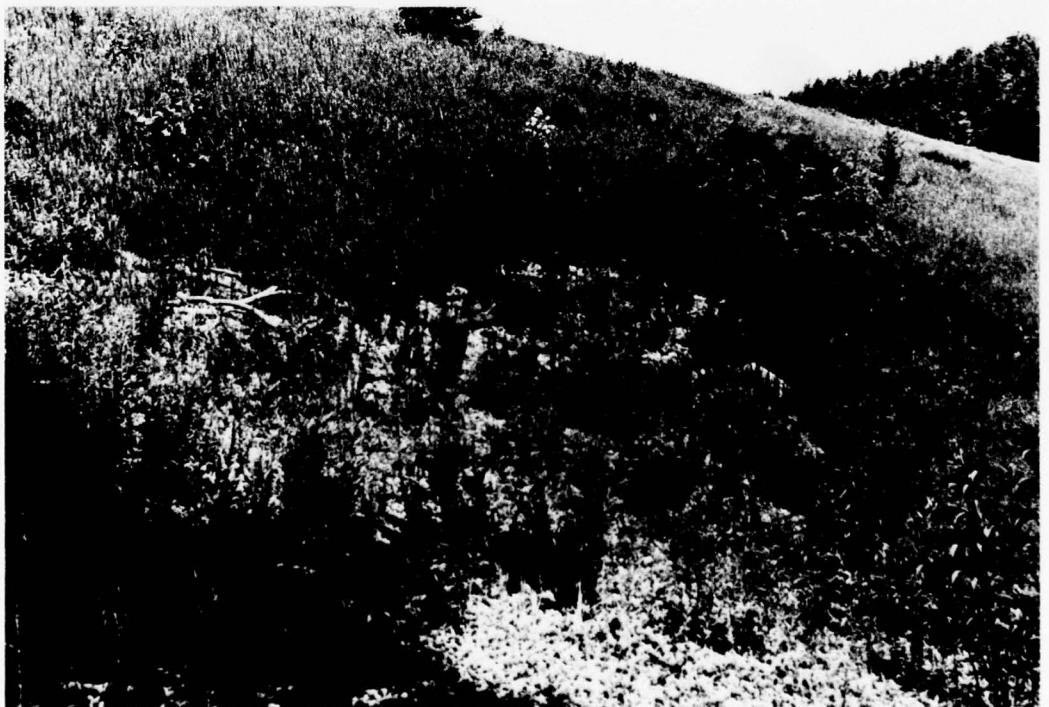
- 3.1.2 Dam: The embankment was in good condition with no noticeable seepage. The ground cover was very heavy except on the downstream face, right abutment where there is slight erosion, and at the left abutment where leaves and wood debris have prevented growth. Trees and large bushes are growing at various places on the upstream and downstream face of the dam. Surface runoff in front of the left toe of the dam is being drained by existing tire tracks; consequently, large gullies are present.

**PHOTO 4. Debris on Upstream Slope Near Curve on Left Side**

- 1) Cut and remove the tree growth on the faces of the dam to prevent further root growth.
- 2) Remove debris on the upstream dam face and mow both embankment slopes prior to annual inspections.
- 3) Fill and reseed tire tracks and minor erosional gullies.
- 4) Repair deteriorated concrete on the exposed part of the principal spillway riser.

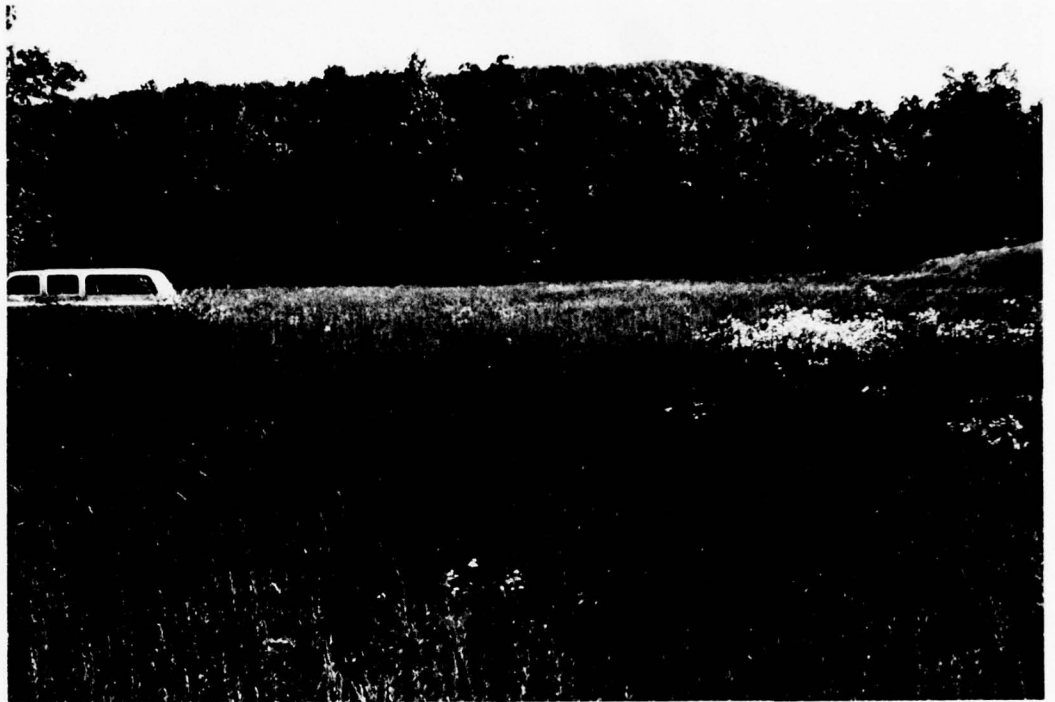
**PHOTO 5. Upstream Portion of Emergency Spillway**

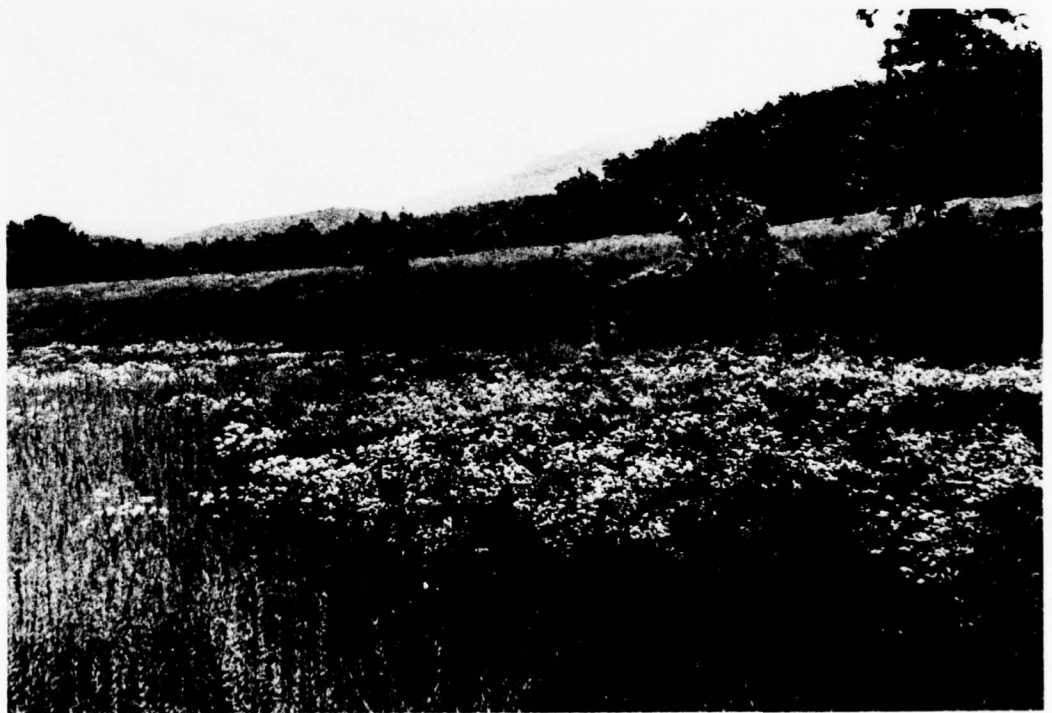
**PHOTO 6. Cut Slope in Rock and Soil on Left Side of Emergency Spillway  
With Borrow Area Beyond**

VISUAL EXAMINATION OF	OBSERVATIONS	REMARKS OR RECOMMENDATIONS
CONCRETE WEIR	There is none.	
APPROACH CHANNEL	The approach channel into the spillway is cut in residual soil overlying sandstone and shale with a dip of 40°-50° SE. away from the spillway and a strike N. 15° E. The channel is covered with soil and grass.	
DISCHARGE CHANNEL	The channel is cut into steeply dipping sandstone and shale with a cover of soil and grass. The downstream end of the channel shows signs of minor erosion caused by spillway flow. The small valley directly below the channel exit shows considerable signs of erosion.	
BRIDGE AND PIERS	There are none.	
CUT SLOPES	The cut depth averages six feet primarily in hard sandstone with softer shale at an uneven 0.5:1 slope with four feet of silty sand and gravel above. The rock dips at 40°-50° to the SE. away from the spillway with a strike of N. 15° E. Some vertical joints are perpendicular to the bedding and at other angles including in the direction of the spillway alignment with no predominant set of joints. There is no significant erosion on the cut slope. The beds are thin to medium thick.	The cut slope appears to be stable with minor talus accumulation.
