**Name Of Dam:** SOUTH RIVER NO. 11

**Location:** AUGUSTA COUNTY, STATE OF VIRGINIA

**Inventory Number:** VA 01512

# PHASE I INSPECTION REPORT

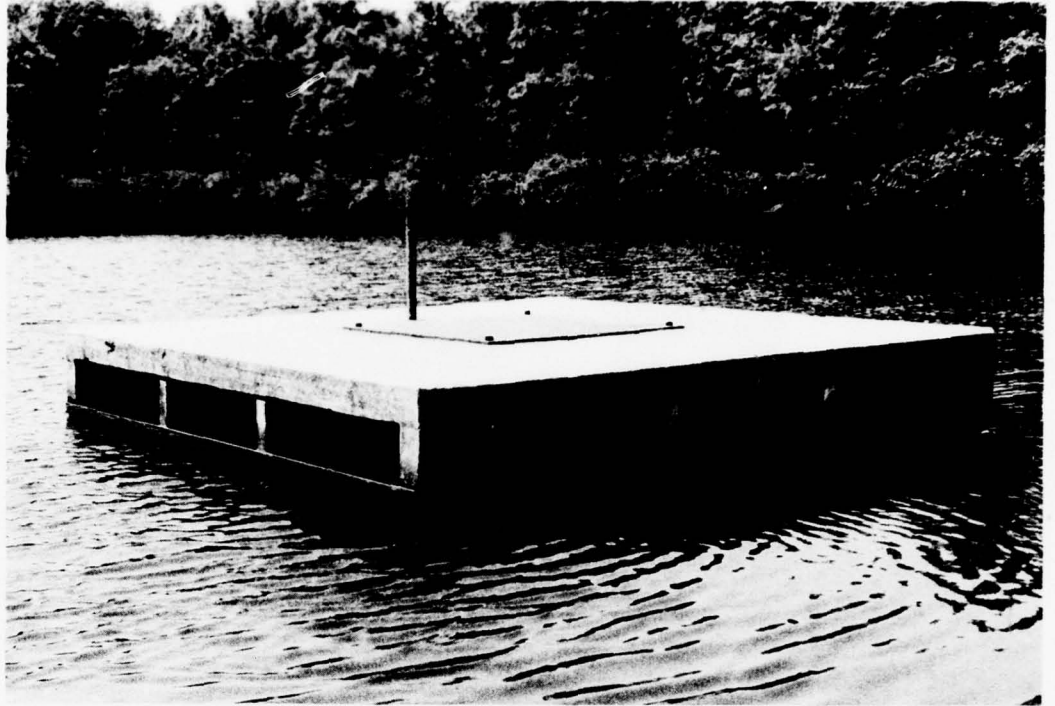
- 3.1.3 Appurtenant Structures: The inlet and outlet structures appeared to be in good physical condition and functioning properly; however, a heavy layer of rust covers the trash rack. No serious deficiencies were noted in the emergency spillway. Many small trees were present in both the approach and discharge channels.

**PHOTO 1. Inlet Riser in Reservoir**

- 2) The eroded pathways on both faces of the dam should be filled and reseeded.
- 3) The trash rack should be periodically cleaned and a rust preventive coating applied.
- 4) The banks of the downstream channel should be cleared periodically.

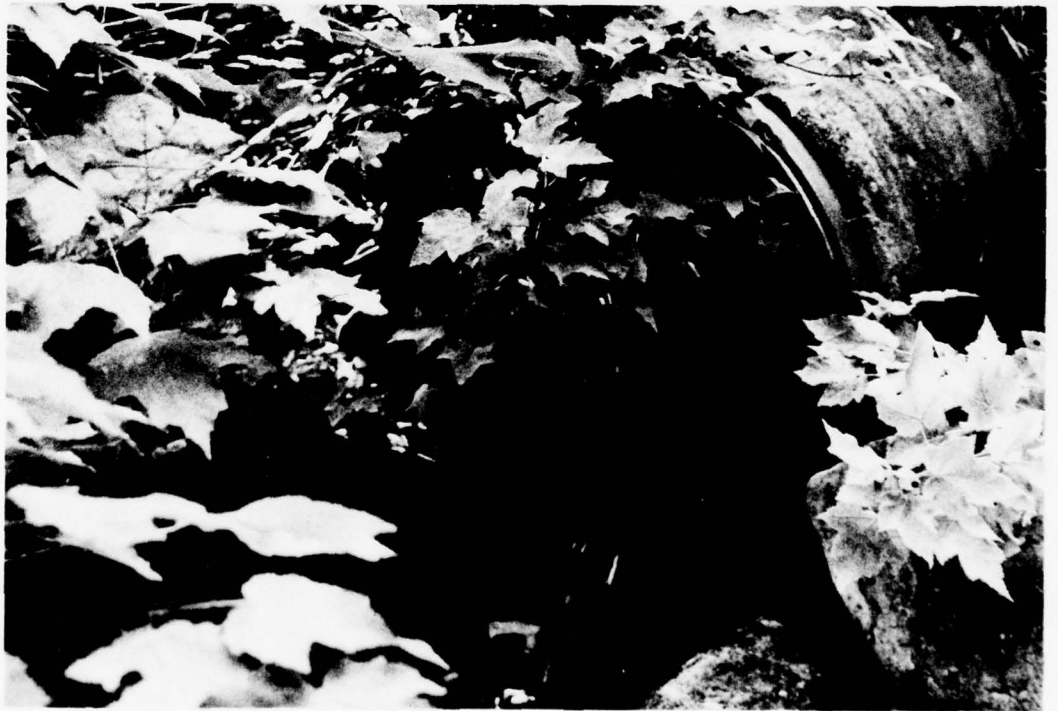
**PHOTO 2. Outlet Pipe at Toe of Downstream Slope**

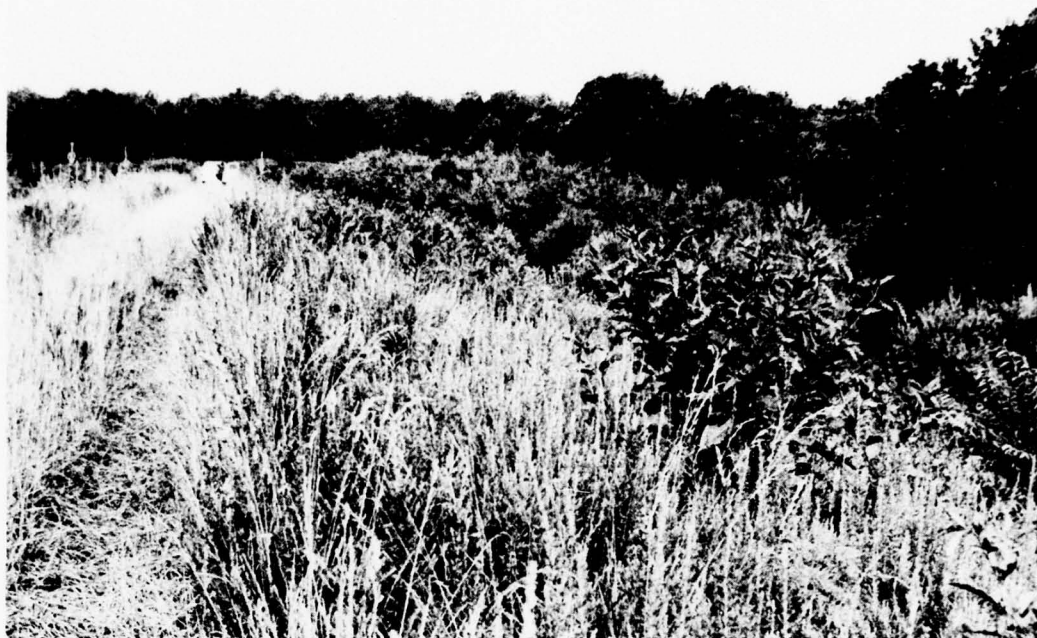
- 3.1.2 Dam: No seeping or sloughing was observed during the inspection. A few, eroded, pedestrian paths are present on both the upstream and downstream faces of the dam. Also, small trees and thick brush were noted growing on the embankment (see Photos 3 and 4).

**PHOTO 3. Brush and Trees Growing on Downstream Face Looking From Right Side**

- 1) The brush and small trees growing on the embankment and in the emergency spillway should be removed.

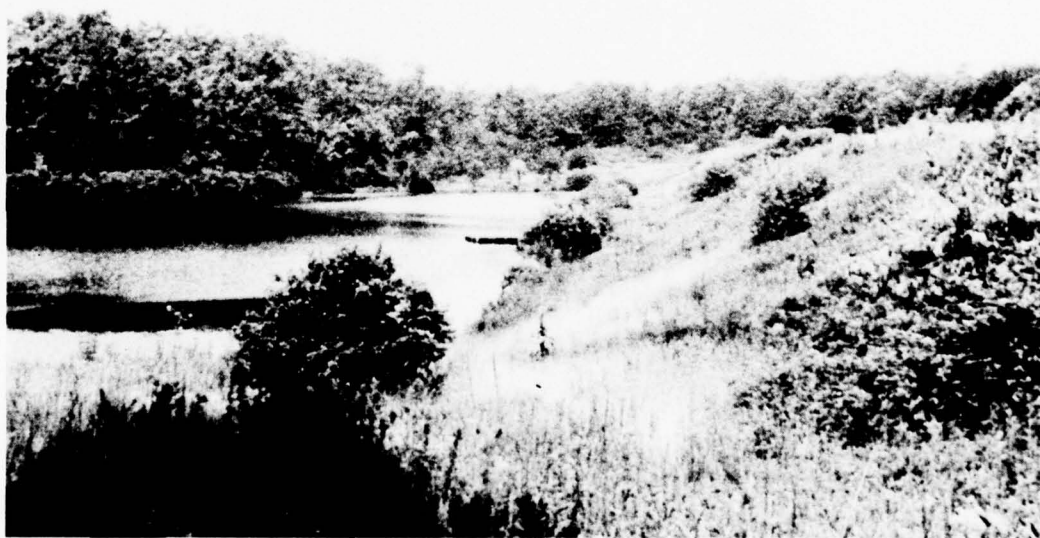
**PHOTO 4. Brush and Trees on the Upstream Face Looking From Right Side**
