Name of Dam: Coles Run *Dam*

Inventory Number: VA 01519

PHASE I INSPECTION REPORT NATIONAL DAM SAFETY PROGRAM

SEPTEMBER 1978

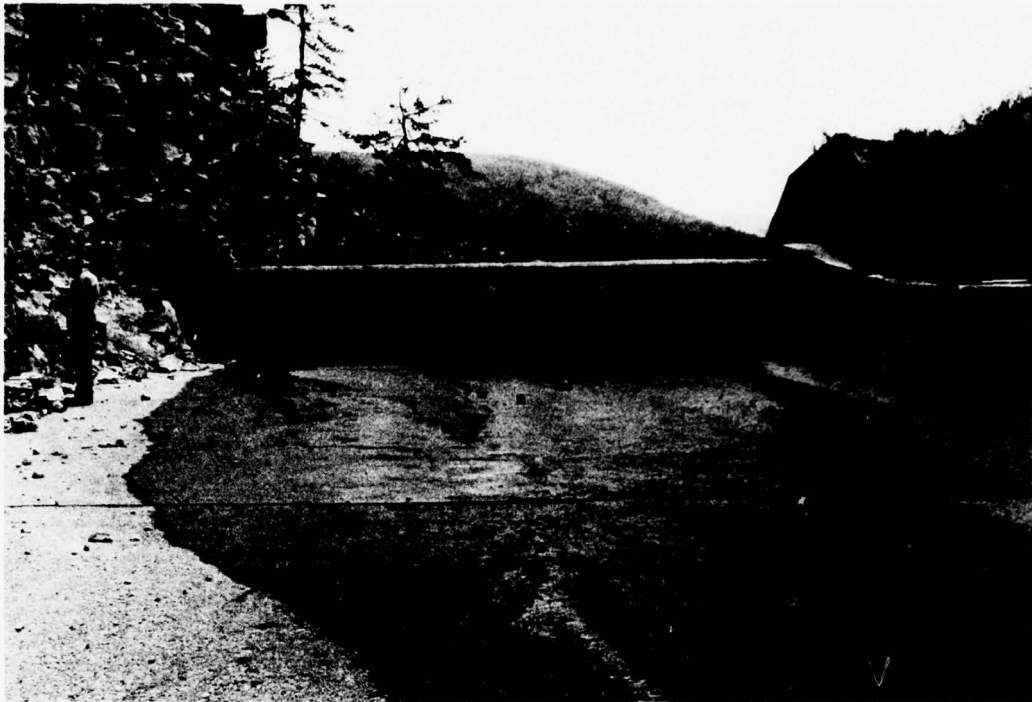
- 3.1.3 Appurtenant Structures: Some water was leaking through the flashboards at the areas of contact between the spillway concrete and the wood of the flashboard. Cracks have appeared at the jointure of the old and new concrete of the widened spillway.

PHOTO 1. Weir in Spillway With Leakage Principally on Right Side Near Dam

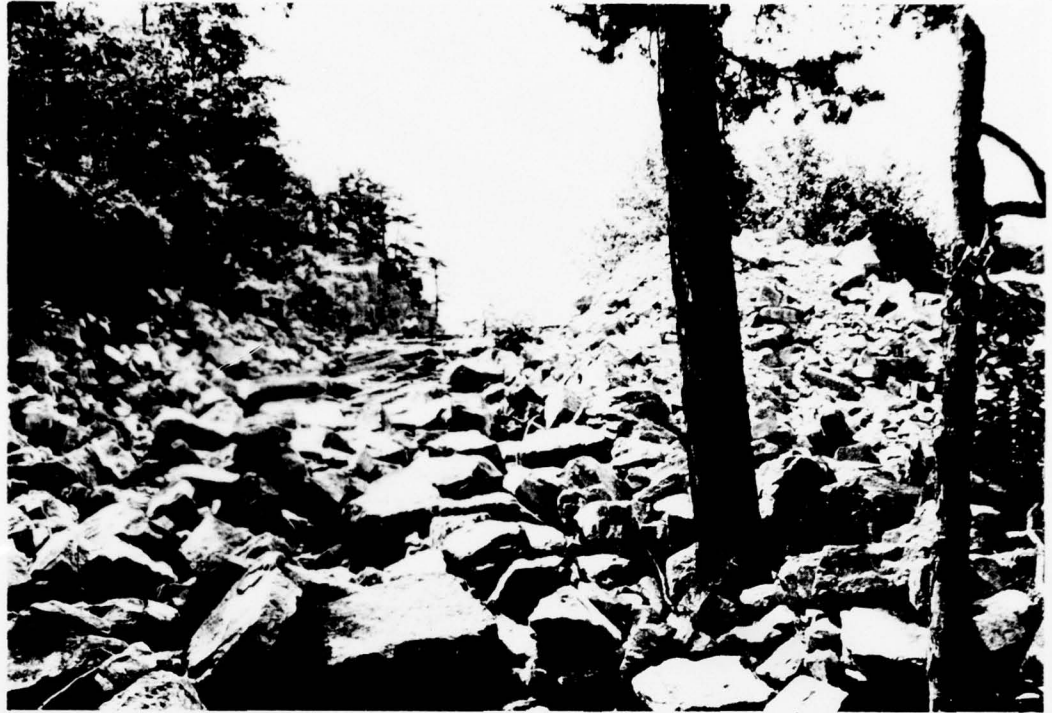
PHOTO 3. Rocks in Channel Downstream From Open Spillway

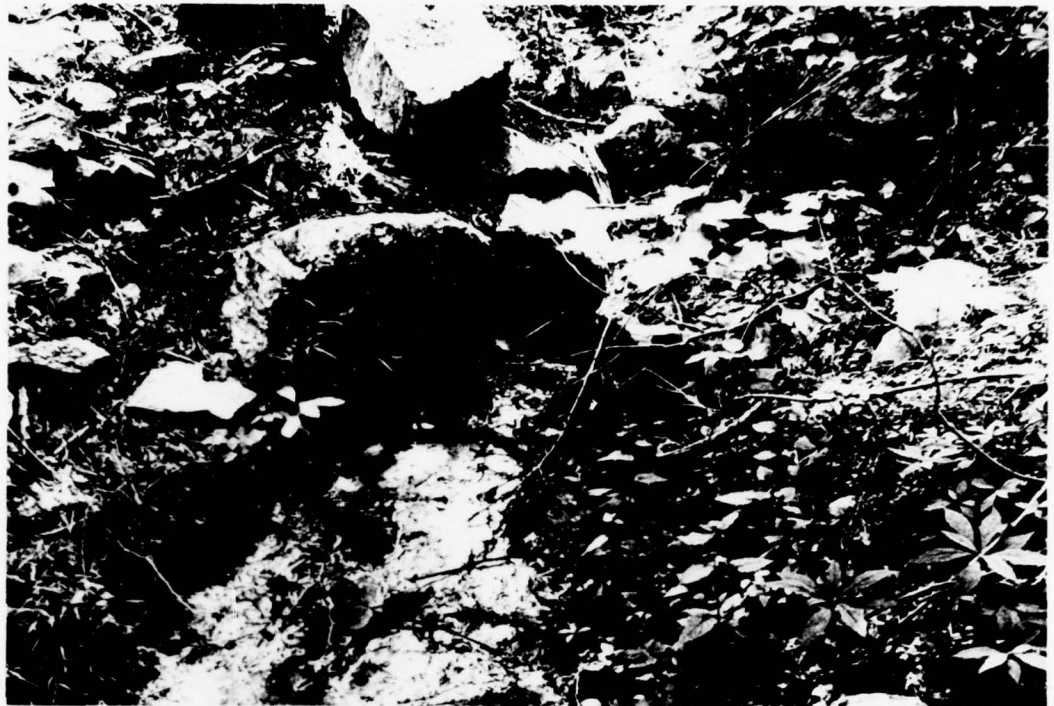
- 3.1.2 Dam: The embankment was in good condition with minor clear seepage noted at two places. Non-measurable seepage was observed from sandstone and rockfill near the 72 inch conduit outlet. Clear seepage (red in color due to iron staining) amounting to 0.25 g.p.m. was observed near the downstream toe. In addition, an eight inch drainpipe from the rock toe on the right side of the dam was flowing at 10 g.p.m. There is a heavy growth of small trees and brush on the downstream face and a few bushes on the upstream face.

**PHOTO 5. Seepage of Red Water at 0.25 G. P. M. From Downstream
Rock Toe Drain in Old Channel**
