# STILLWATER RESERVOIR DAM

## PHASE I INSPECTION REPORT NATIONAL DAM SAFETY PROGRAM

NY 00316

Date of Inspection: June 13, 1978

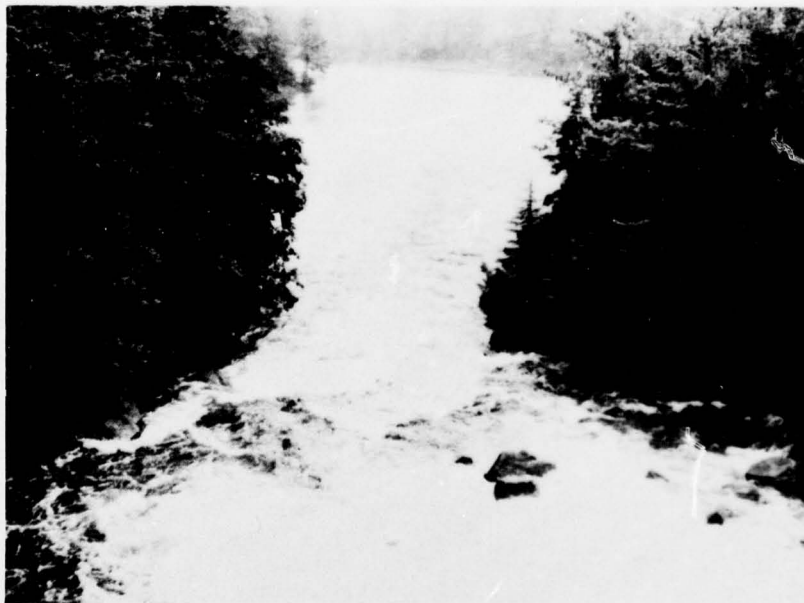
Downstream Channel - the downstream channel converges and flashboard leakage and low flows are discharged into three 21 inch diameter culverts constructed under a service road. The emergency spillway channel outlet to the river below the south dam is through a natural swamp area.

DOWNSTREAM CHANNEL

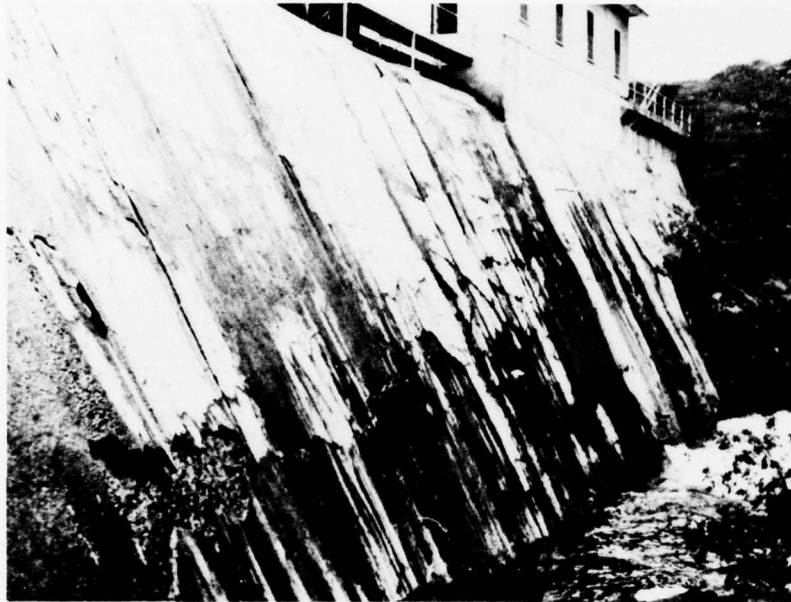
The downstream face of the spillway has also been surfaced with a protective material. A much more significant deterioration of the material than observed on the non-overflow section was evident. In areas where the material had dislodged from the structure, spalled concrete was again noted. No seepage was observed in the toe area of the gravity section.

The concrete surface protection has cracked and spalled in several places on the downstream face of the gravity structure. However, this condition does not appear to adversely affect the stability of the structure.

DOWNSTREAM SLOPE OF SPILLWAY

3. Remove and replace the deteriorated concrete surface protection material as required.

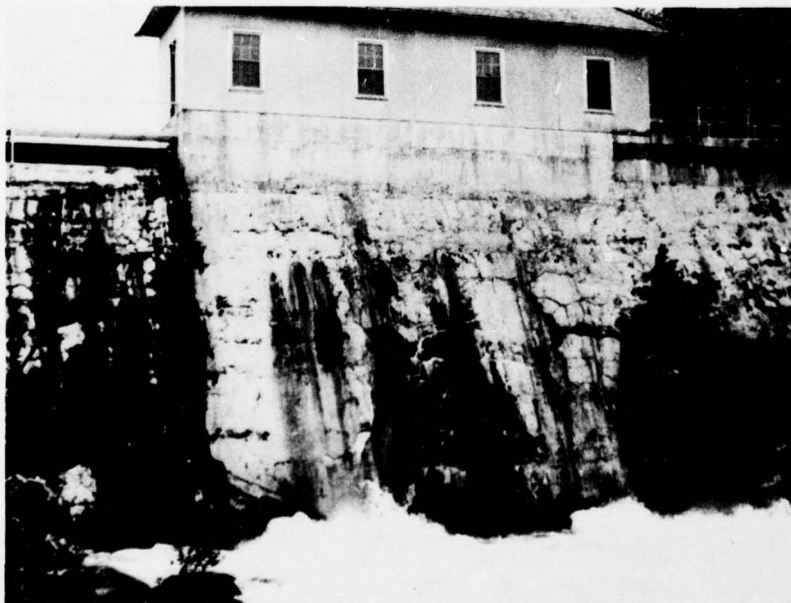
The downstream face of the non-overflow section shows signs of deterioration. A protective surface treatment (gunite) which was applied to the structure has weathered and cracked. Some spalling of the gunite was noted in the downstream slope of the non-overflow section.

DOWNSTREAM FACE OF GATE HOUSE

| VISUAL EXAMINATION OF | OBSERVATIONS | REMARKS OR RECOMMENDATIONS |
|---|---|---|
| OUTLET STRUCTURE<br>A-11 | The protective surface treatment applied to the non-overflow section below the gatehouse is cracked over most of the downstream face. | |
