CHADWICK LAKE DAM

PHASE I INSPECTION REPORT NATIONAL DAM SAFETY PROGRAM

NY 00509

Name of Dam: Chadwick Lake Dam
County and State: Orange County, State of New York
Inventory Number: NY 509

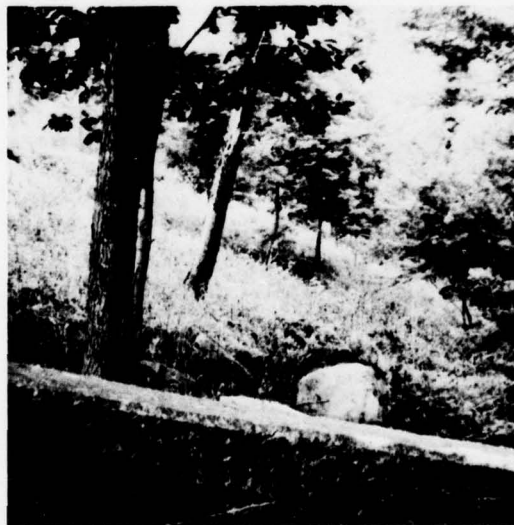
DOWNSTREAM SLOPE OF EMBANKMENT

The presence of large trees on the embankment represents a potential hazard: the trees could be uprooted during severe storms, and the root systems may provide seepage paths that could lead to future piping problems.

1) All trees on the embankment should be cut off as near the embankment surface as practicable. A further investigation should be made to determine the extent of the root systems before remedial measures can be recommended.

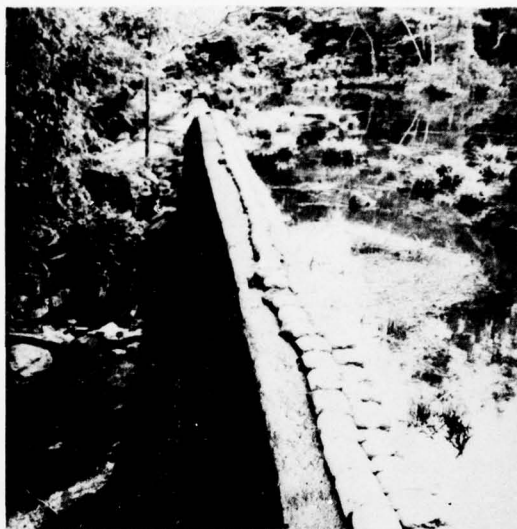
The visual inspection showed considerable variation from the plans. The left abutment wing wall is in satisfactory condition with minor spalling of the concrete. The crest of the spillway is flat with a length of about 30 feet set 1 foot lower than the remainder of the crest. The lower part has 1 foot high stoplogs installed to the level of the remainder of the spillway, and the remainder of the spillway crest has 2 rows of sandbags along its entire length. This effects an increase in the lake level of about 1 foot. During the inspection, water was spilling only over the stop logged crest. The upstream face of the spillway is silted almost up to the top of the concrete crest.

VIEW ALONG SPILLWAY CREST

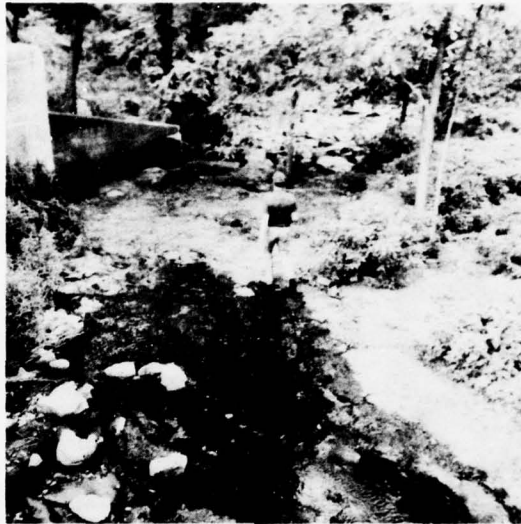
Flow from the spillway discharges into a wide ledge rock channel; a portion of the rock surface is concreted to provide a smoother surface and to close the rock seams. Numerous trees and brush are now growing in this channel and are rooted in the seams of the rock. The channel drops off rapidly and in parts very abruptly into an area filled with loose rock and boulders, which serves as an energy dissipator. The entire outlet channel turns to the left and runs roughly parallel to the downstream toe of the embankment until it joins the channel of Quassaick Creek.

SPILLWAY OUTLET CHANNEL ABOVE DROP-OFF

4) The spillway outlet channel should be cleared of all trees, brush and debris to provide unimpeded flow over the rock channel. Open seams in the rock bed of the channel immediately below the spillway should be sealed with grout or gunite to minimize ice and freezing damage, and prevent further plant growth.

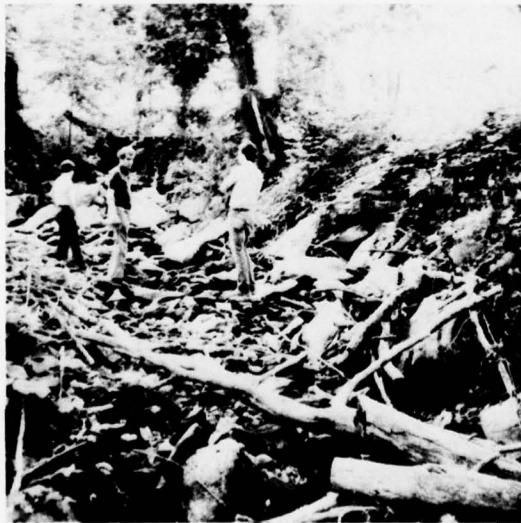
SPILLWAY OUTLET CHANNEL DOWNSTREAM
