LOWER WARWICK RESERVOIR DAM
ORANGE COUNTY NEW YORK
INVENTORY NO. 59

PHASE I INSPECTION REPORT
NATIONAL DAM SAFETY PROGRAM

Prepared by: NEW YORK DISTRICT CORPS OF ENGINEERS
Date: SEPTEMBER 1978

LOWER WARWICK RESERVOIR DAM
NEW YORK STATE
ORANGE COUNTY
WALLKILL RIVER BASIN
INSPECTED 9 AUGUST 1978

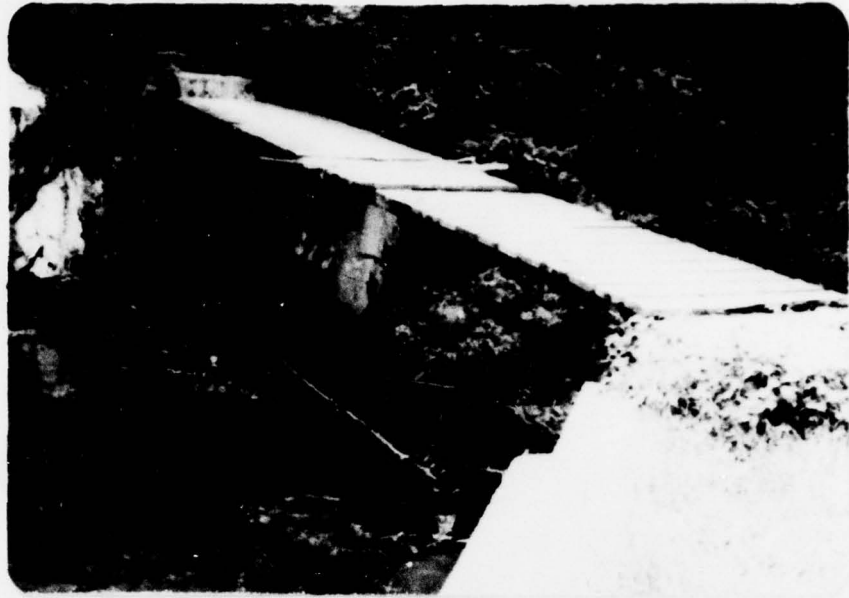
OVERVIEW OF SPILLWAY

d. Spillway. The spillway, located at the west abutment is a concrete gravity section 25 feet in width. Two to three inches of water was flowing over the spillway at the time of inspection. The concrete appeared to be in good condition with minor surface scaling. There is no evidence of structural cracking. The spillway is cut into bedrock and the west abutment contact is in rock. No evidence of distress was evident.

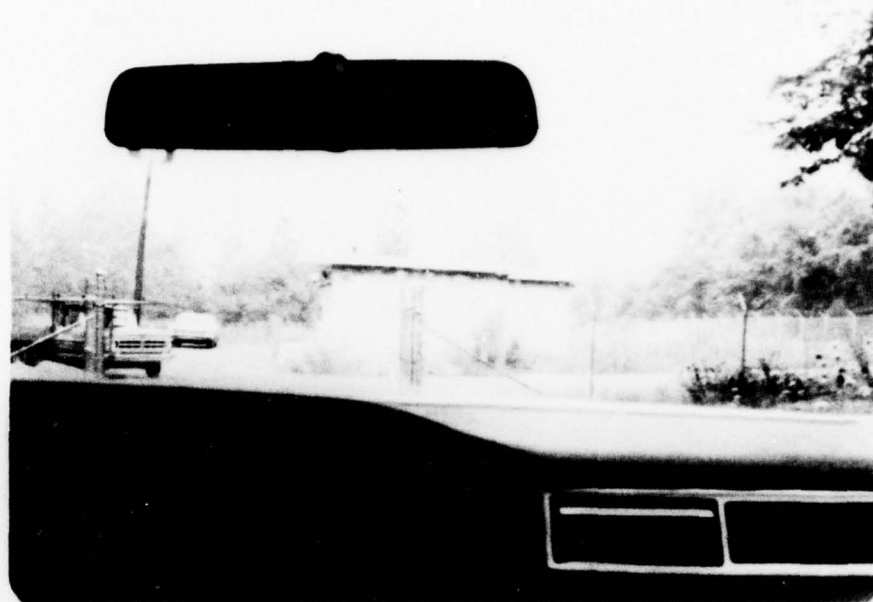
CLORINATION AND PUMP BUILDING
