National Dam Safety Program. Tipton Dam (NDI I.D.-525), Susquehanna River Basin, Tipton Run, Blair County, Pennsylvania. Phase I Inspection Report.

## TIPTON DAM

### PHASE I INSPECTION REPORT NATIONAL DAM INSPECTION PROGRAM

TIPTON DAM  
NDI I.D. NO. 525  
JULY 11, 1978

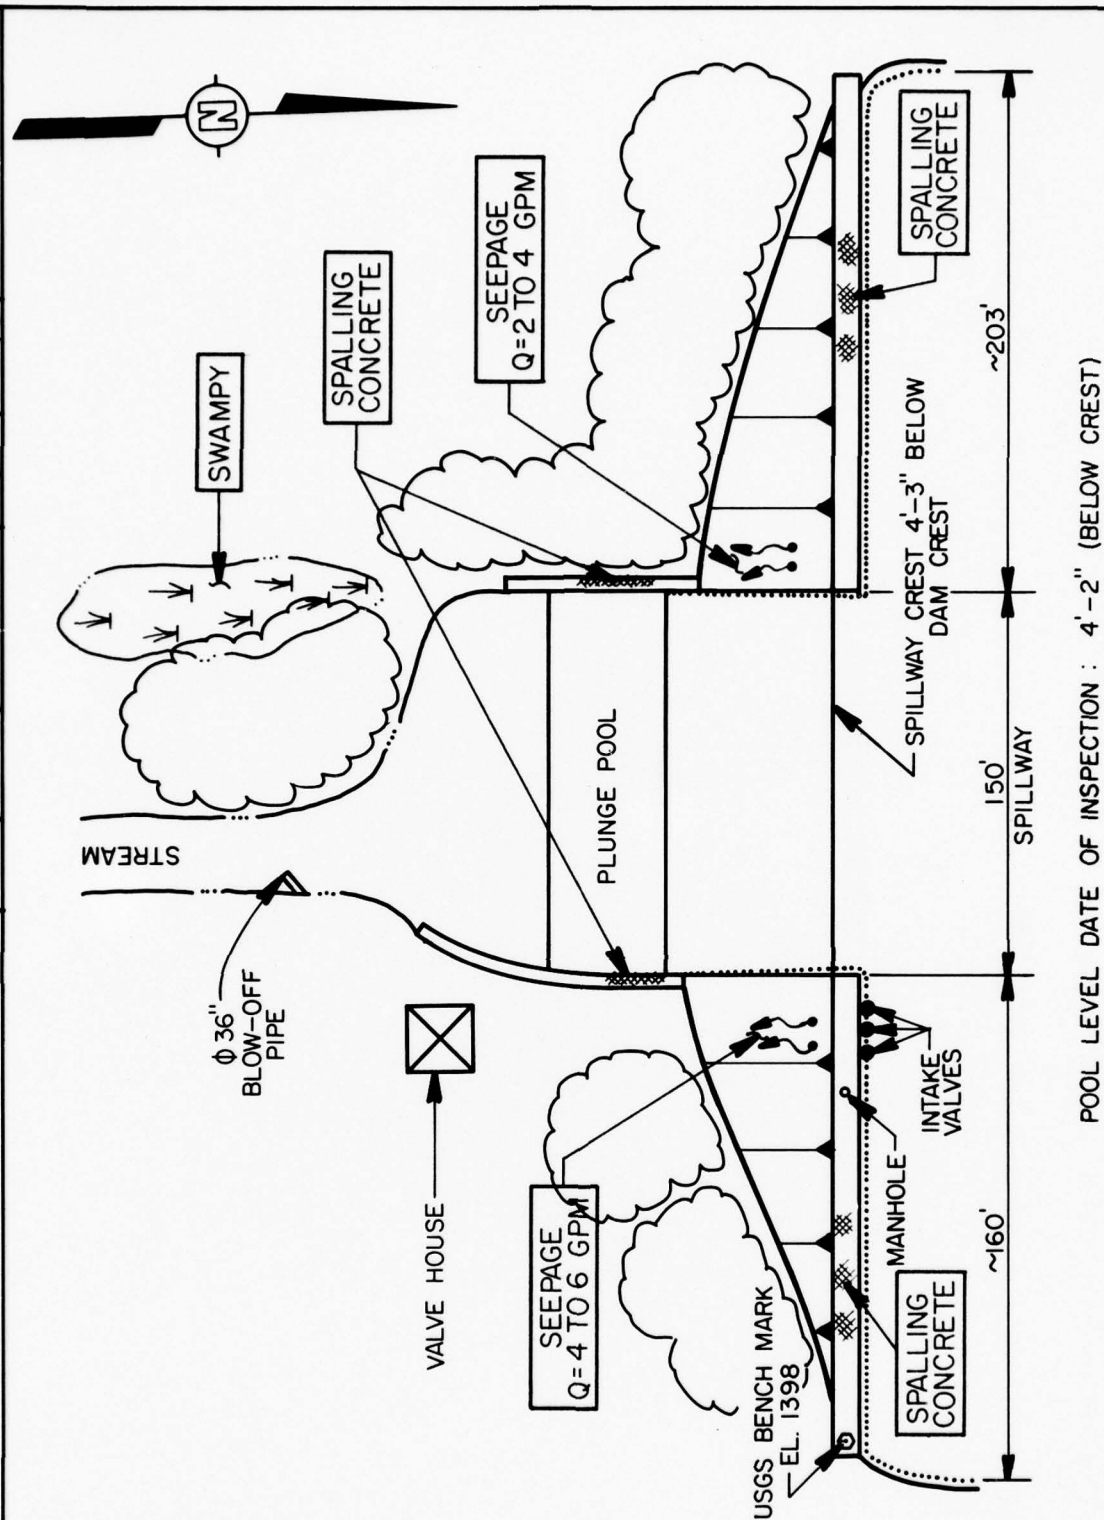
TIPTON DAM NDI : 525  
GENERAL PLAN  
FIELD INSPECTION NOTES  
FIELD INSPECTION DATE : JULY 11 , 1978

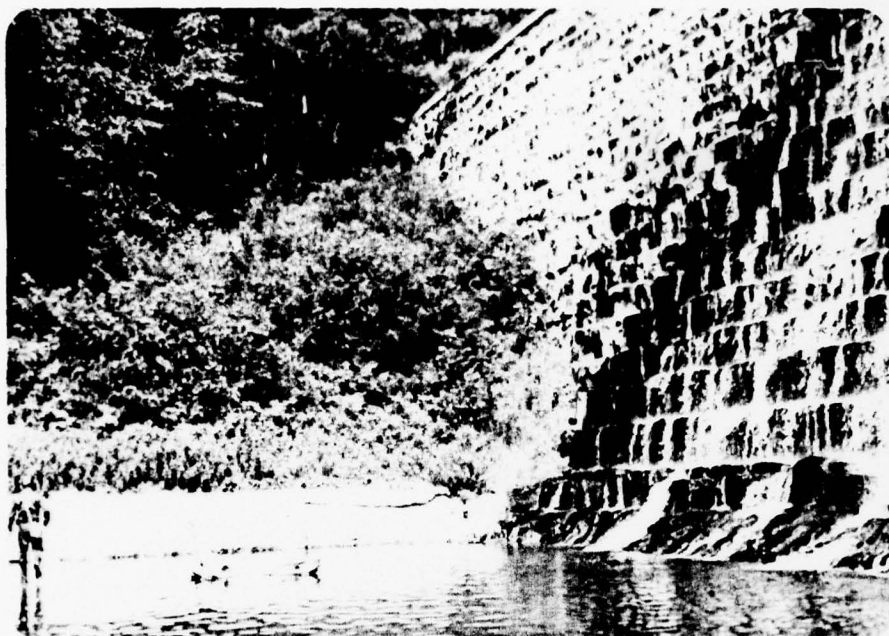
Photograph No. 1  
Right abutment.

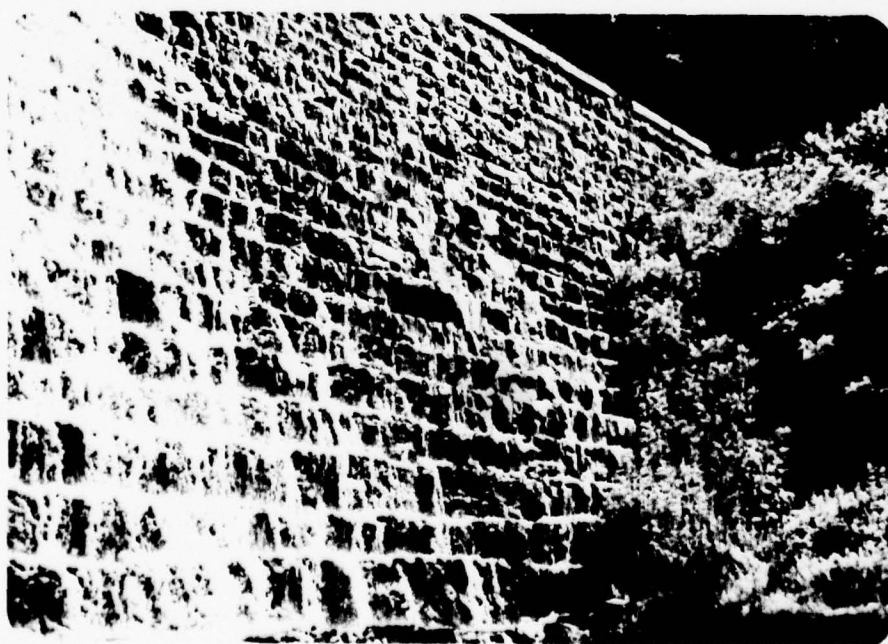
Photograph No. 2  
Left abutment.

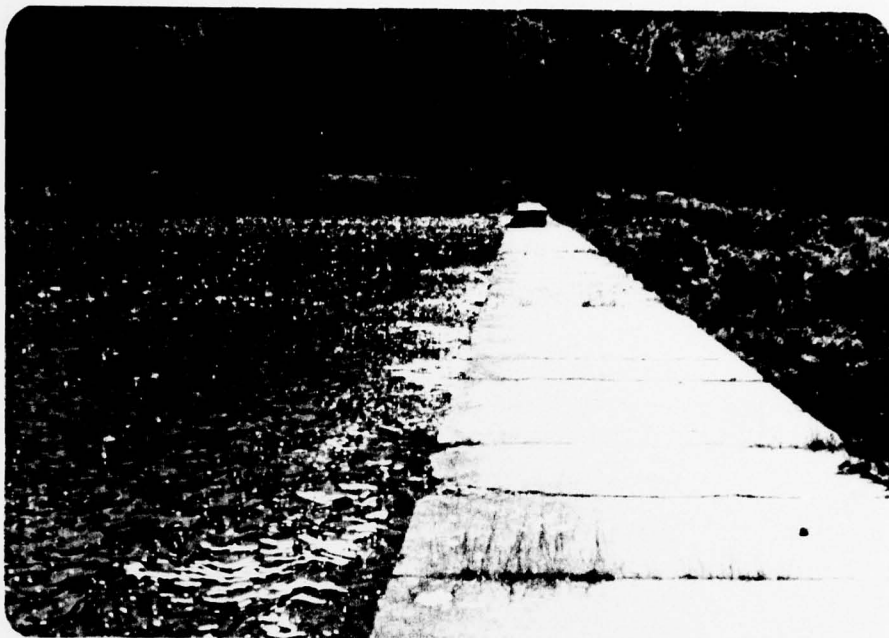
| VISUAL EXAMINATION OF | OBSERVATIONS | REMARKS OR RECOMMENDATIONS |
|---|---|---|
| SURFACE CRACKS<br>CONCRETE SURFACES | SOME CREST CURING BLOCKS SPALLING. | |

Photograph No. 3  
Crest (looking east).

1. It is recommended that the owner immediately evaluate the operational condition of the reservoir blow-off valve and perform necessary maintenance.
2. Spalling concrete capping blocks and plunge pool side walls should be repaired as soon as practicable.
3. Because the dam may overtop during unusually high runoff, it is recommended that during such periods the owner should provide around-the-clock surveillance for early detection of problems, such as erosion of the abutments.
4. It is recommended that brush and trees on the abutments should be cleared over a distance of approximately 20 feet from the dam to permit adequate future visual inspection of the abutment areas.

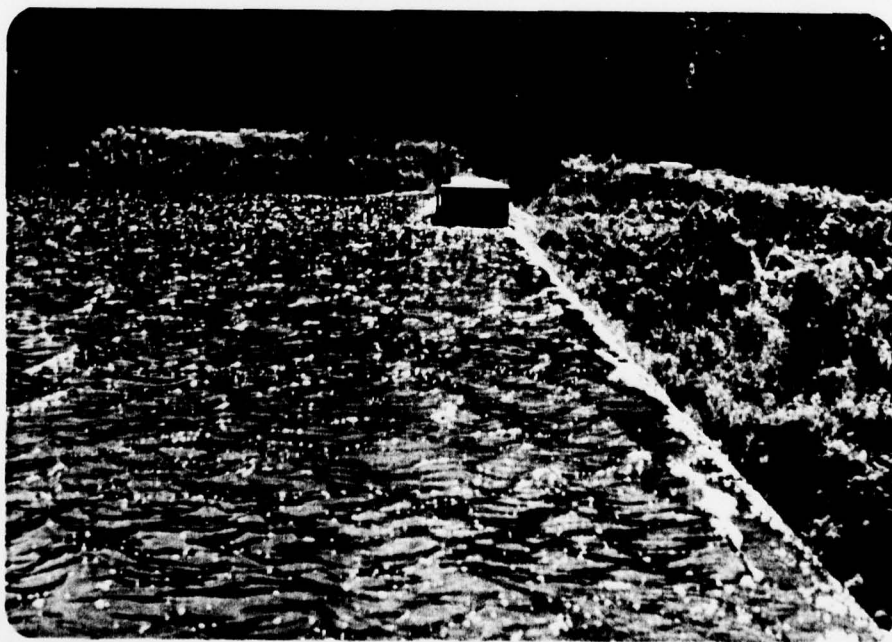
| VISUAL EXAMINATION OF | OBSERVATIONS | REMARKS OR RECOMMENDATIONS |
|---|---|---|
| CONCRETE WEIR | SUBMERGED. VISIBLE PORTIONS ON EACH SIDE GOOD CONDITION. | |

Photograph No. 4  
Spillway crest (looking east).

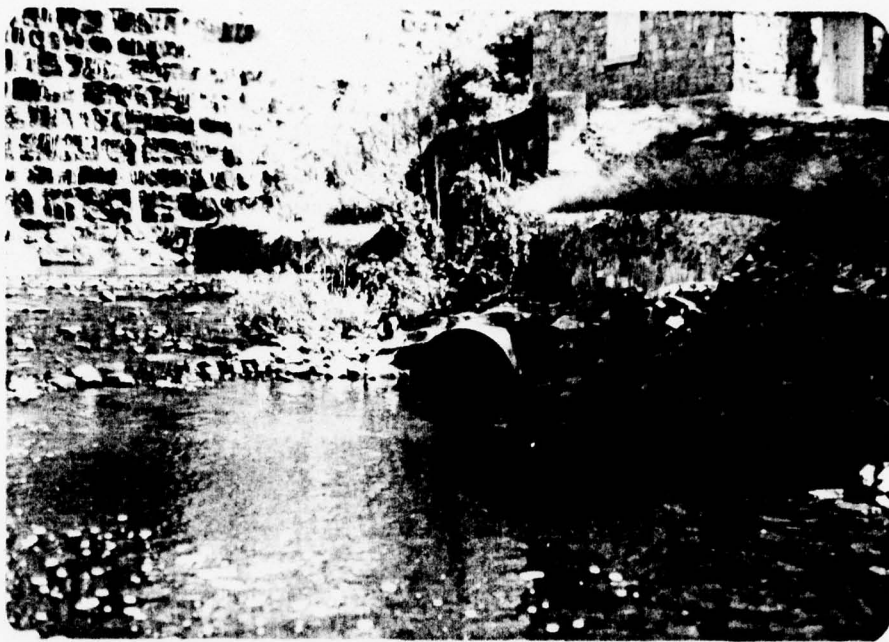
Photograph No. 7

| VISUAL EXAMINATION OF : | OBSERVATIONS | REMARKS OR RECOMMENDATIONS |
|---|---|---|
| EMERGENCY GATE | 36-INCH CAST IRON PIPE. (OUTLET VALVE WAS NOT OPERATED. WATER COMPANY DECLINED TO OPERATE THE VALVE WITHOUT COMPENSATION FOR SERVICES PLUS ANY DAMAGES CAUSED BY THE OPERATION) | |

Blow-off pipe (note valve house in  
righthand corner).
