BEAVERDAM RUN DAM

FD-NO. PA. 805

PHASE I INSPECTION REPORT

Beaverdam Run Dam (PA 805), Ohio River  
Basin, Beaverdam Run, Cambria County,  
Pennsylvania. Phase I Inspection Report.

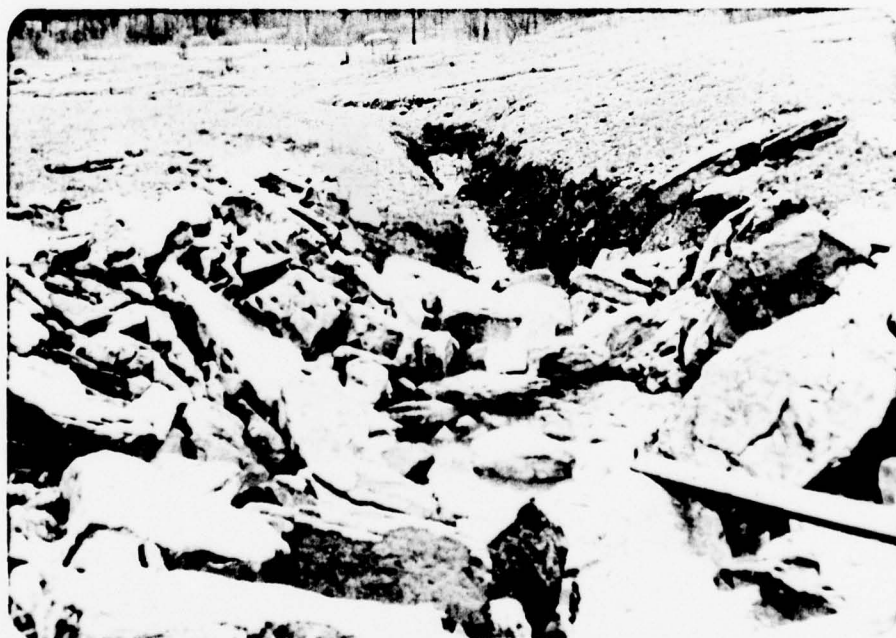
Photograph No. 4  
Primary spillway, plunge pool, and discharge channel.

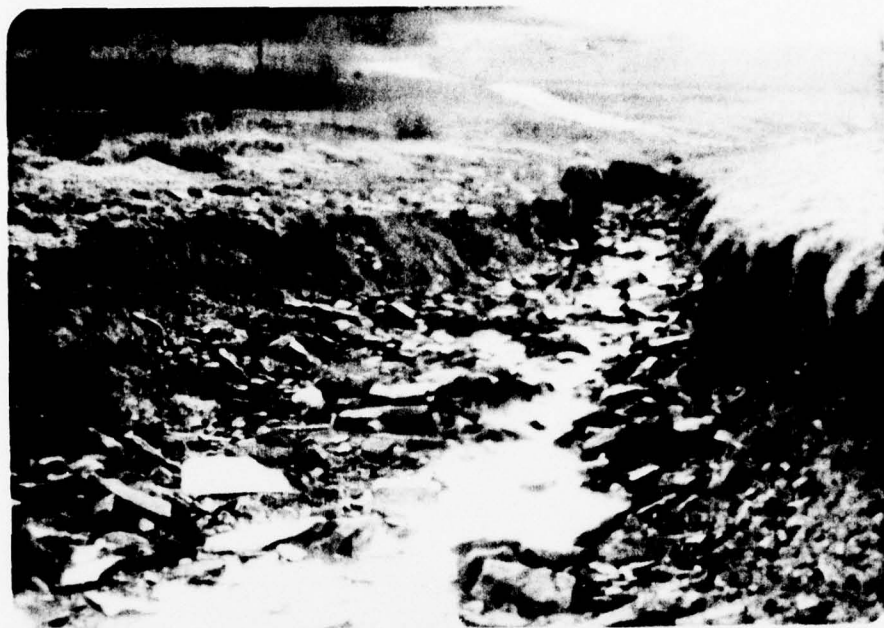
In general, the structures were found to be in good condition, with the exception of major erosion observed in the primary spillway discharge channel (Photograph 7) downstream from the plunge pool. This condition is not considered to be a safety hazard at its present extent. However, it should continue to be monitored to assure that it will not affect the performance of the plunge pool. The riprap at the emergency spillway entrance channel is inadequate to protect the embankment from erosion during high flows. Approximately 100 feet downstream from the crest, the left side of the emergency spillway channel is too low to contain major flows through the spillway. At flow depths of two to three feet over the spillway crest, it appears that the channel would overflow downslope toward the toe of the embankment.

In this current inspection, the condition of the seepage and channel scour was found to be similar to that described in the previous inspection report.

Photograph No. 7  
Erosion in discharge channel.

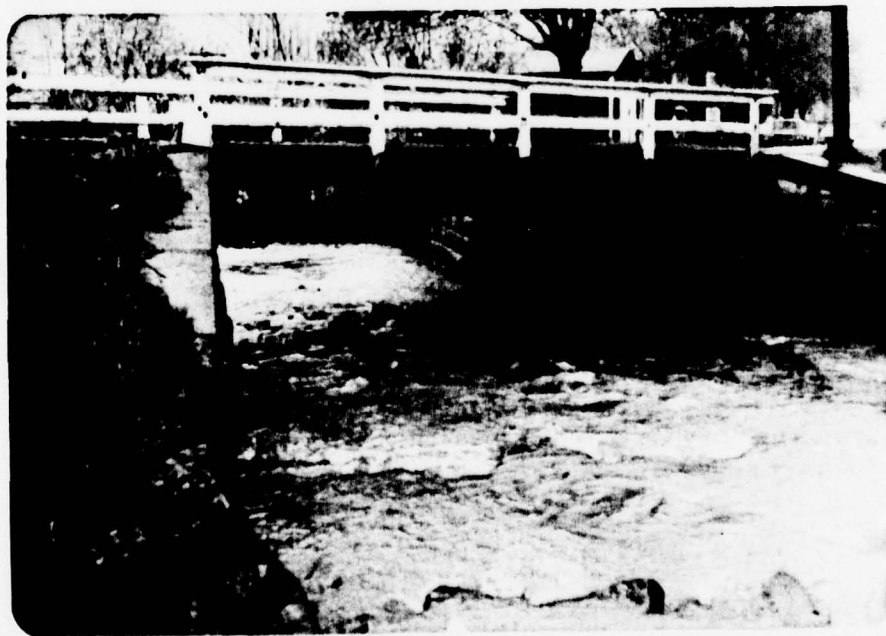
Photograph No. 8  
Bridge No. 1.
