TAR RUN DAM
NDS ID NO. PA-00692
DER ID NO. 54-124

PHASE I INSPECTION REPORT
NATIONAL DAM INSPECTION PROGRAM

Prepared by
GANNETT FLEMING CORDDRY AND CARPENTER, INC.
Consulting Engineers
Harrisburg, Pennsylvania 17105

AUGUST 1978

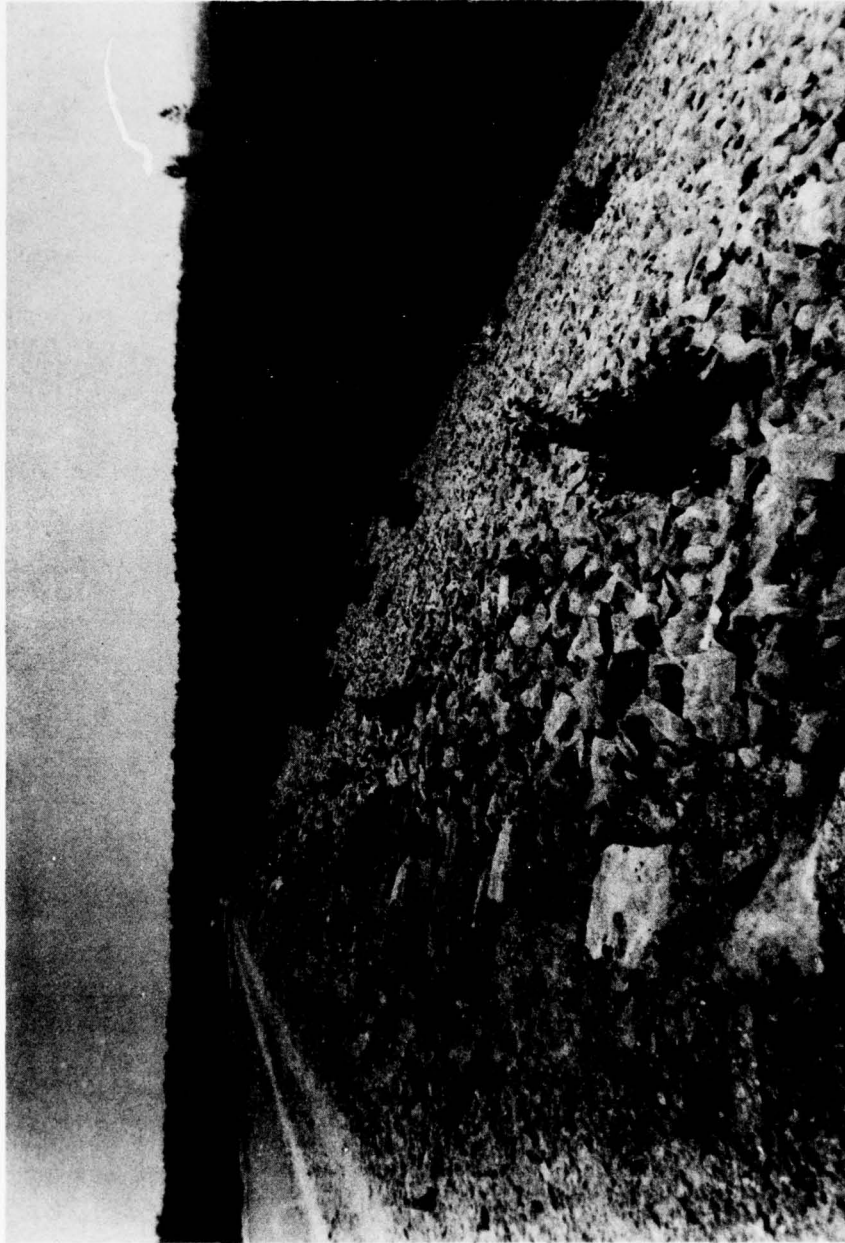
Downstream Slope of Embankment from Spillway.

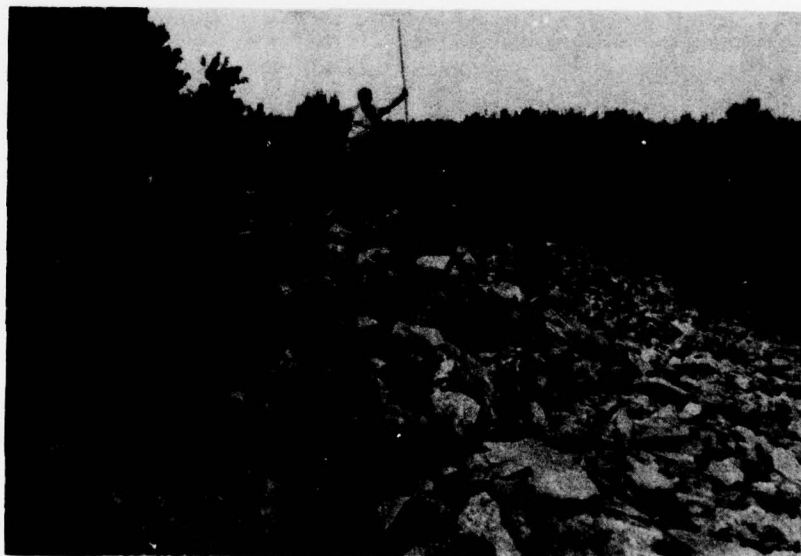
The riprap on the downstream slope is very loose with many uneven areas. It slid underfoot when an inspector walked on it. The uneven areas appear to be slides.

The bulges on the riprap on the downstream slope were thought to be surface sliding of the loose riprap, with no sliding of the embankment beneath. The sliding could, however, be an indication of more serious problems.

D. Riprap on Downstream Slope of Embankment.

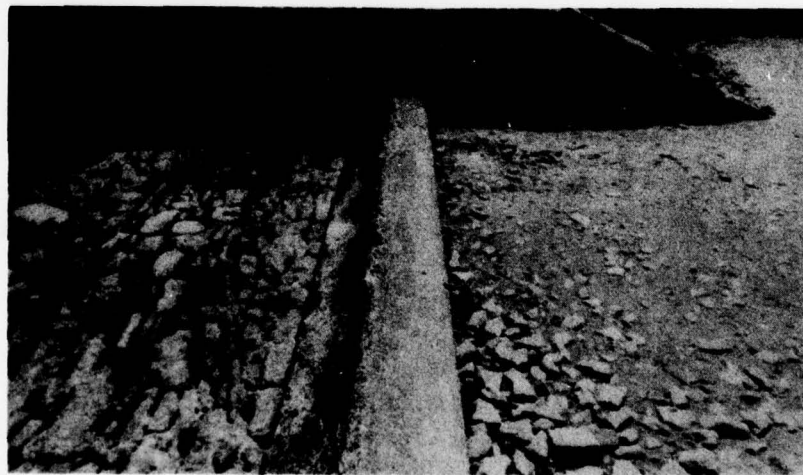
c. Appurtenant Structures. The spillway weir has a crest length of 40 feet, and it was apparently constructed as a single monolith (Photographs E and F). Four shrinkage cracks extend through the weir. The upstream side of the weir, near the crest, has spalled to a depth of 2 inches. The downstream side of the weir has spalled to a greater extent, one area being spalled along a 12-foot length to a depth of 4 inches. In the spillway approach walls, the mortar is completely deteriorated below spillway crest level. The mortar is also deteriorated where the weir joins the walls.

b. Appurtenant Structures. The shrinkage cracks in the spillway weir were probably caused by the excessive monolith length. The spalling is probably caused by exposure to flowing water or honeycombing of the concrete during construction. Neither of these conditions are sufficiently serious to present an immediate hazard. The deterioration of the mortar in the approach walls was probably caused by exposure to fluctuating pool levels and freezing-thawing cycles. The deteriorated mortar may prevent the wall from acting as a watertight structure.

F. Concrete Spillway Weir and Masonry Apron.

(3) Repair spalling concrete on spillway weir.

(4) Monitor shrinkage cracking of concrete at spillway weir and surface cracking at outlet works headwall. If changes are noted, take appropriate action.
