PIKES CREEK DAM

NDS ID NO. PA-00576

PHASE I INSPECTION REPORT
NATIONAL DAM INSPECTION PROGRAM

JULY 1978

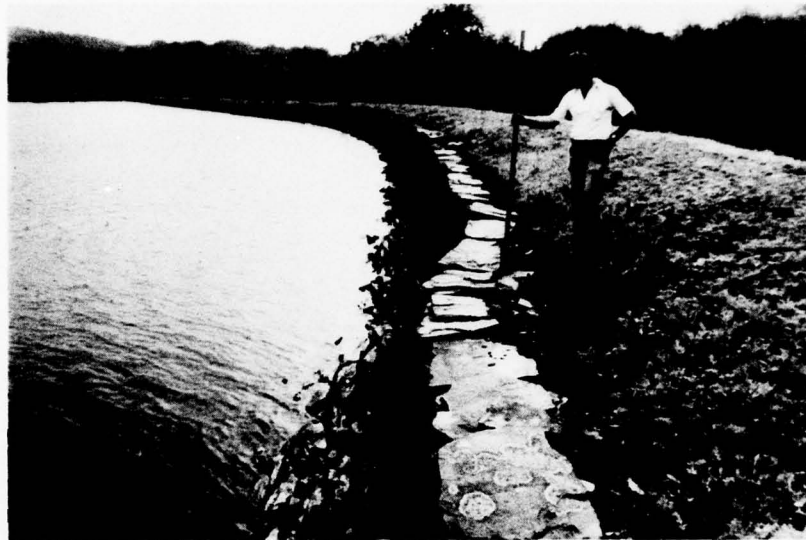
C. Riprap on Upstream Slope

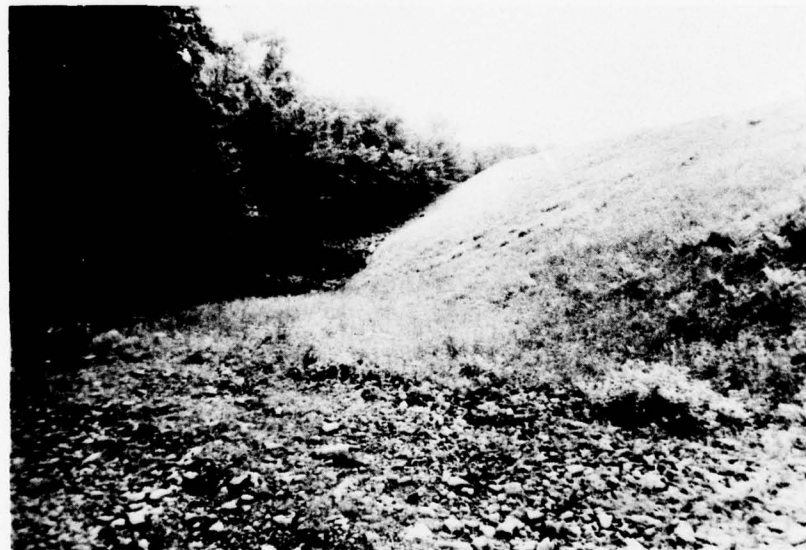
b. Embankment. The sod on the embankment is in excellent condition. There are a number of holes, made by burrowing animals, in the embankment. A number of turtles were observed making holes to lay eggs in. Some other holes were observed to be of a size suitable only for small rodent-sized animals. A few larger holes were observed. None of the larger holes appeared to be active. The vertical alignment of the dam is uneven, with the lowest elevation being 1055.9. These low spots are not localized but extend over most of the dam, except at the abutments. One 10-foot long section of rip-rap on the upstream slope of the embankment is bulged toward the reservoir (Photograph C). The dry masonry wall at the downstream toe of embankment near the valve house is bulged. The center of the wall protrudes about 6 inches further downstream than the ends. Along lengths of the downstream toe, the tree line is at the toe. Some surface cracking was observed on the top of dam. One crack extended normal to the centerline of dam across the entire top. Another crack extended longitudinally for about 100 feet. This crack appeared intermittent. These cracks were very fine and their depth could not be measured. No relative movement was observed at the cracks. Seepage was observed at three separate areas along the downstream toe. One area (Photograph D) was near the left abutment. This area measured approximately 225 feet along the toe and extended about 300 feet downstream of the toe. The area was irregular in shape and had a swampy surface. Water was observed over most of the area. A low artificial pond was also observed in the middle of the wet area. Clear seepage of about 15 gpm was observed flowing from the wet area. The Owner reports that the water in this area is coming from the left abutment hillside. He reports that the pond was originally used to store bait. A second seepage area, about 1 square foot, exists 150 feet left of the valve house. Clear water was seeping from this area at the rate of about 1 gpm. A dry erosion gully extends from the embankment berm to this area. A third seepage area was observed at the valve house. The source of the seepage was not evident. Water was clear and flowing at a rate of about 10 gpm. The Owner reported that the source of the seepage was leakage from the defective packing on the valves in the valve house.

D. Embankment and Wet Area
Near Left Abutment

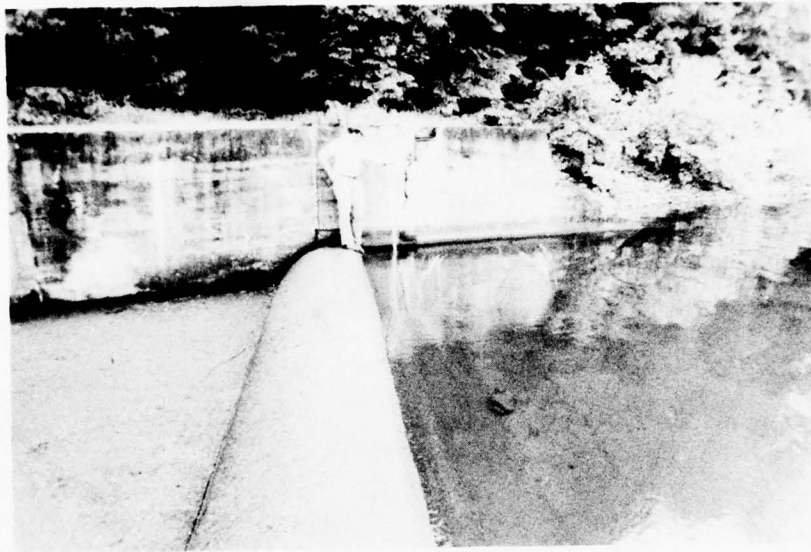
c. Main Spillway. The concrete weir of the main spillway is in generally good condition (Photograph E). The weir was placed in two 36-foot long monoliths. Shrinkage cracks are evident. The aggregate is exposed on the weir. The right approach wall is cracked (Photograph E). Evidence of relative movement was observed. The approach channel slab has a crack, parallel to the weir, extending across the entire slab. The flume downstream of the weir is in generally good condition. Two of the monoliths in the bottom of the flume are pitted over most of their area. The concrete walls were constructed as 30-foot long monoliths and numerous shrinkage cracks were observed. At the cracks there was evidence of slight leaching, as white deposits or "efflorescence" was observed. The toe of the wall stem is slightly scoured along the entire length. The top of the walls are slightly spalled in spots. At a few joints, the concrete has spalled to a depth of about 2 inches over an average length of 5 inches. The reinforcing bars, which appear to extend continuously between monoliths, are exposed in these areas. Trees are very close to the left wall. The branches hang over part of the flume. The inspection of the flume ceased about 500 feet downstream of the spillway crest.

b. Main Spillway. The crack in the right approach wall of the main spillway was probably caused by settlement. The crack in the approach channel apron may be related to settlement or may have been caused by ice pressure. Neither condition presents an immediate hazard to the dam. The shrinkage cracks were probably caused by the excessive monolith

lengths. The other deficiencies noted in the concrete are to be expected after long term exposure to the weather and to flowing water. Long term neglect will lead to further deterioration of the concrete and deterioration of the exposed reinforcing bars. Trees close to the walls are undesirable.

E. Main Spillway Crest and
Main Spillway Right Training Wall

(4) Visually monitor surface cracking, spalling, shrinkage cracks, and pitting in the main spillway walls and apron, auxiliary spillway walls, and outlet works headwall. Areas where reinforcing bars are exposed and areas where concrete is severely disintegrated should be repaired.

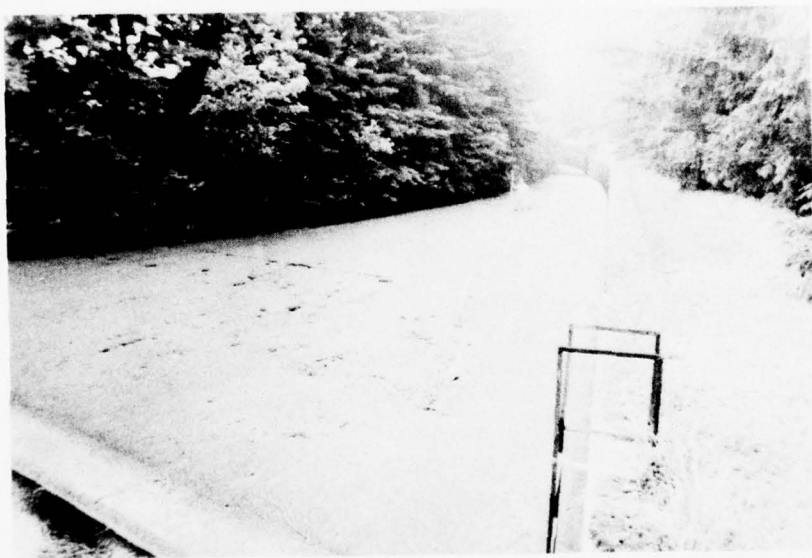
F. Main Spillway Channel

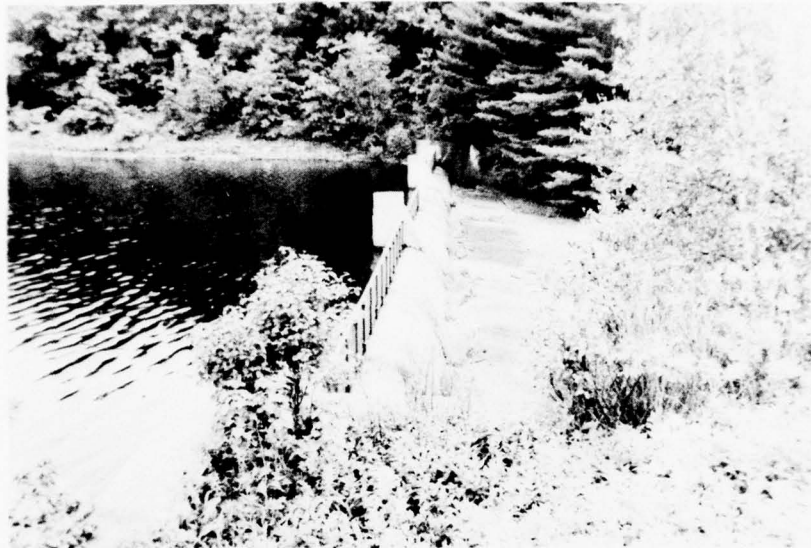
d. Auxiliary Spillway. The auxiliary spillway crest is pitted in localized areas. Spalling, typically 0.5-inch deep, was observed at the joints. One of the piers on the crest was slightly spalled at its junction with the crest. The steel flashboards appeared to be in excellent condition. The concrete apron has a minor amount of vegetation growing at the joints. Vegetation was also observed in localized areas of the mortared stone apron. The left auxiliary spillway wall has a surface crack and leaching approximately at the crest of the auxiliary spillway. The top of the walls on both sides is slightly spalled. Trees are close to both walls. Shrinkage cracks were observed at identical locations in the curved section of each wall. Downstream of the apron, the auxiliary spillway channel (Photograph H) is heavily overgrown and swampy. It was not possible to inspect it. It was not possible to measure the inside diameter of the hollow-pipe pins which support the flashboards.

c. Auxiliary Spillway. The pitting of the auxiliary spillway crest may have been caused by honeycombing of the concrete when it was placed. The shrinkage cracks in the walls and surface crack in the wall near the crest are probably caused by the location of the joints. The other deficiencies in the concrete are probably caused by exposure to the weather. Long term neglect can lead to worsening conditions. The vegetation in the apron and the trees adjacent to the walls are undesirable. The overgrown channel below the apron can significantly affect the hydraulics. This situation is further evaluated in Section 5, Hydrology and Hydraulics. Except for the downstream channel, the conditions observed at the auxiliary spillway present no special concern.

G. Auxiliary Spillway and Flashboards

(3) Remove the flashboards from the auxiliary spillway or ascertain that they will fail as designed.

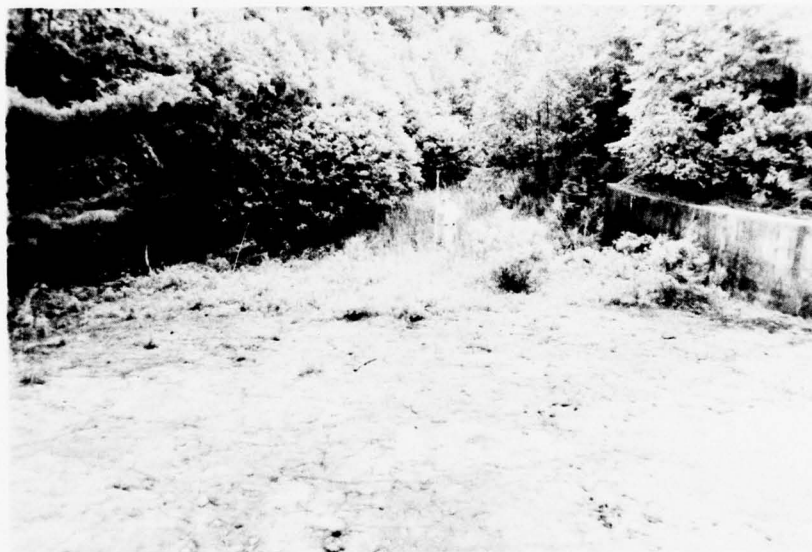
c. Visual Observations. During the inspection of Pikes Creek Dam, it was observed that the channel downstream of the auxiliary spillway was heavily overgrown. This vegetation could cause backwater to reduce the auxiliary spillway discharge capacity. It was also estimated that Harveys Creek Canal was hydraulically unable to pass large flows from the auxiliary spillway. As Harveys Creek Canal does not present a hazard to the dam, this condition was only of slight concern. No habitations were observed near Harveys Creek Canal.

H. Auxiliary Spillway Channel

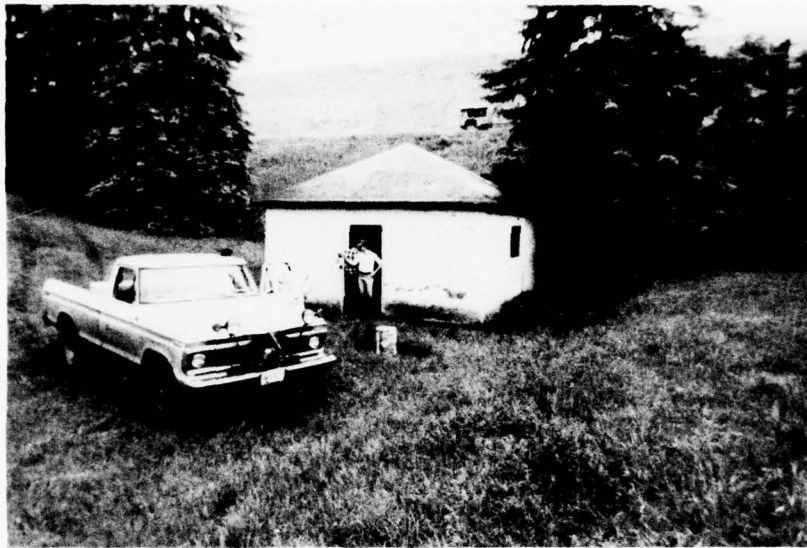
e. Outlet Works. The headwall is slightly spalled along the exposed edges and more heavily spalled at the downstream end of the walls. One 4-inch square pitted area was observed. The valve packings in the valve house leak. The position indicator on the right valve was missing. The operation of the valves was observed. It required four men turning a 30-inch diameter handwheel to operate the valve. It is estimated that it would require about 1 hour to fully open a valve manually. The Owner supplied an air compressor and attachments to operate the valves. It took two men 20 minutes to fully open a valve. All valves are operational.

d. Outlet Works. The spalling and pitted concrete observed is usual after long-term exposure to the weather and to flowing water. Leaking valve packings are undesirable. The operation of the valves was satisfactory. It would be desirable to have position indicators on all valves.

I. Valve House — Embankment in Background

(5) Repair leaking valve packings.

(6) Replace missing valve position indicator.

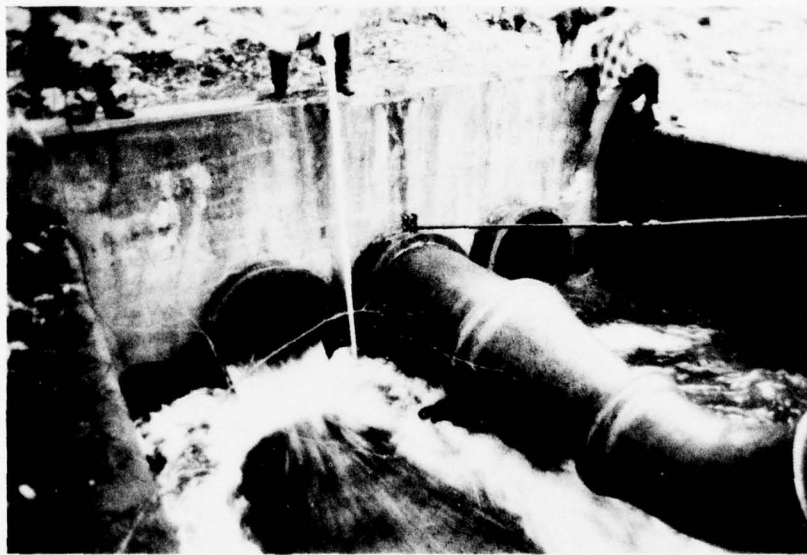
J. Outlet Works Headwall
