PARKER POND  
NDI NO. MD 00085

PHASE I INSPECTION REPORT  
NATIONAL DAM INSPECTION PROGRAM

Prepared By: Maryland Water Resources Administration ✓  
AUGUST 1978

Name of Dam: Parker Pond Dam  
State Located: Maryland  
County Located: Wicomico  
Stream: Beaver Dam Creek  
Date of Inspection: 14 July 1978  
Inspection By: State of Maryland  
Department of Natural Resources  
Water Resources Administration

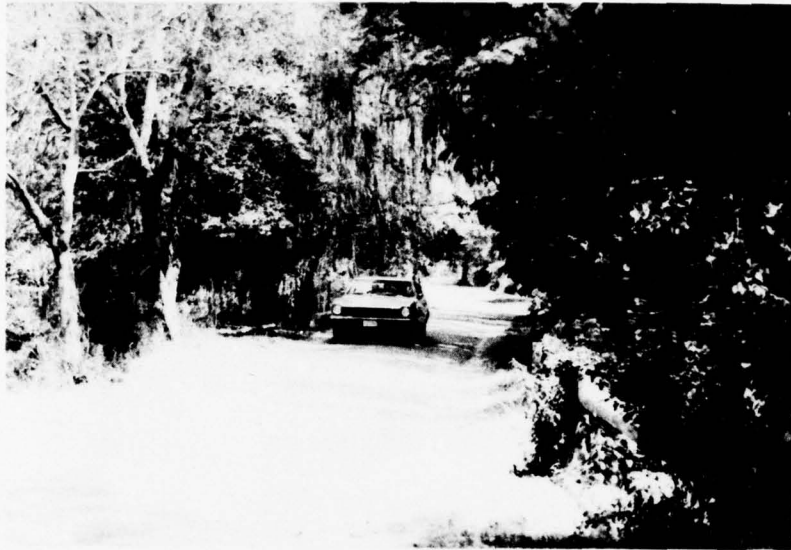
Top of dam  
east view

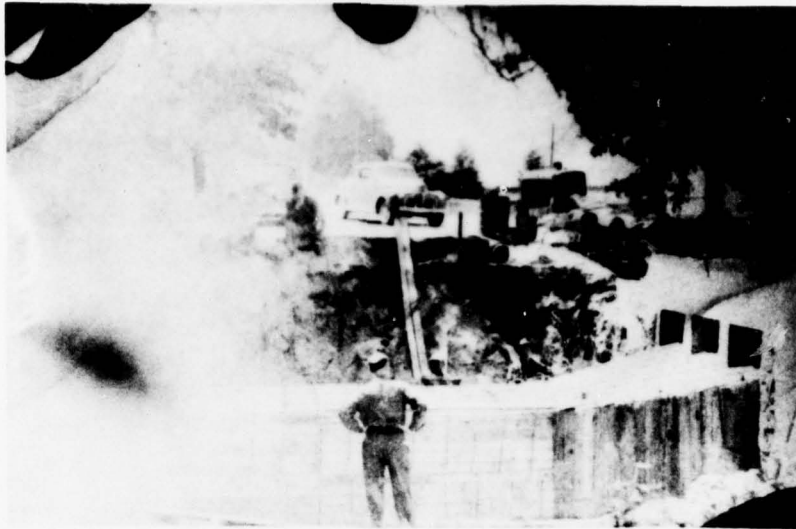
(Photo reproduction) construction of  
west (hydroelectric) spillway 1956

In 1956 an automobile left the road way and totally destroyed the old mill house and part of the spillway wingwall (downstream side) The mill was removed. Also in 1956 the right side of the dam washed out due to internal erosion. The spillway was replaced with a concrete flume containing hydroelectric equipment. (two twin turbines)

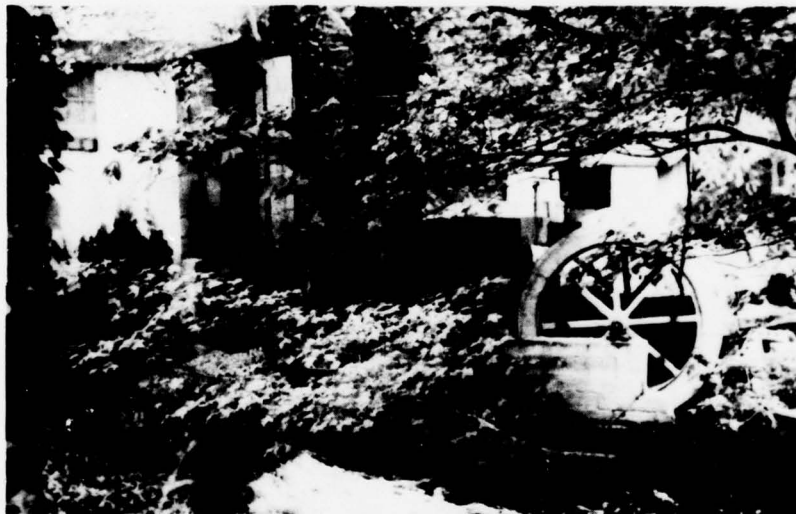
Downstream view of west (hydroelectric)  
spillway

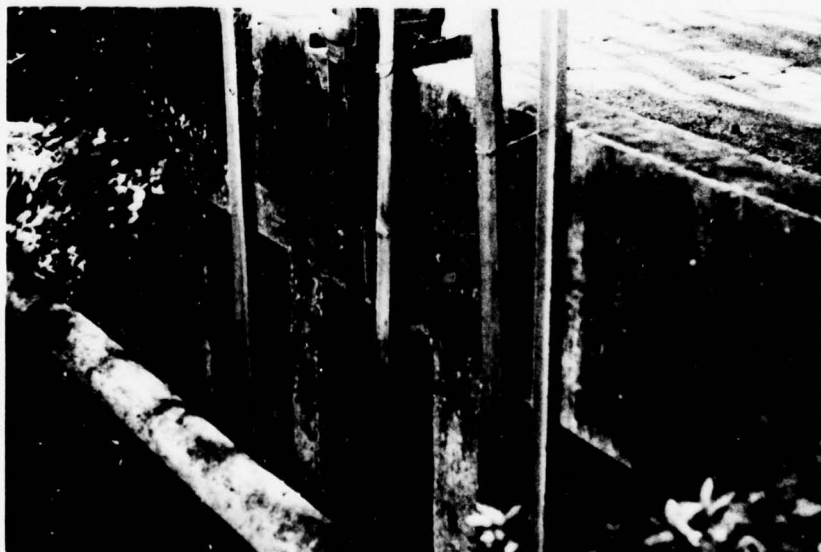
East spillway  
upstream face  
Parker Pond  
MD 00085
