Name Of Dam: BIG CHERRY DAM

Inventory Number: VA 19502

# PHASE I INSPECTION REPORT NATIONAL DAM SAFETY PROGRAM

GILBERT ASSOCIATES, INC.

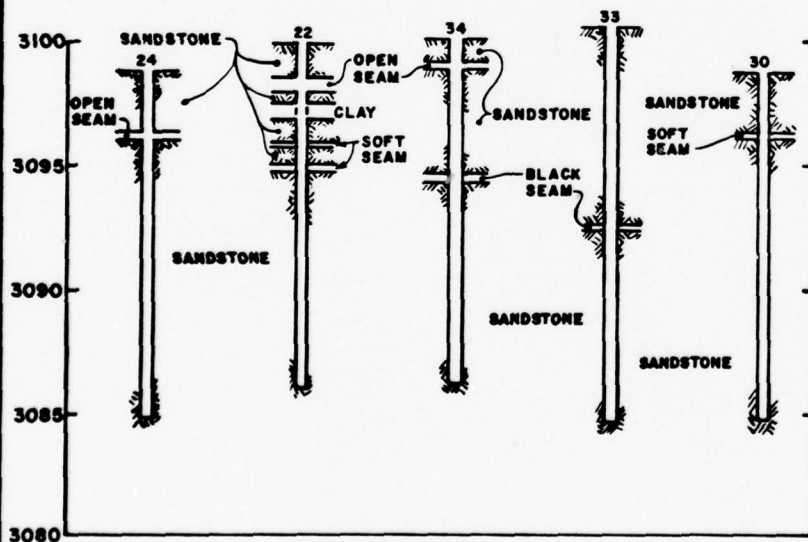
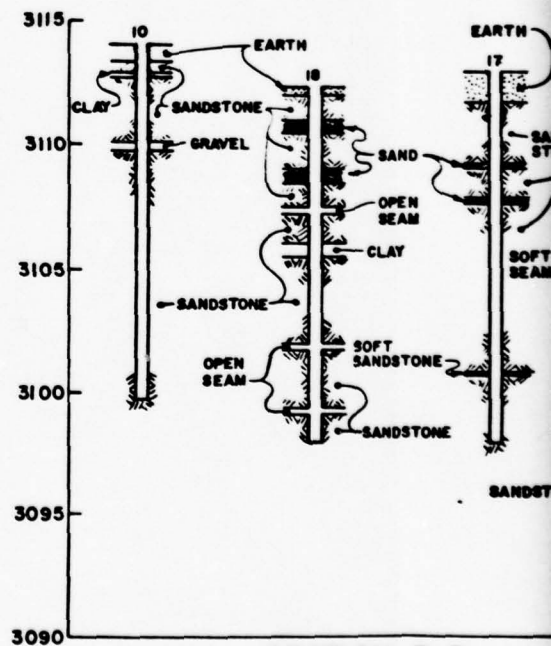
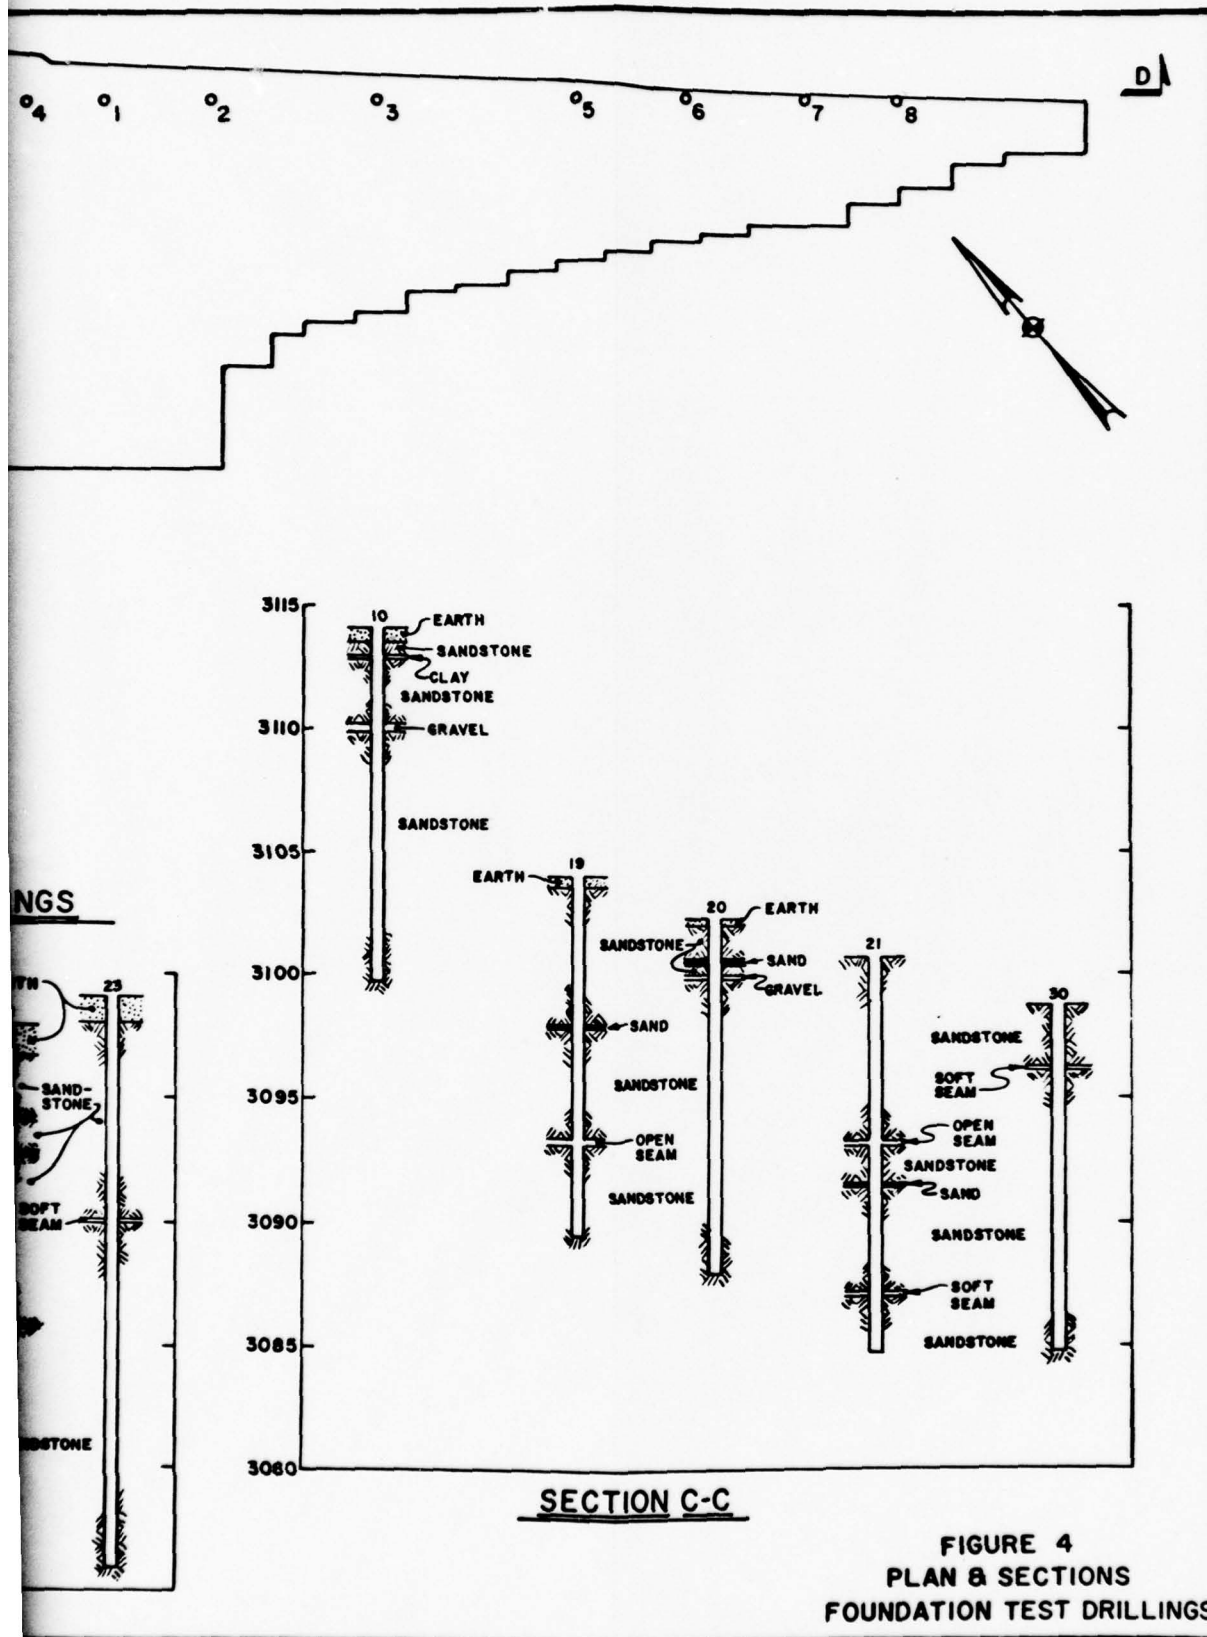
FIGURE 4  
PLAN & SECTIONS  
FOUNDATION TEST DRILLINGS

6.2 Foundation and Abutment: The open seams indicated on the attached figures seem to be parallel to the bedding planes and may have been originally caused by stress relief or shearing forces. The short durations of overtopping (see Table 5.1) are not likely to cause significant erosion at the abutments; however, increased seepage pressures along the weak seams during the floods are likely to cause sliding. Excessive seepage and resulting deterioration of strength along the weak seams or planes at shallow depths needs further examination and studies.

b. Initiate within three months a program of test borings, soil sampling and analysis to determine the characteristics of the underlying material, revise the stability analysis, and thereafter implement any appropriate remedial actions required.

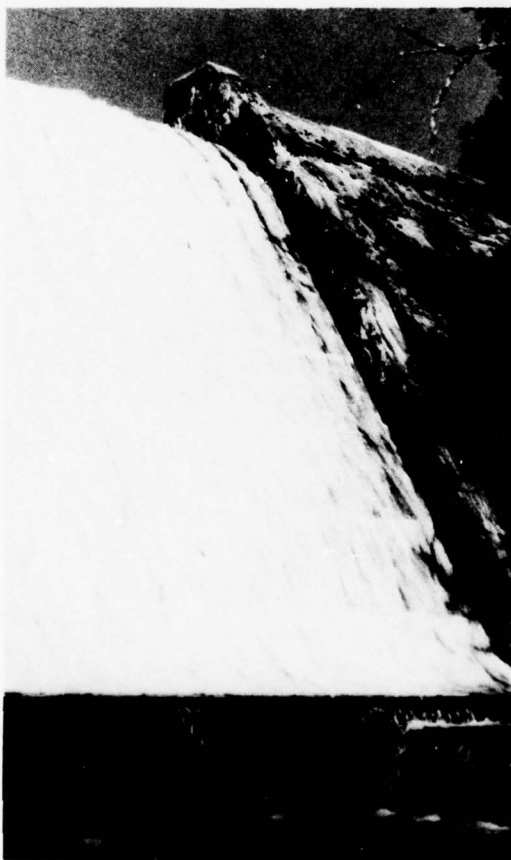
VIEW OF STILLING BASIN

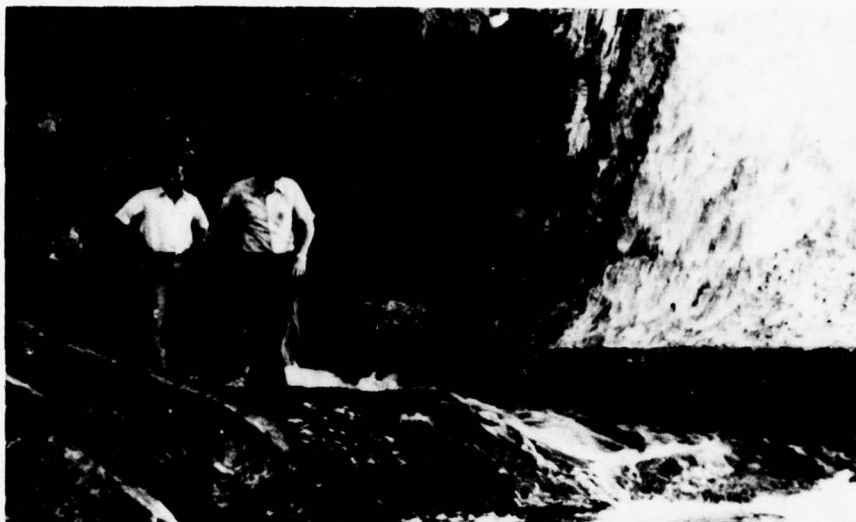
STILLING BASIN AND RIGHT ABUTMENT
