**JEROME PARK RESERVOIR DAM
BRONX COUNTY, NEW YORK**

**NY 64
PHASE I INSPECTION REPORT
NATIONAL DAM SAFETY PROGRAM**

Prepared by
CONVERSE WARD DAVIS DIXON
CONSULTING ENGINEERS
91 ROSELAND AVENUE, P.O. BOX 91
CALDWELL, NEW JERSEY 07006

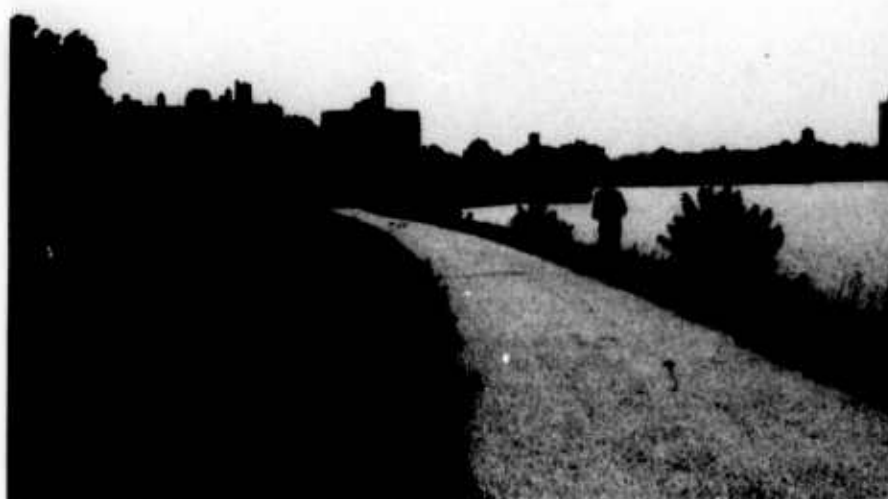
FIGURE 2 WESTERN EMBANKMENT AND SEDGEWICK AVENUE
LOOKING NORTH

In general, all earthen embankments were found to be grass covered and very well maintained (Figs. 2 and 3, Appendix D). No seepage was detected on or at the toe of the downstream slopes. A chain link fence, with barbed wire top in some areas, encircles the reservoir (Fig. 3, Appendix D). Along the western and northern portions of the perimeter, the fence is at or near the toe or toe wall of the embankment. There is a paved city street usually within 50 feet of the fence in these areas, and beyond that private residences. Consequently, no evidence of seepage beyond the toe could be observed.

A small section of the chain link fence surrounding the reservoir was missing along the eastern perimeter on the day of the inspection. We were informed by NYCDWRBWS personnel that breaches such as this were commonplace and that the one observed had not been there the previous day. It became apparent during the inspection and from conversations with Messrs Ragucci and Kuse that security measures in effect at the reservoir were not totally effective. We were informed that four trespassers had drowned in the reservoir in the past two years. On the day of the inspection, joggers (trespassers) were observed within the compound (Figs. 2 and 3, Appendix D).

(e) Breaches of the chain link fence should be repaired.

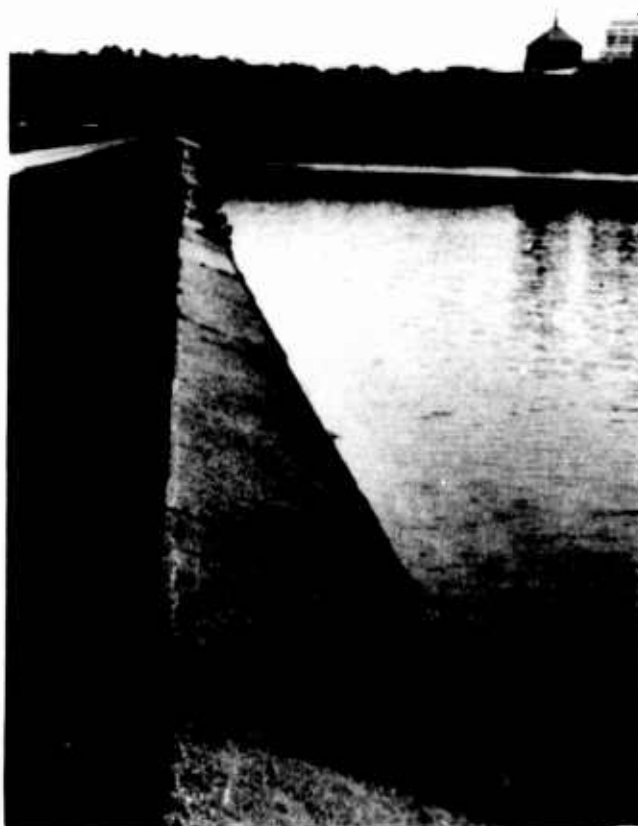
FIGURE 4 CONCRETE APRON AT NORTHERN END OF RESERVOIR

The earthfill and core wall section at the northern end of the reservoir was inspected and found to be in generally good condition. No significant deterioration of the upstream concrete apron was observed; vegetative growth in some of the construction joints was noted (Fig. 4, Appendix D).

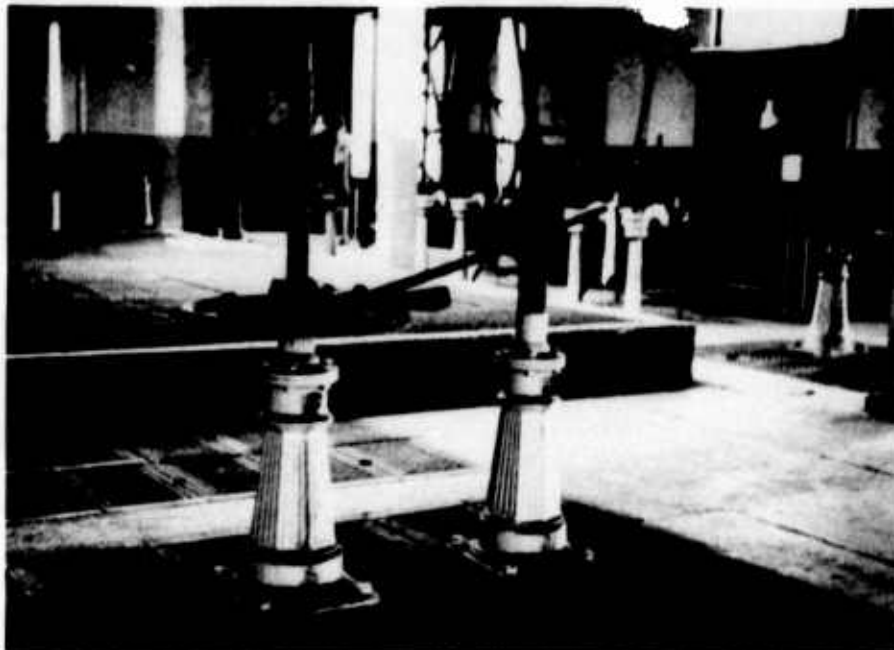
FIGURE 7 GATEHOUSE No. 5 GATE STAND ARRAYS

The four gates controlling flow from Main Chamber No. 19 in Gate House No. 5 to Shaft No. 21 (Manhattan's water supply line) were inspected and observed to operate satisfactorily. They are driven by a portable electric motor mounted on a tripod (see Background in Fig. 7, Appendix D).

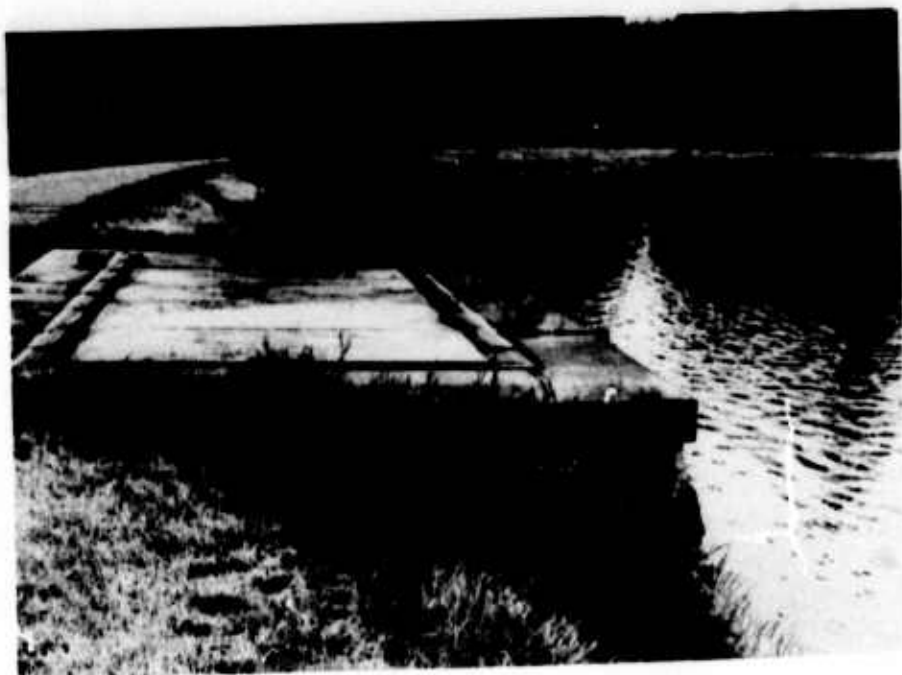
FIGURE 11 WASTE WIER

The exposed portion of the waste weir was inspected and found to be in generally good condition (Fig. 11, Appendix D). Here again, the top grill had been replaced by steel plates welded to the grill mounts because of past experience with vandalism. Water was heard flowing over the waste weir; flowing water could also be observed through joints between the steel cover plates. From field observation and from a review of the design drawings, it seemed that if the weir structure should fail, water from the reservoir would flow freely into the Broadway Sewer.
