⑥ National Dam Inspection Program. Dehart Dam (Inventory Number NDS-PA-561), Susquehanna River Basin, Clarks Creek, Dauphin County, Pennsylvania. Phase I, Inspection Report.

DEHART DAM

PHASE I INSPECTION REPORT

Name of Dam: DEHART DAM
State & State No. PENNSYLVANIA - 22-9
County: DAUPHIN
Stream: CLARKS CREEK
Date of Inspection: July 7, 1978

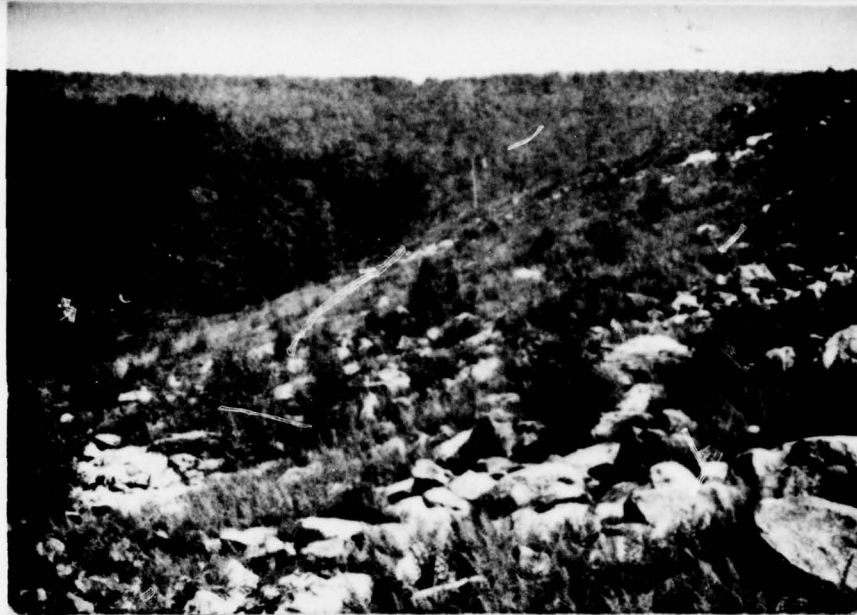
Downstream
Slope

The embankment shows no signs of distress. The rock slopes, both upstream and downstream are relatively uniform considering the size of rock (18 to 48 inches) which cover these surfaces. Heavy fern growth is found between the nested rocks on the downstream slope. Some light fern growth is located near the top of the slope on the upstream slope. The presence of this vegetation does not have any influence on the stability of the embankment; however, some trees on the downstream slope should be removed.

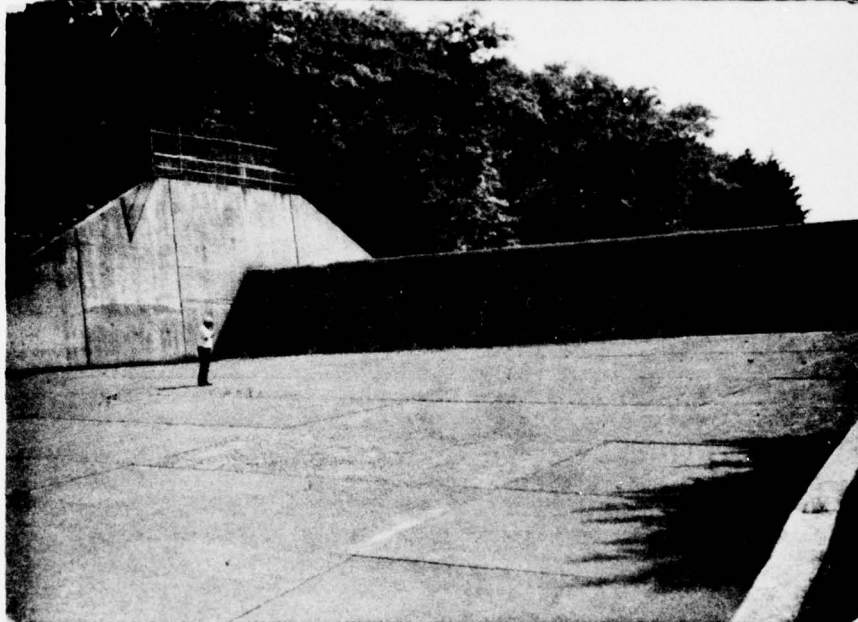
Spillway

The spillway was observed to be in good condition. Its dimensions were checked and found to be in accordance with the 1954 modifications.

The cutoff wall at the right abutment was found to be exposed at the surface indicating a short low section just behind the wall.

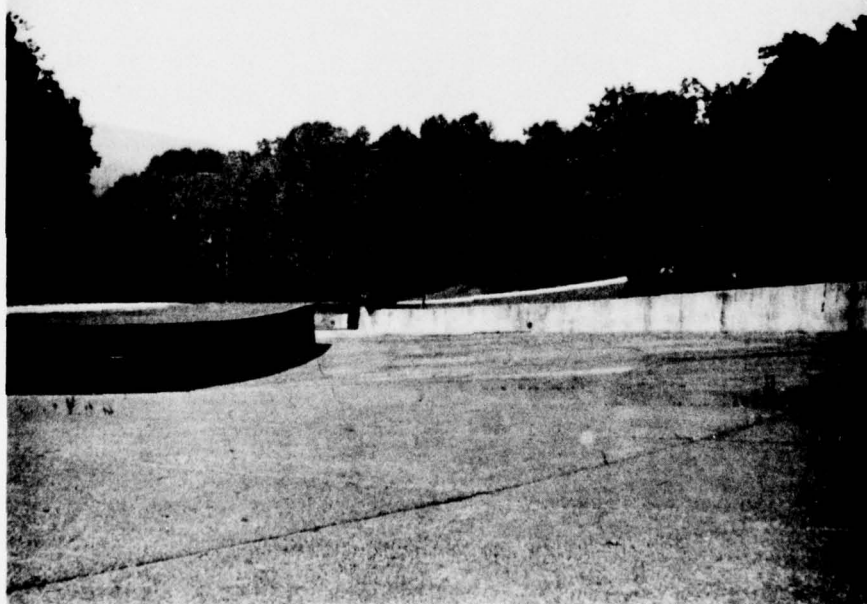
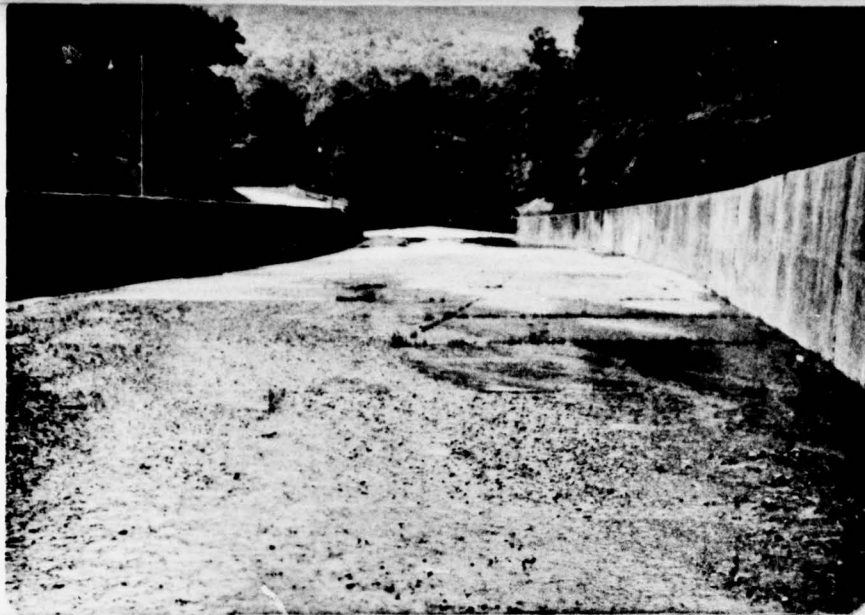
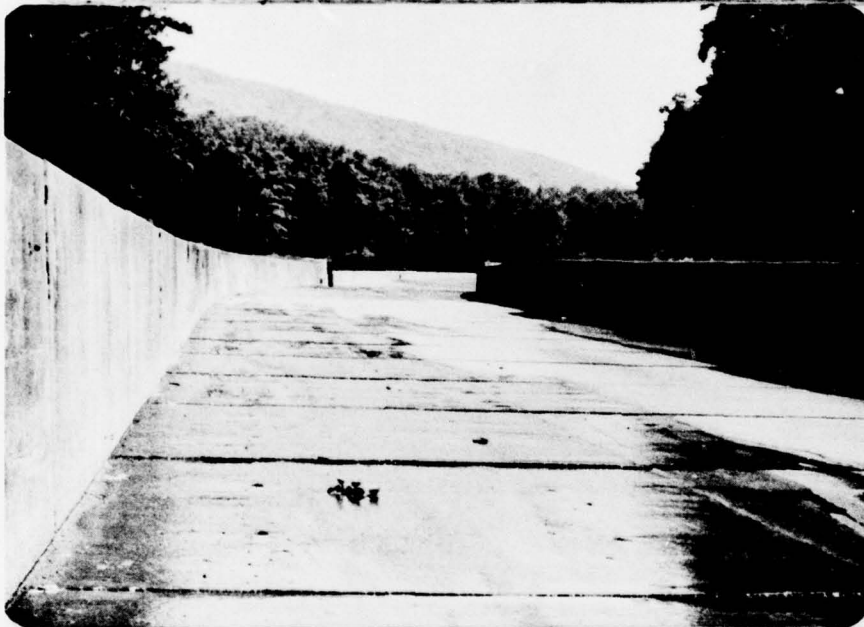
With the exception of some surface weathering on several slabs and exposed joints, the slabs of the spillway channel are in good condition. The walls are also in good condition. Some heavy spalling was observed at the top of some of the wall sections at the construction joint. These conditions do not impair the function of the spillway but preventative maintenance should be encouraged.

New slabs placed as a result of the 1972 tropical storm Agnes were observed to be in excellent condition. Weep holes were placed in these new slabs.

C. DISCHARGE CHANNEL Lining Cracks Spilling Basin	Spalling on wall at end of sloped section on left side at top plus several others along the entire channel. Slabs in good condition. Curbed, superelevated channel Cracks in top of right spillway sloping wall.

1. Observe and record the behavior of the apparent seepage at the toe of the embankment left of the left spillway wall. Take appropriate remedial measures if indicated.
2. Repair the spillway walls and slab of the spillway outlet channel as soon as possible.
