⑥ National Dam Safety Program,
Lake Meade Dam, Susquehanna River Basin,
Commonwealth of Pennsylvania, Adams
County (NDS-PA-331). Phase I
Inspection Report.

LAKE MEADE DAM

PHASE I INSPECTION REPORT

Name of Dam: LAKE MEADE
State and State No. PENNSYLVANIA - 1-81-A
County Located: ADAMS
Stream: MUD RUN, SUSQUEHANNA
Date of Inspection: July 21, 1978

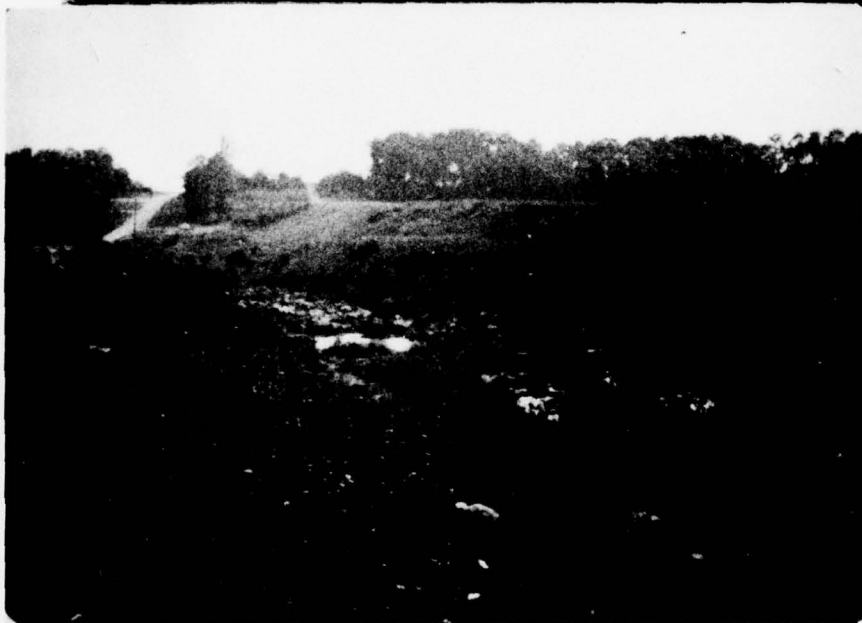
Spillway Channel

The capacity of the chute appears to be adequate for the top-of-dam weir discharge of 7,400 cfs but it is recommended that the conveyance of the chute be maintained by removing the brush.
