National Dam Inspection Program,  
Little Buffalo Creek Dam, Susquehanna  
River Basin, Commonwealth of  
Pennsylvania, Perry County (NDS-PA-582),  
Phase I Inspection Report.

LITTLE BUFFALO CREEK DAM

## PHASE I INSPECTION REPORT

Name of Dam: LITTLE BUFFALO CREEK DAM  
State and State No. PENNSYLVANIA - 50-60  
County Located: PERRY  
Stream: LITTLE BUFFALO CREEK  
Date of Inspection: September 11, 1978

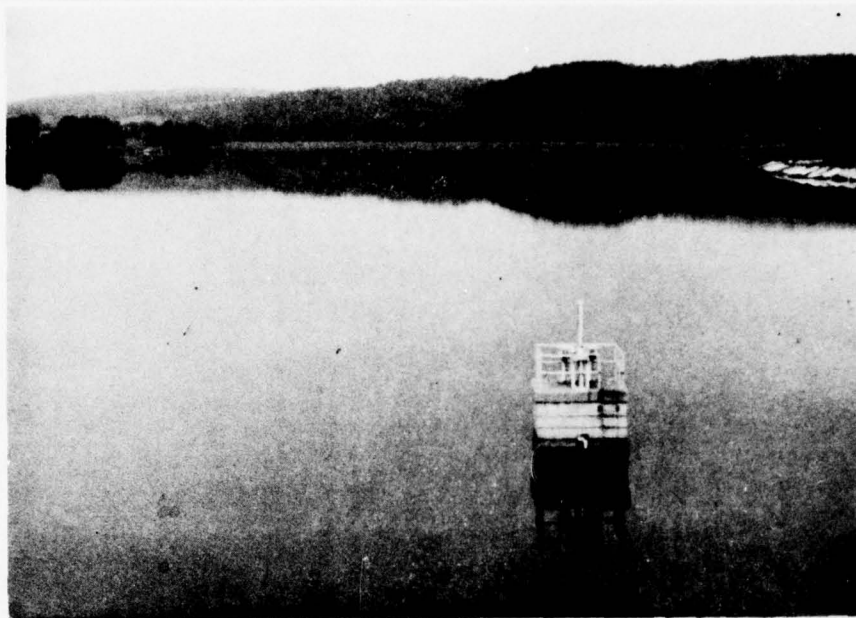
Access to the intake tower is by boat. The visual observations indicate that this structure and its gate and valves are in good condition. The 36-inch sluice gate was opened and closed for this inspection. It is noted that the deck of the tower is below the crest elevation of the dam (515.5 vs. 500.0).

Reservoir and  
Intake Tower
