PLEASURE LAKE DAM
SULLIVAN COUNTY, NEW YORK
INVENTORY NO. 345

PHASE I INSPECTION REPORT
NATIONAL DAM SAFETY PROGRAM

SEPTEMBER 1978

Prepared by: TIPPETTS-ABBETT-McCARTHY-STRATTON

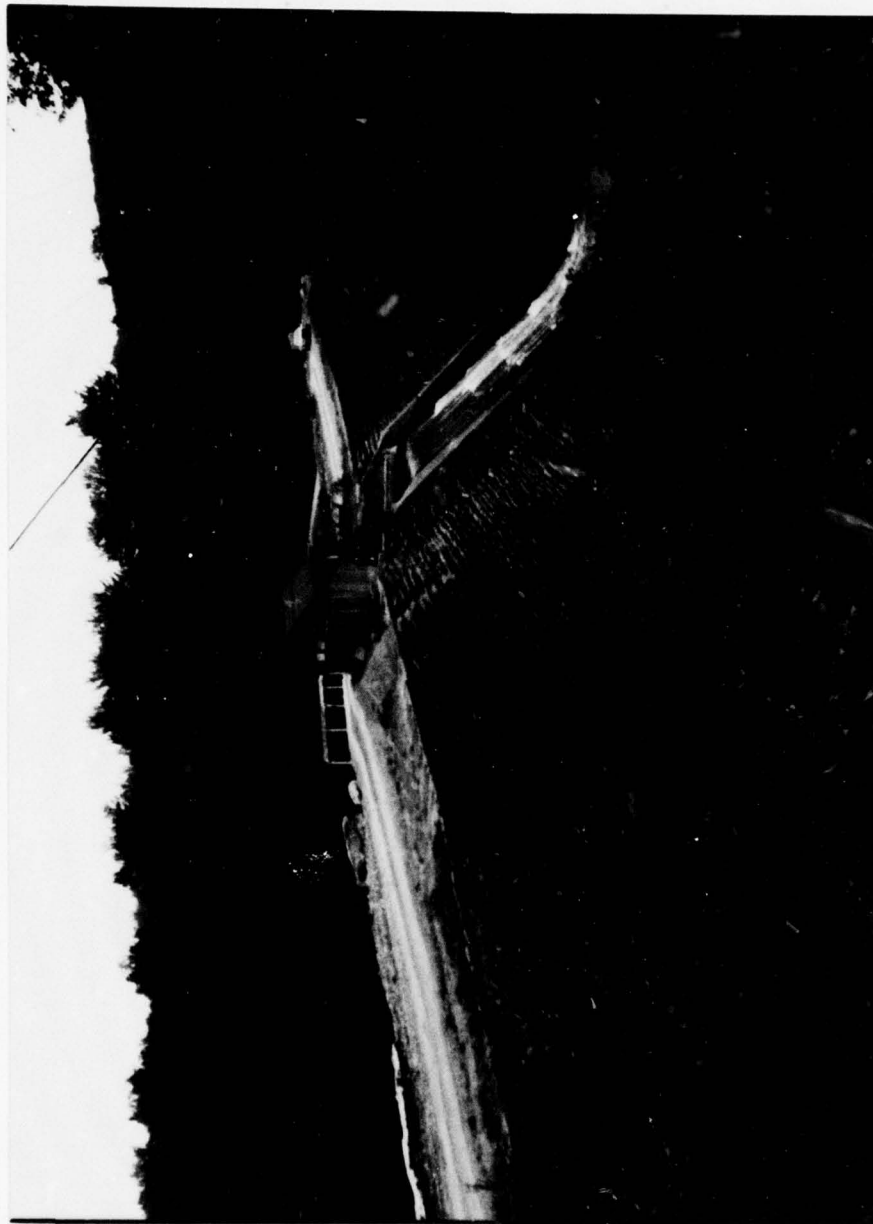
1) GENERAL OVERVIEW OF MASONRY - EARTHFILL DAM AND SPILLWAY

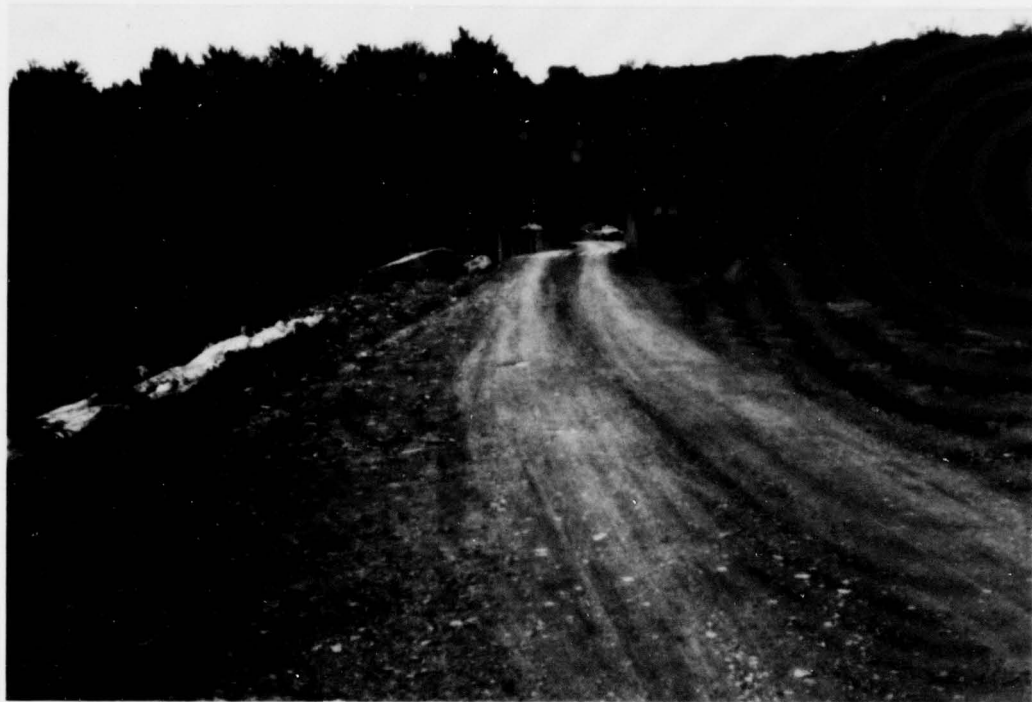
Crest alignment is generally good with only a few depressions created by traffic. An overlay of 65 tons of crushed rock rolled on to the crest road about 10 weeks before the inspection elevates only the road surface about 6 to 12 inches. The horizontal and vertical alignment of the embankment were good. It was observed that the downstream edge of the masonry crest, east of the gatehouse shows some curvature; however, no recent movement is apparent.

A longitudinal crack about 20 feet long is located on the crest, about two feet upstream of the roadway edge and approximately 40 feet west of the bridge. The crack appears to be caused by settlement of the fill placed in 1978.

2) CREST OF DAM LOOKING EAST

- a. The upstream earth slope should be flattened and riprapped. A bedding layer of suitable material should be placed between the earthfill and the riprap. The remainder of the slope should be seeded. The longitudinal crack observed along the upstream slope should be repaired prior to flattening and seeding the slope.

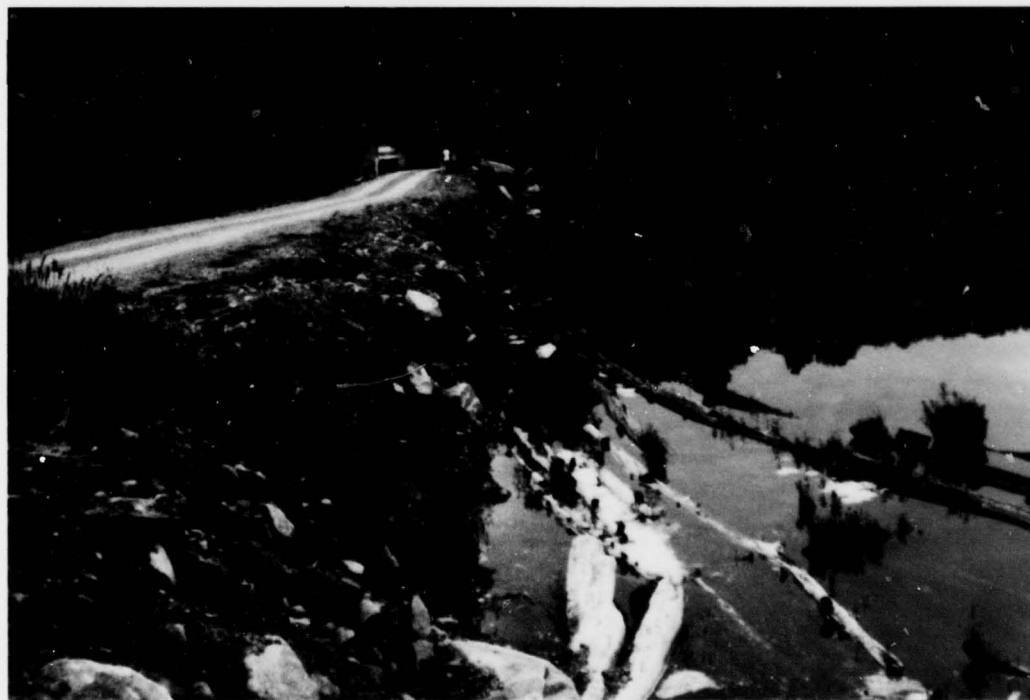
The embankment appears to be in generally fair condition. The entire embankment is devoid of vegetation except for minor weeds and some trees located on the extreme west upstream slope.

3) UPSTREAM SLOPE LOOKING WEST , NOTE LOGS AT WATERLINE

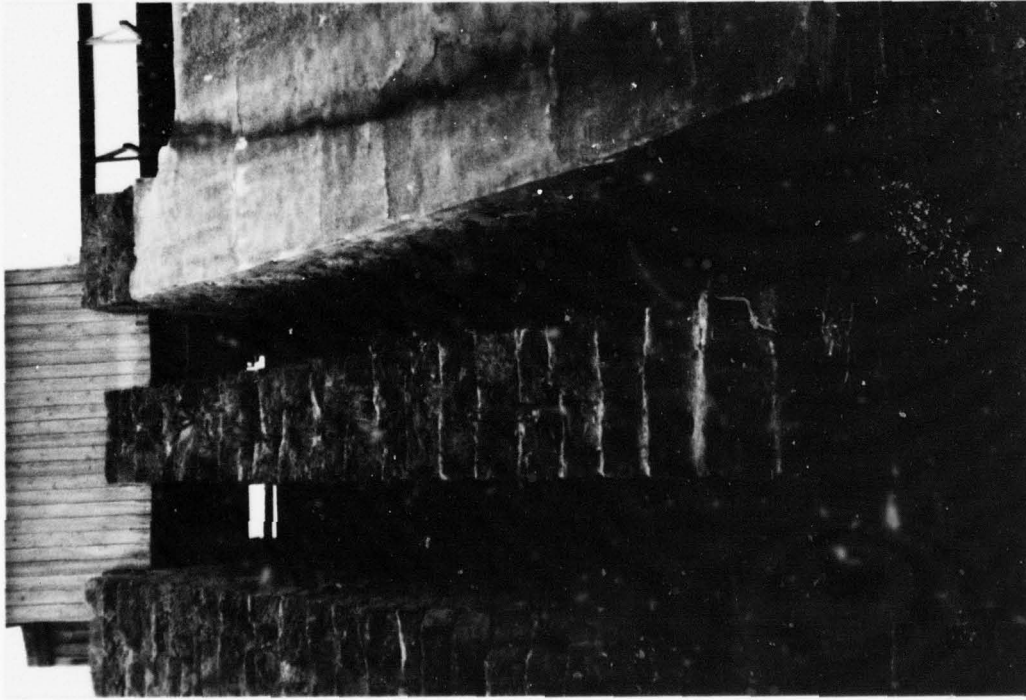
8) SLUICEWAYS

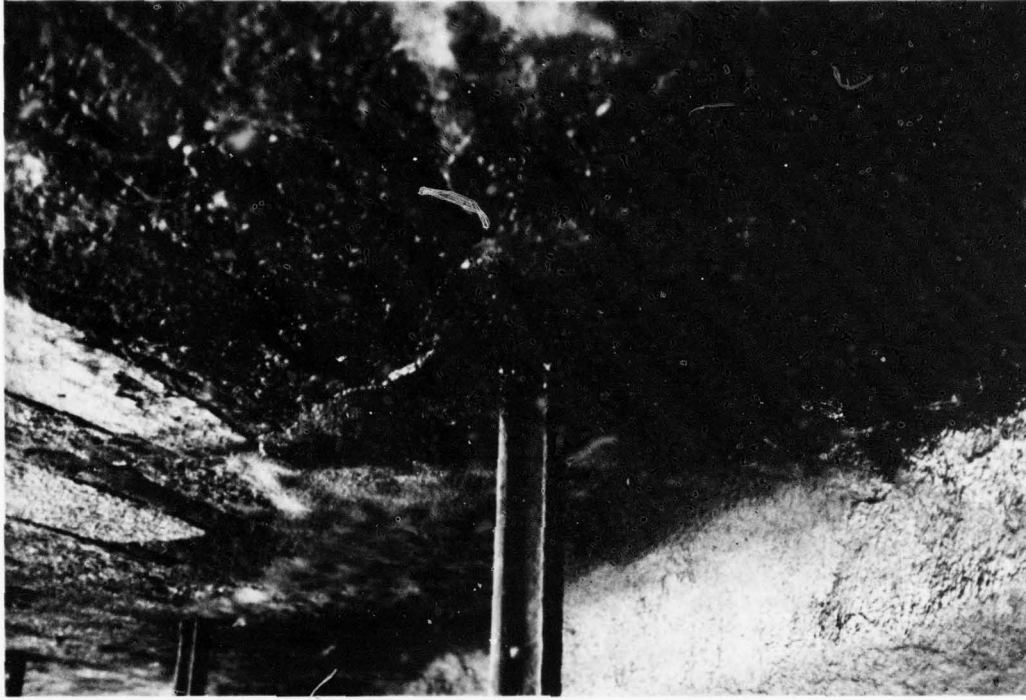
9) EAST WALL OF WEST SLUICEWAY, NOTE LEAKAGE

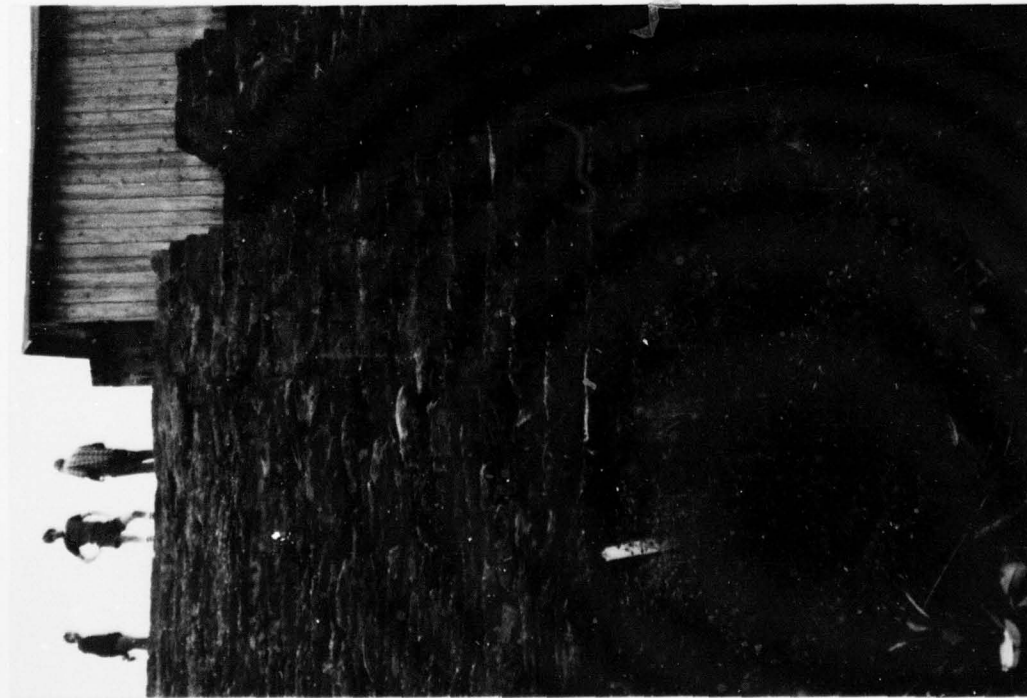
Settlement of the embankment has occurred adjacent to the west sluiceway training wall. Seepage was observed at the toe of the embankment near the location where the settlement occurred. The leakage is estimated at 5+ gpm. The clear water and limonite stained algae growth tend to indicate that the seepage is an old condition. There are several damp areas along the western toe of the dam; however, no visible seepage was visible at these locations. No seepage was observed along the eastern embankment toe.

10) ABUTMENT WEST OF SLUICEWAYS, NOTE
VERTICAL SETTLEMENT IN MASONRY

training wall there appears to be a settlement which has caused
a vertical displacement of stones approx 3"

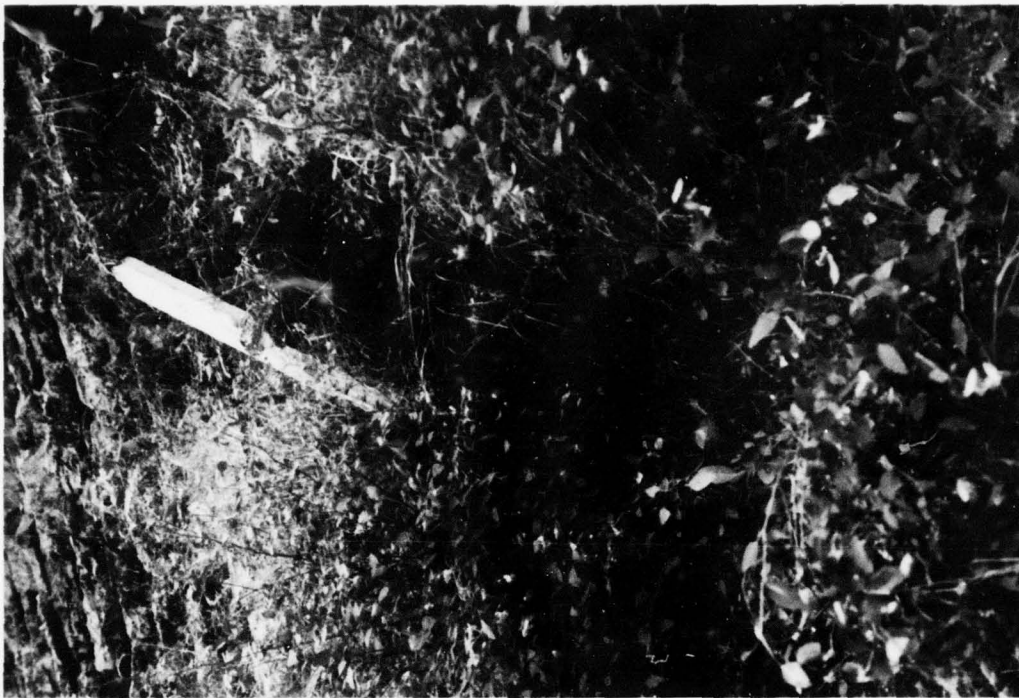
11) SEEPAGE (IN CENTER OF PHOTO) LOCATED
AT SETTLEMENT NEAR WEST ABUTMENT OF
SLUICEWAYS

Leakage approx 5-10 gpm at right (west) training wall at
toe; water clear; appears old because of lichen-like algae growth.
Several other damp zones at toe, no moving water, may be runoff.
