PEPORT DOCUMENTATION PAGE	READ INSTRUCTIONS
	3. RECIPIENT'S CATALOG NUMBER
TITLE (and Sublitio) Gruber Wagon Works, Blue Marsh Lake, Berks Count	5. TYPE OF REPORT & PERIOD COVERED
Pa. : Historic Structures report	Final

6. PERFORMING ORG. REPORT NUMBER
7. AUTHOR(+)	8. CONTRACT OR GRANT NUMBER(*)
De Siltes, Robert R.A. Parrott, Charles A.	DACW61-78-C-0038 men
John) Milner Associates West Chester, Pa.	10. PROGRAM ELEMENT, PROJECT, TASK AREA & WORK UNIT NUMBERS

1. CONTROLLING OFFICE NAME AND ADDRESS	12. REPORT DATE
U.S. Army Engineer District, Philadelphia	28 April, 1978
Custon House, 2nd & Chestnut Sts. Philadelphia. Pennsylvania 19106	13. NUMBER OF PAGES

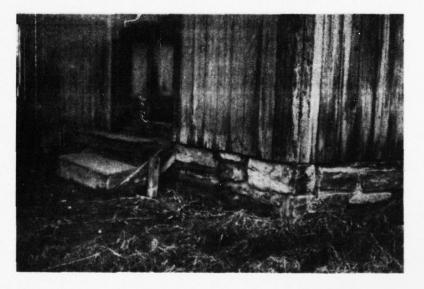
A6-3

B) Stone Foundation Under Engine Room Addition "C-1"
