DELAWARE RIVER BASIN  
SOUTH BRANCH TIMBER CREEK  
GLOUCESTER AND CAMDEN COUNTIES  
NEW JERSEY

**GRENLOCH LAKE DAM**

**NJ 00402**

**PHASE 1 INSPECTION REPORT  
NATIONAL DAM SAFETY PROGRAM**

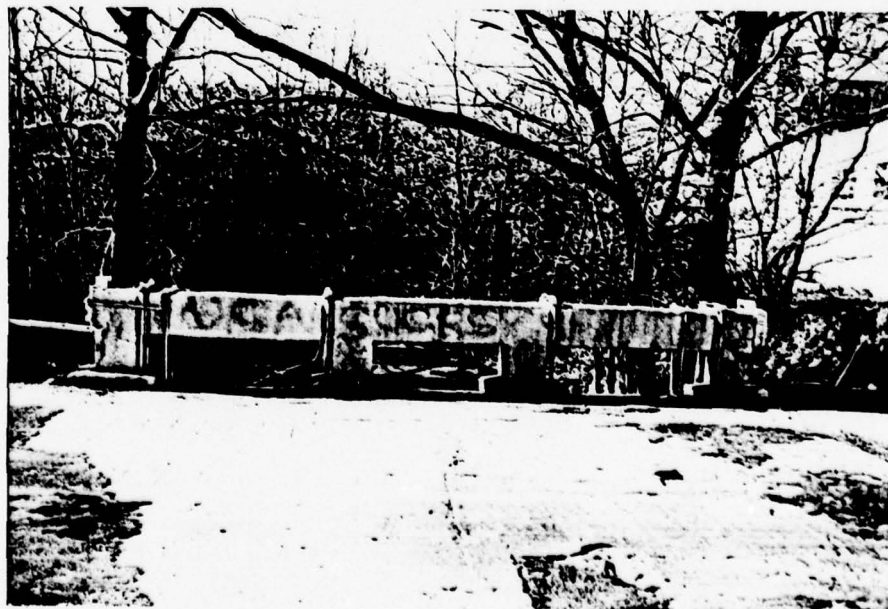
The concrete bridge which carries the Central Avenue traffic over the spillway is in poor condition. It is a rather unique three-celled culvert with 5 feet wide cells divided by solid piers and cross beams below spillway elevation. Each sluiceway originally had stoplog barriers at the fascia line but these have been completely vandalized or removed. Hoisting devices were originally installed on the parapet railings but the only equipment remaining are the torsional anchorages. The concrete is in an overall poor condition with severe spalling and cracking. At the northwest corner, there is a large piece of the concrete wingwall that has been undermined and collapsed down into the embankment toe.

Bridge deck and rail

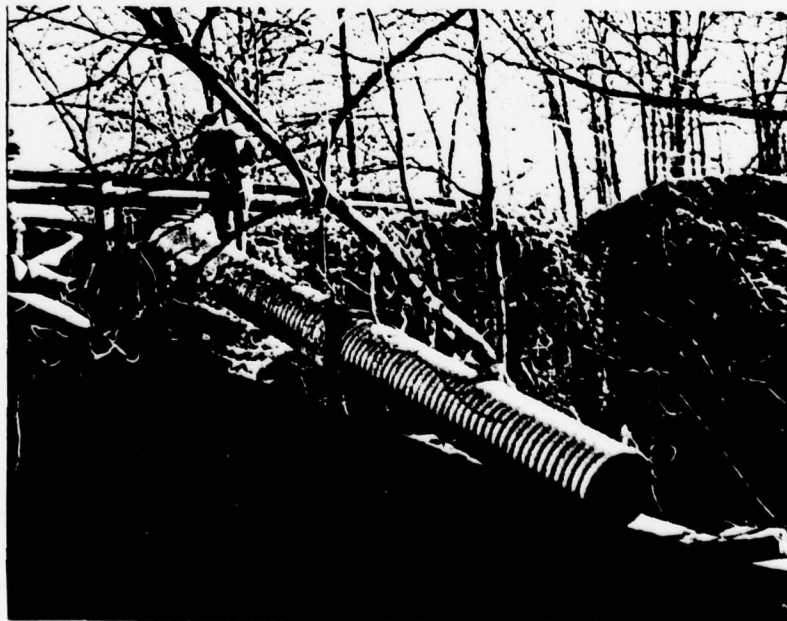
Surface drain pipe
