ALMONESSON LAKE DAM

NJ 00401

PHASE 1 INSPECTION REPORT NATIONAL DAM SAFETY PROGRAM

February, 1979

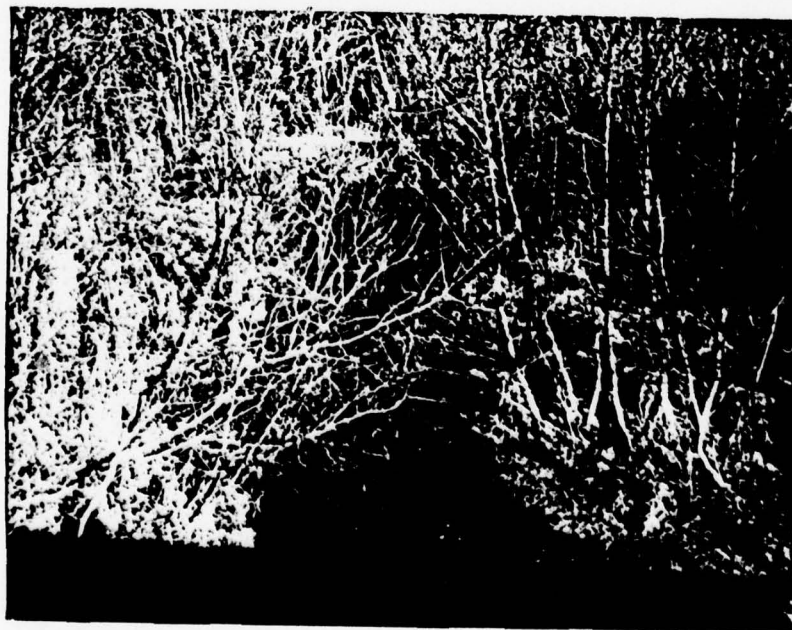
VISUAL EXAMINATION OF	OBSERVATIONS	REMARKS OR RECOMMENDATIONS
CRACKING AND SPALLING OF CONCRETE SURFACES IN OUTLET CONDUIT	None	
INTAKE STRUCTURE		
OUTLET STRUCTURE		Steel sheeting driven along channel banks.
OUTLET CHANNEL	Natural stream channel - clear no obstructions. Approximately 10'-15' wide. Secondary growth on side banks.	
EMERGENCY GATE	None

Downstream channel

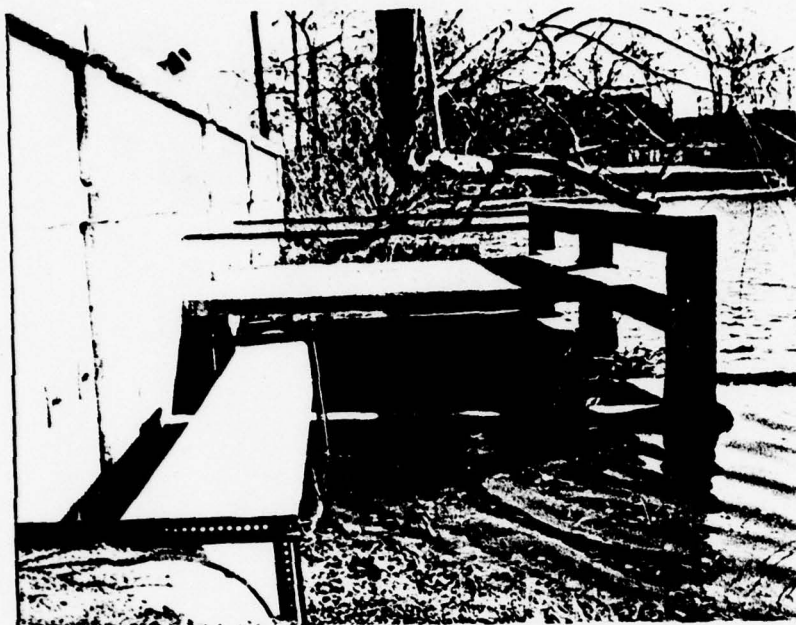
VISUAL EXAMINATION OF	OBSERVATIONS	REMARKS OR RECOMMENDATIONS
SURFACE CRACKS CONCRETE SURFACES	Some spalling and deteriorated areas on inlet structure	
STRUCTURAL CRACKING	Yes Tie rods installed between east wingwalls (condition good)	Horizontal cold joints show some efflorescence.
VERTICAL AND HORIZONTAL ALIGNMENT	Satisfactory	
CONJOINT JOINTS	None	
CONSTRUCTION JOINTS	Satisfactory

Spillway structure

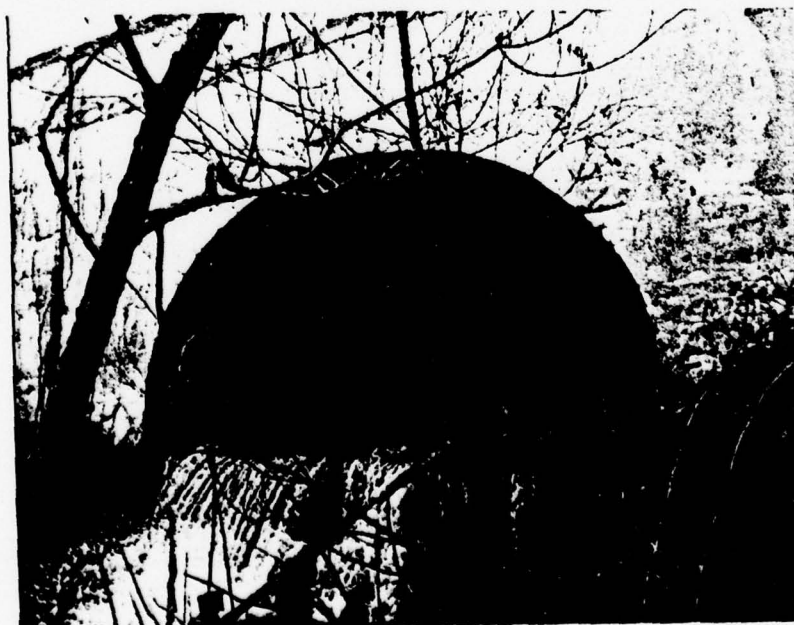
At the outfall invert of the culvert (on the north bridge fascia) there is a drop of about 4.5 feet to the downstream channel and vertical steel sheeting has been driven at roughly 45° angles from the fascia line to protect the toes of slope at the base of each wingwall. Some loose riprap has been dumped into the outfall channel (which replaces 2 x 8 timber lagging originally constructed in this area). The drop in the outfall appears to be the long term result of erosion and scour.

Downstream bridge opening (22' dia.)

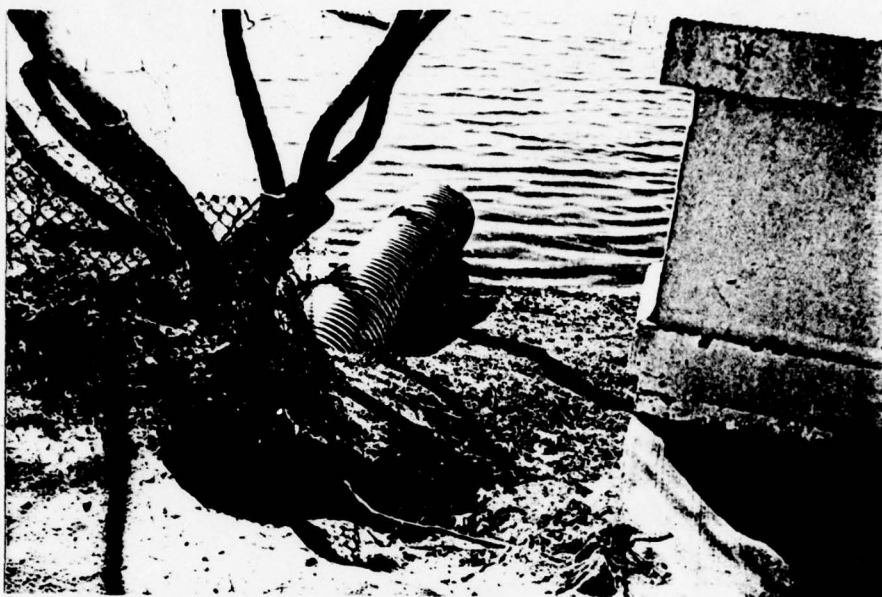
VISUAL EXAMINATION OF	OBSERVATIONS	REMARKS OR RECOMMENDATIONS
JUNCTION OF EMBANKMENT AND ABUTMENT, SPILLWAY AND DAM	Satisfactory (very ill-defined)	
ANY NOTICEABLE SEEPAGE	No	
STAFF GAGE AND RECORDER	None	
DRAINS	Roadway catch basins and curb inlets.	Road runoff scouring out ends of wingwalls.

Roadway drain at S.E. wingwall

(5) Construct curbs and additional catch basins along the roadway gutters to better control the surface runoff.

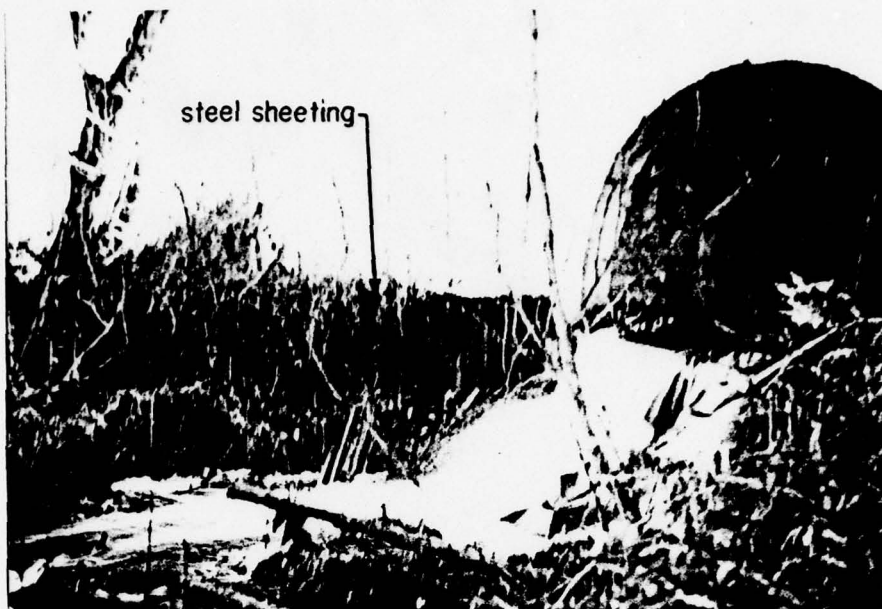
Downstream of bridge opening

(4) Place additional riprap in the downstream stilling basin to provide scour protection.
