# GLENDOLA RESERVOIR

## NJ 00096

### PHASE 1 INSPECTION REPORT NATIONAL DAM SAFETY PROGRAM

Philadelphia District  
Corps of Engineers  
Philadelphia, Pennsylvania

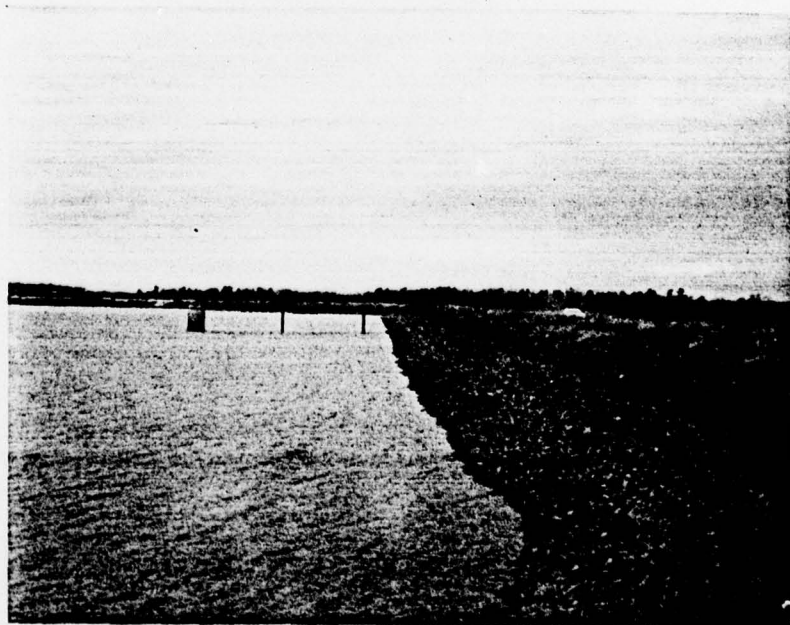
The only appurtenant structure is the 80-foot concrete wetpool intake tower in the reservoir for the 36-inch inlet/outlet pipe. The access bridge and working platform are in a satisfactory, well-maintained condition.

Intake structure

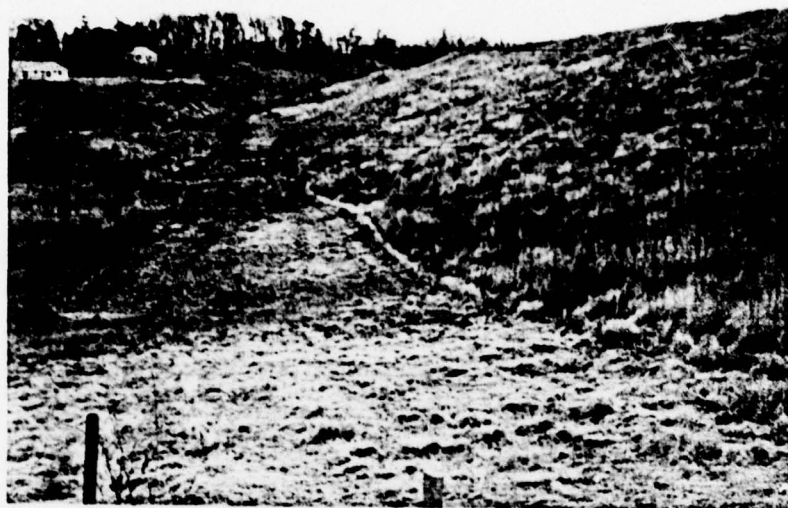
Downstream toe of dam

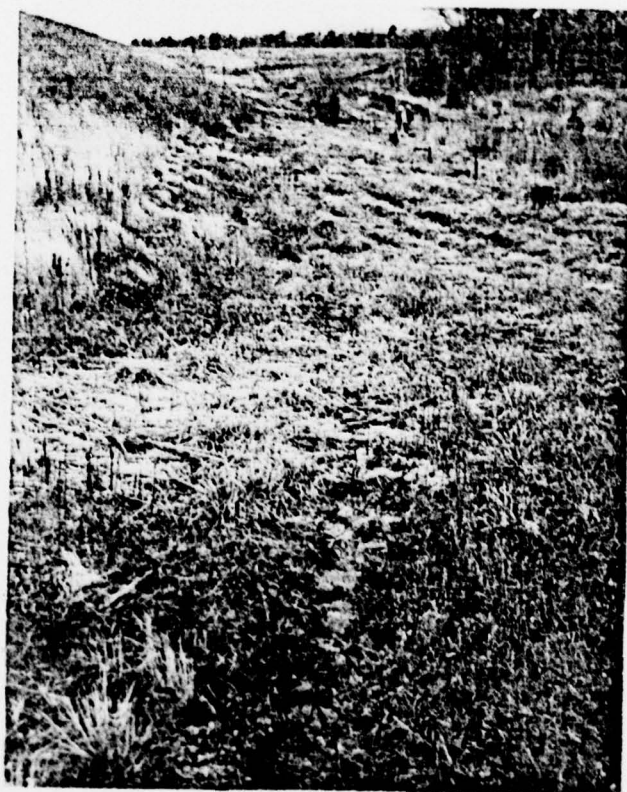
There are wet zones at and beyond the toe in several areas and some seepage appears to be emanating from the embankment. There is a line of a dozen or more relief wells in the vicinity of Robins Swamp Brook that feed into a collection box located approximately at the midpoint. The outlets are several inches below grade and appear to be flowing freely. Additionally, there are also piezometers in and beyond the toe. At one water was flowing out of a hole at the top (through the rusted casing). The toe drains and relief wells are apparently functioning on a continuous basis to relieve the hydrostatic head. However, in certain areas, the significant seepage observed may indicate that either the relief structures are silting up, or, to some extent, the wells are inadequate. A berm area at the downstream toe forms a terrace that extends some 200 feet beyond the toe and then slopes abruptly down into a relatively large borrow area that most probably was excavated during the construction of the dam.

Seepage at downstream toe

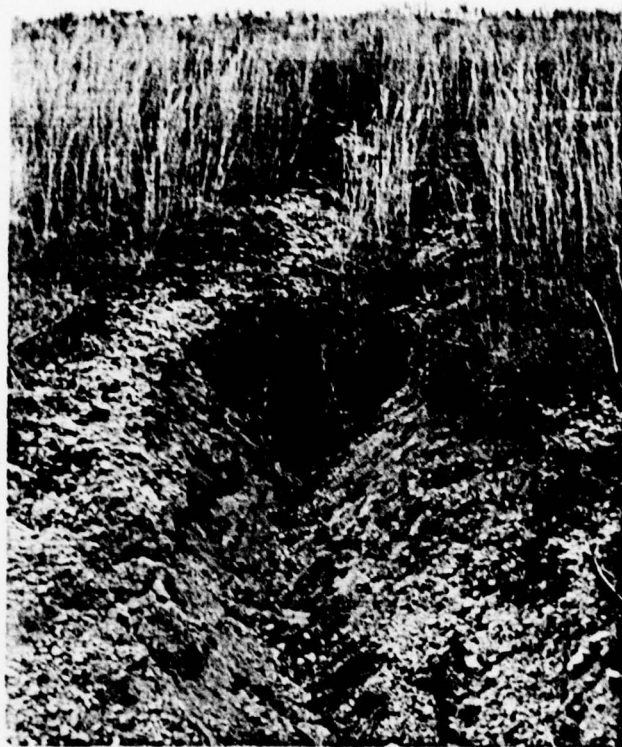
The major portion of the horseshoe-shaped embankment lies just west of Gully Road and is over 60 feet high in the vicinity of the Robins Swamp Brook channel. The embankment extends along the northeast side and the remainder of the reservoir is bounded by the natural high ground. The reservoir side slope varies between 2:1 and 3:1 and is protected with riprap, although only the top few feet could be observed. The riprap appears in good condition with only minor subgrade erosion. There is no riprap on the downstream slopes but concrete and macadam have been placed at the northwest corner, apparently to retard erosion. The dam crest is 20 feet wide and stabilized with a 6" gravel roadway which is in good condition. The embankment backslopes have a fairly uniform cover of grass and secondary growth near the toe, but in numerous areas where the grass has not taken, there are erosion gullies which are quite severely incised. There are numerous rodent burrows on the slopes and erosion gullies are scoured out immediately down the slope, apparently caused by the burrow openings.

Erosion of downstream slope of dam

- a. Regrade the eroded backslopes and fill the burrow holes.
- b. Overseed the slopes with consideration given to supplying a different type of ground cover which might take better hold on the dry arid slopes.
- c. Continue study and analysis of piezometer readings to evaluate whether the continued cleaning and/or backflushing of the relief wells is sufficient in the long-term aspects of controlling the seepage at the downstream toe. Quite possibly, new wells or an extension of the zone protection might be indicated in the analysis.

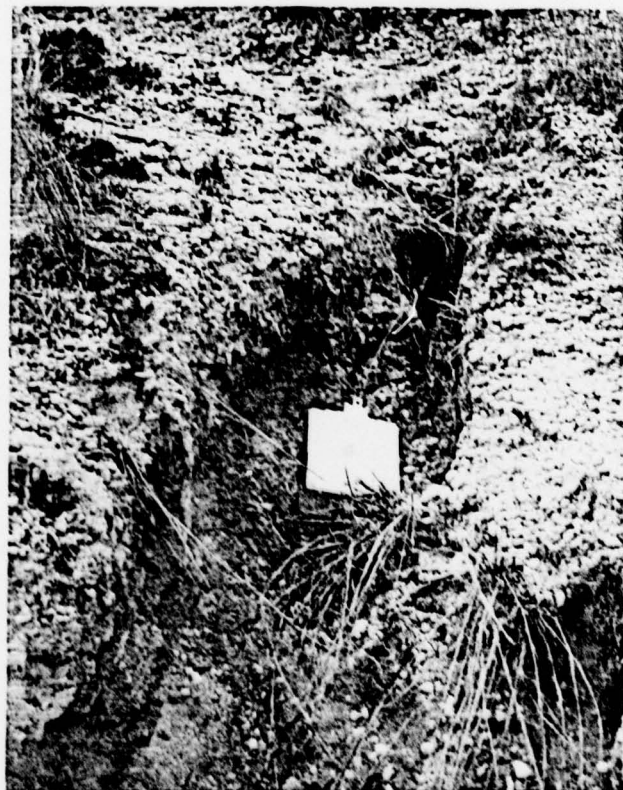
Erosion of downstream slope of dam

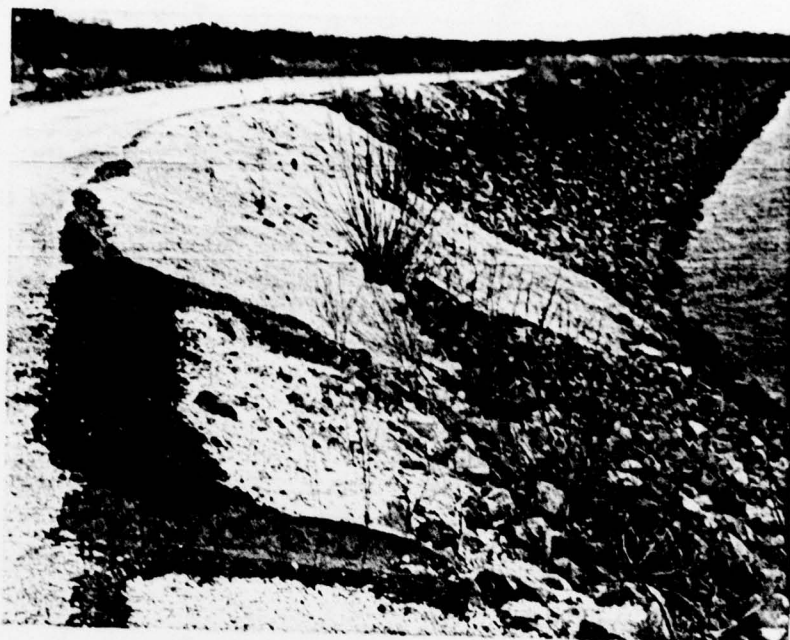
Repaired embankment

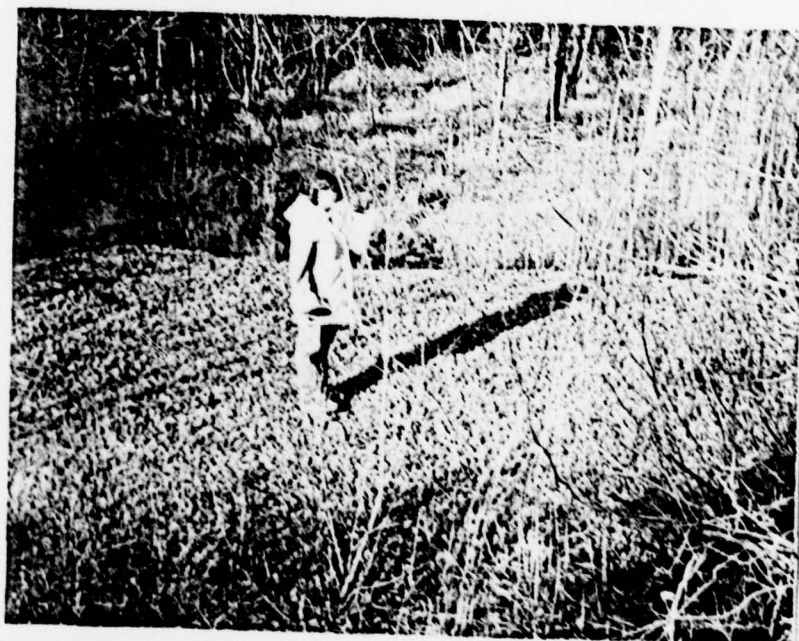
Boiling occurred at a point approximately  
100' from toe of westerly portion of  
embankment. Condition has been  
corrected.

Location of boil

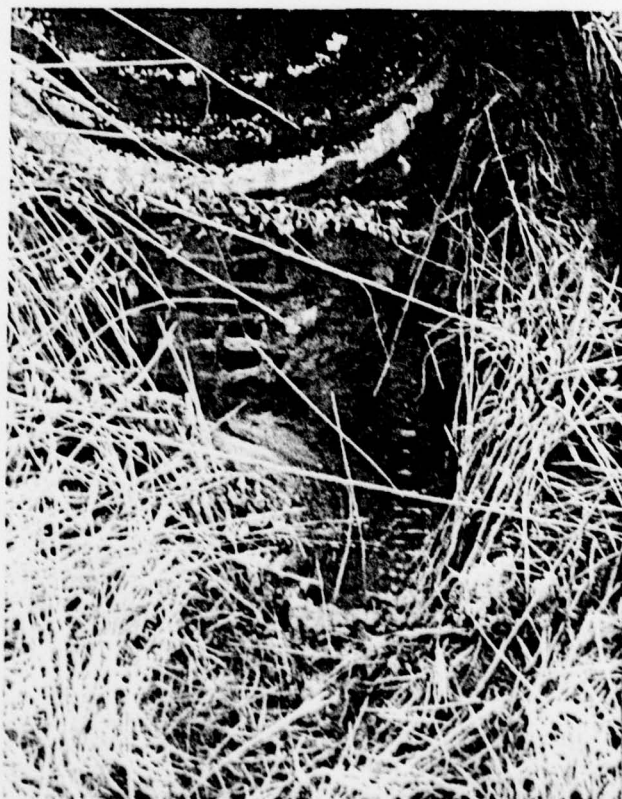
INSTRUMENTATION		REMARKS OR RECOMMENDATIONS
VISUAL EXAMINATION NONUMENTATION/SURVEYS	OBSERVATIONS None	
OBSERVATION WELLS	See piezometers	
WEIRS	None	
PIEZOMETERS	Every 100 ft. 20% of the piezometers are out of operation. Located at toe at 20' depth below toe. They are observed every month.	
OTHER Relief Wells	50' depth below toe.	Apparently becoming clogged.

Relief well
