MISCELLANEOUS PAPER GL-79-4

EVALUATION OF THE EFFECTIVENESS OF MEMBRANES FOR PREVENTION OF CRACK REFLECTION IN THIN OVERLAYS

Geotechnical Laboratory
U. S. Army Engineer Waterways Experiment Station
P. O. Box 631, Vicksburg, Miss. 39180

March 1979

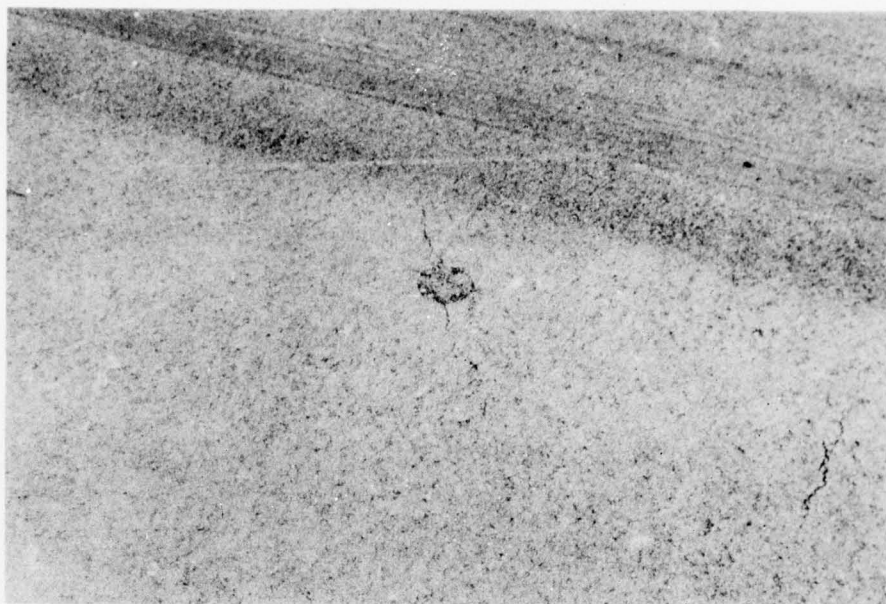
Photo 61. Fort Lewis--fine hairline crack created
in overlay by wrinkle in Mirafi 140 fabric

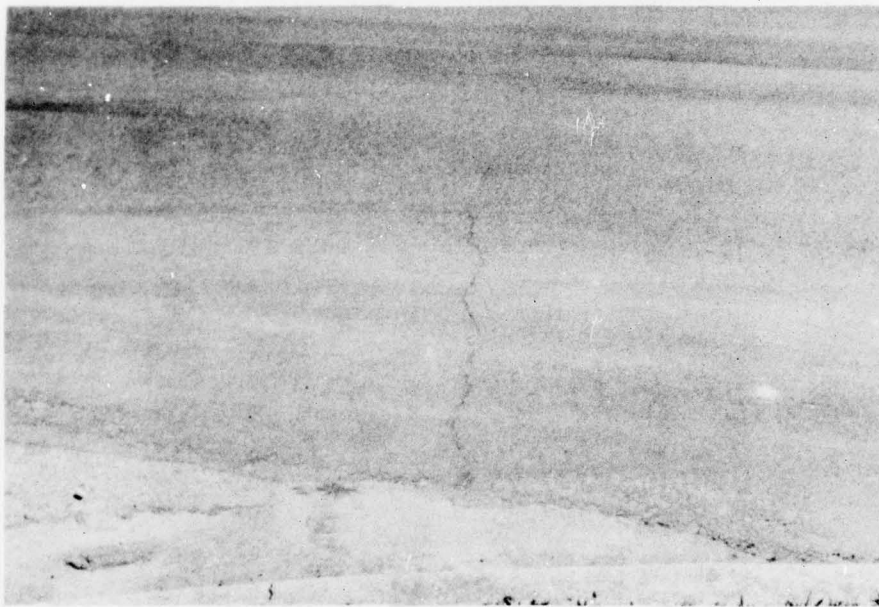
Photo 63. Fort Lewis--reflection crack in control
section on north side of Faith Avenue

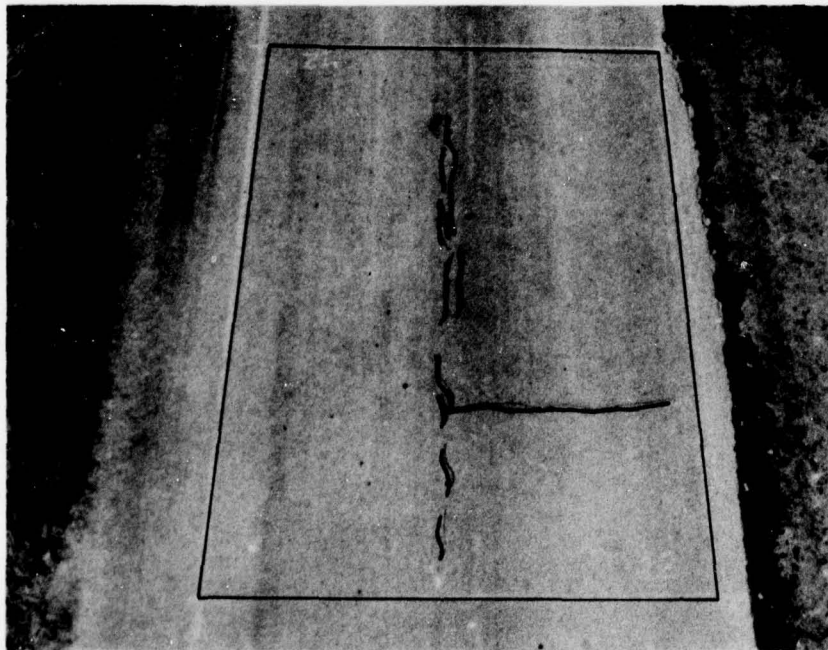
50. Results of the crack survey for the condition of Wilderness Road prior to the placement of the overlay are presented in Photos 117-128 and the corresponding transparencies for these photographs. A survey to determine the performance of the test areas will be made in the spring of 1979, approximately 1 year after placement of the materials.

Photo 128. Fort Carson--condition of test area No. 12
prior to overlay
