LAKE SHENANDOAH DAM
NJ 00099

PHASE 1 INSPECTION REPORT
NATIONAL DAM SAFETY PROGRAM

March, 1979

7. AUTHOR(s) Richard J. McDermott, P.E.		6. PERFORMING ORG. REPORT NUMBER
9. PERFORMING ORGANIZATION NAME AND ADDRESS Storch Engineering 220 Ridgedale Ave. Florham Park, N.J. 07932		8. CONTRACT OR GRANT NUMBER(s) (15) DACW61-78-C-0124

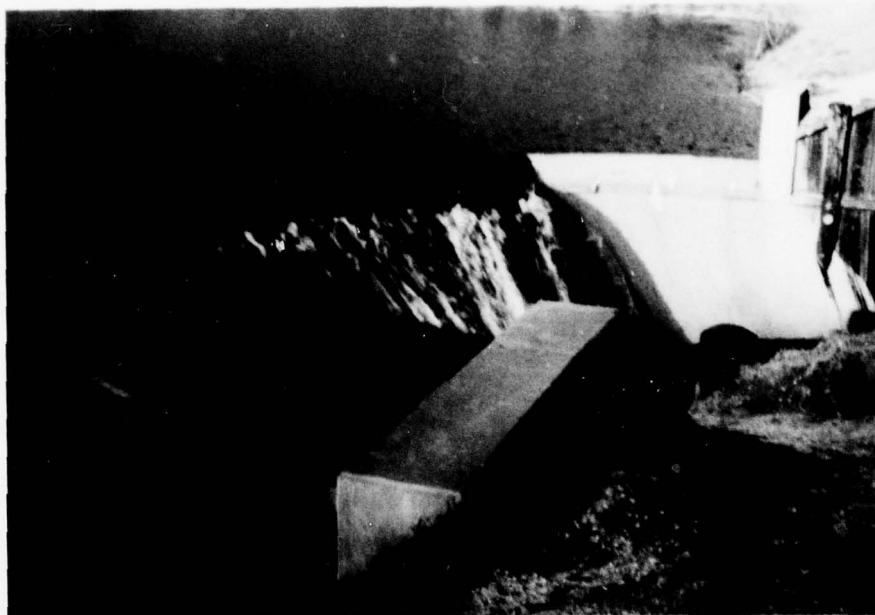
PHOTO 1
SPILLWAY

The crest of the spillway appeared uniformly aligned, although a major part of it was submerged by overflow at the time of inspection. Water was flowing over the principal (elev. 24.4) part of the spillway and, therefore, the condition of much of the spillway surface was not clearly observed. In the sections of the spillway which were dry, some cracking and spalls, as well as leaching, were observed. In general, all concrete appeared to be in good condition.

4. The concrete spillway should be thoroughly inspected and repaired as outlined below:
 - a. Drain the lake to an elevation equal to the invert of the outlet pipe.

- c. Pressure grout all major cracks and patch all spalls and eroded surfaces.
 - d. Seal the leak at the joint between the fishway inlet and the spillway.
5. The silt layer should be cleaned from the downstream end of the outlet pipe.

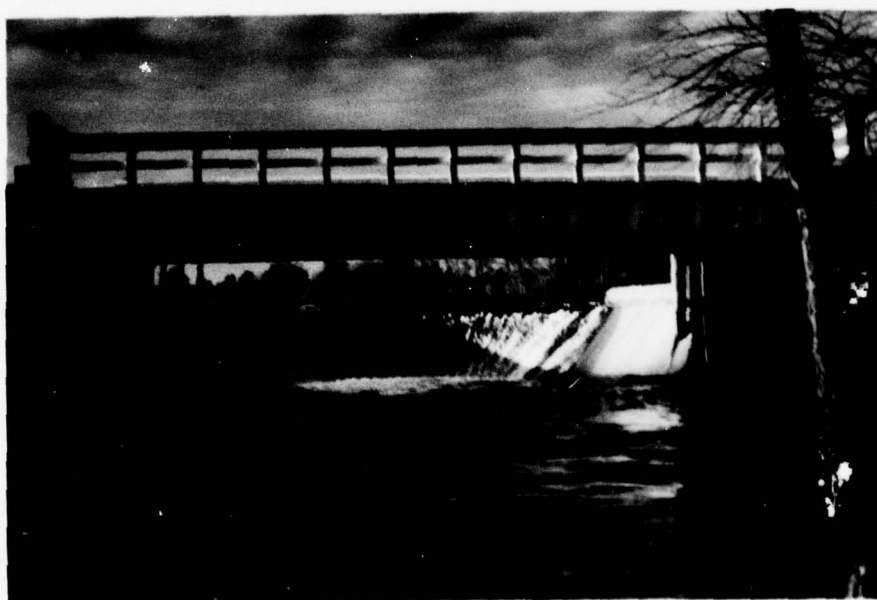
PHOTO 2
ROAD BRIDGE OVER SPILLWAY DISCHARGE CHANNEL

The timber bridge over the spillway appeared to be in good condition.

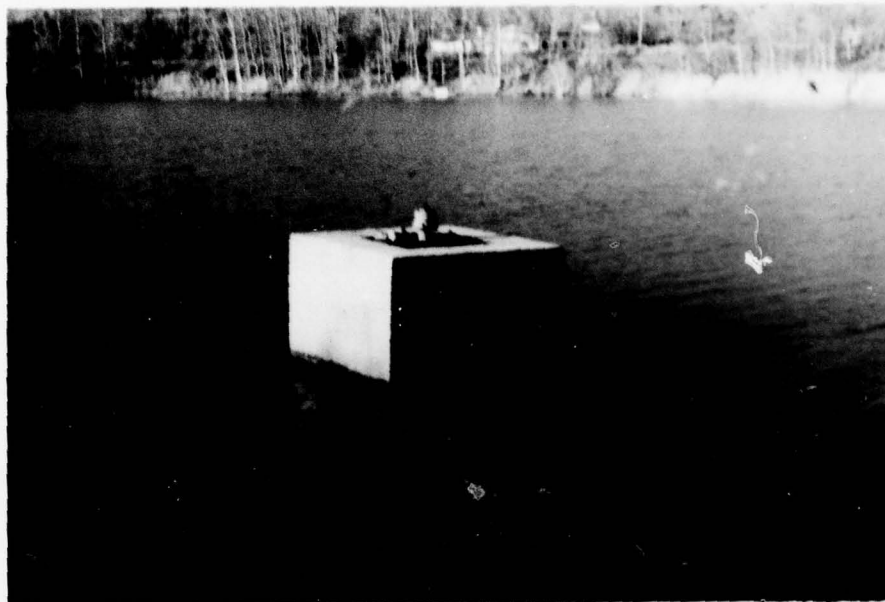
PHOTO 3
OUTLET WORKS MANHOLE

Reportedly, the outlet equipment is in good working condition, although its operation was not observed at the time of inspection. The 48" diameter C.M. pipe was examined at its outlet end and appeared to be in good condition. However, a silt layer of 6 inches depth was observed at the invert of the pipe. The manhole housing the outlet gate was observed to be in good condition.
