NATIONAL DAM INSPECTION REPORT. KAERCHER CREEK DAM (PA-00722), --ETC(U)

KAERCHER CREEK DAM  
BERKS COUNTY, PENNSYLVANIA  
NATIONAL I.D. NO. PA 00722

PHASE I INSPECTION REPORT  
NATIONAL DAM INSPECTION PROGRAM

Name of Dam: Kaercher Creek Dam  
County Located: Berks County  
State Located: Pennsylvania  
Stream: Kaercher Creek  
Coordinates: Latitude 40° 33.4' Longitude 75° 58.2'  
Date of Inspection: 18 July 1978

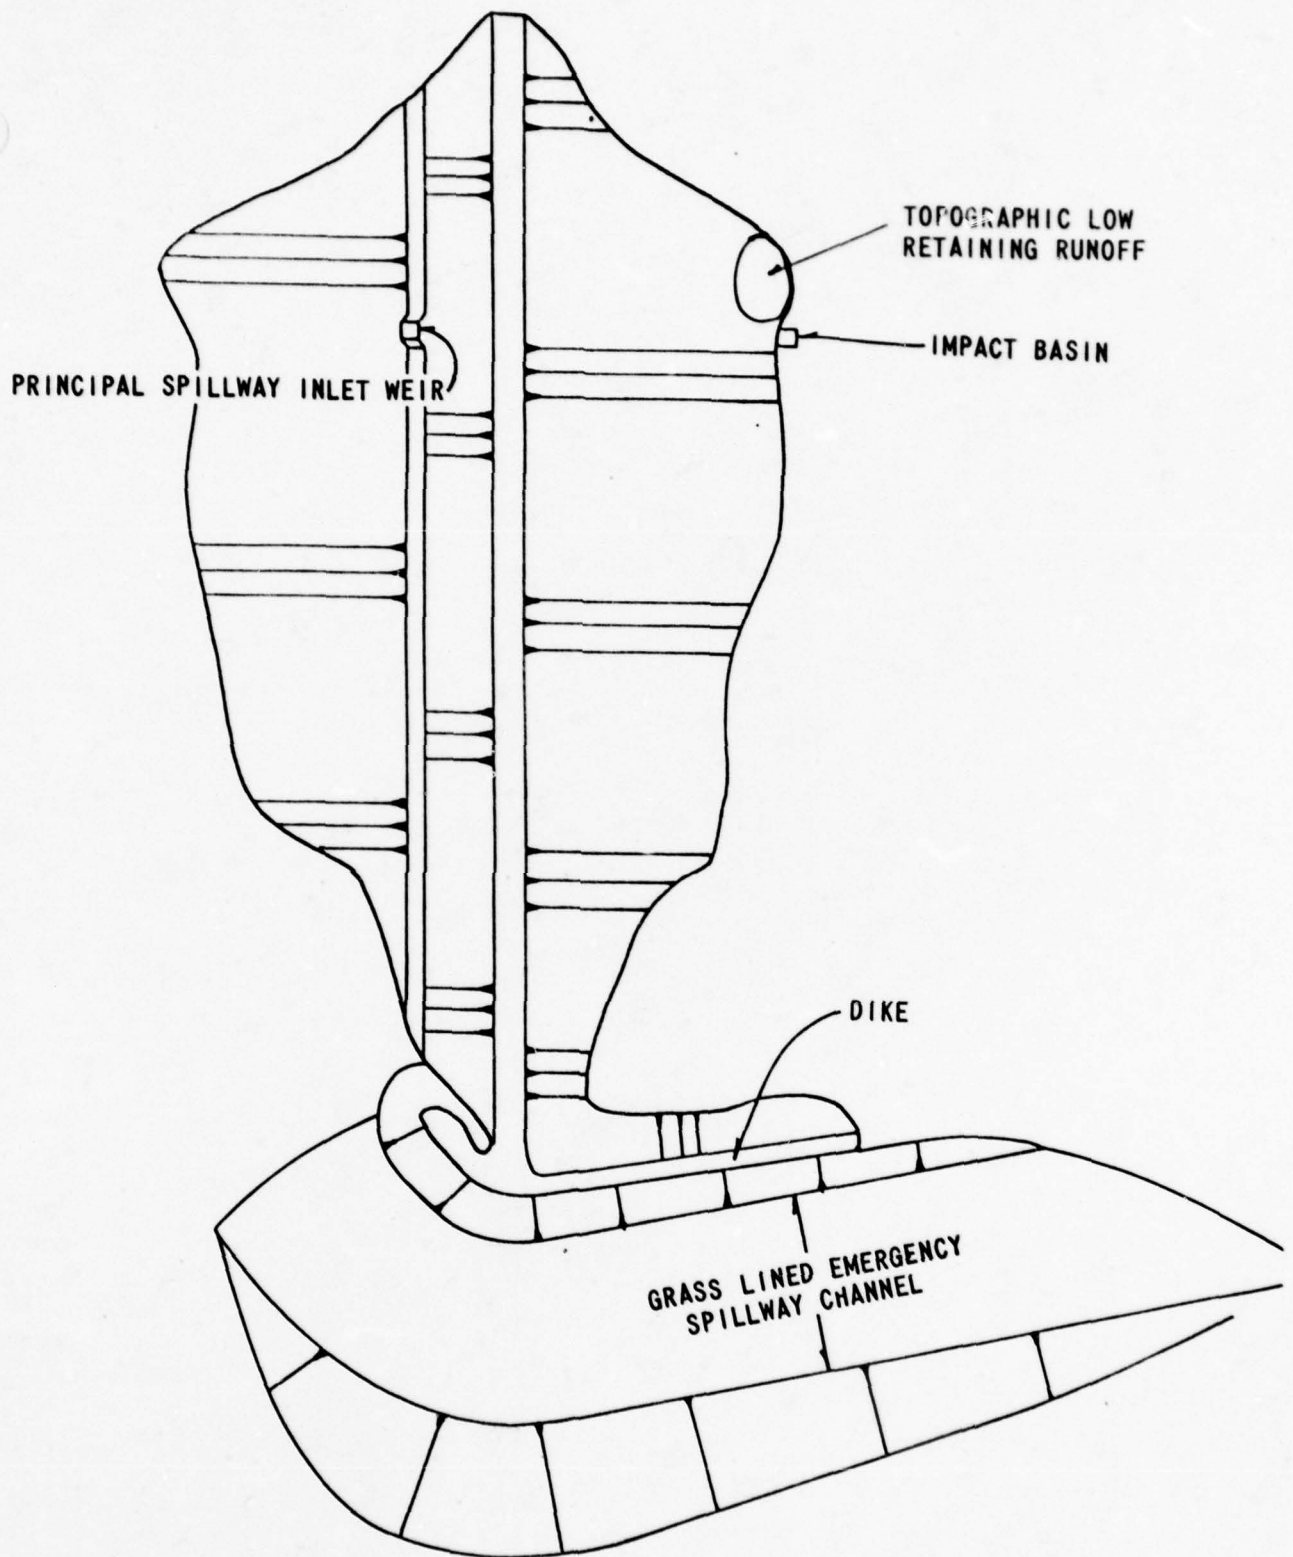
SEEPAGE LOCATION PLAN  
KAERCHER CREEK DAM  
SHEET 5a OF 11

*None observed on downstream side of the dam or around outlet works. Some standing water was observed just left of the impact basin. The area is a topographic low approximately 15 feet in diameter. There was no evidence to indicate the area was a source of seepage. See sheet 5a for the specific location.*

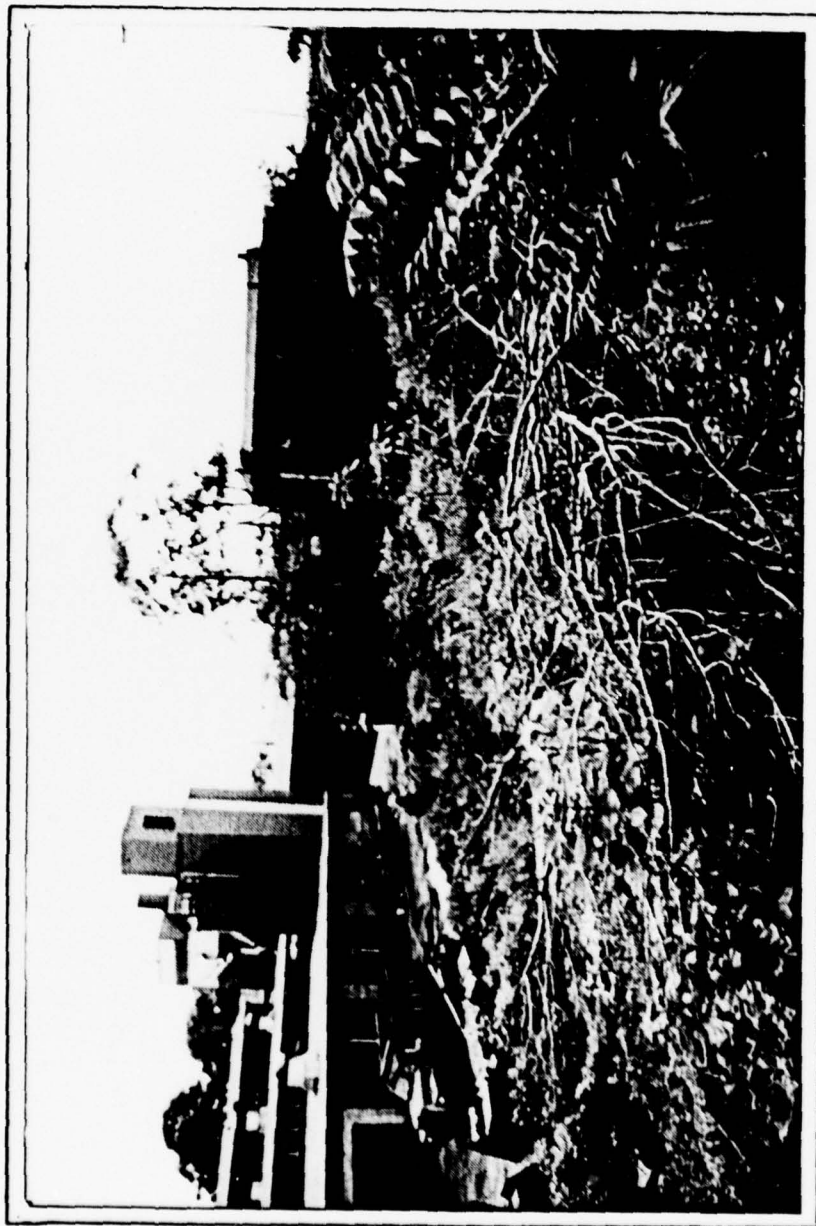
judged that debris along the channel and the equipment stored in the flood plain area above this tunnel would float downstream and possibly block the entrance to the tunnel or form a blockage at the bend in the tunnel. At the time of the inspection, debris was collecting at the bend, including a long tree limb and a ladder. It is assessed that extreme damage would occur as a result of blocking this tunnel. In the event that Kaercher Creek Dam failed, water would back up behind the factory and would probably collapse the tunnel and produce excessive property damage. In summary, damage, including loss of life, would be significantly greater if the dam failed during the passing of the PMF, than damage resulting from large flows if the dam did not fail during the PMF. Thus, the dam is classified as a "High" hazard potential structure.

VIEV OF INDUSTRIAL AREA (HAMBURG FLOW  
FACTORY) WHERE STREAM FLOWS VIA A CON-  
DUIT BENEATH THE FACTORY.

Since there are no formal warning procedures, it is recommended that a procedure be developed so downstream residents, including the industrial areas, be amply warned of possible high flows or potentially hazardous conditions. Operational procedures should also be formalized and documented together with a maintenance procedure and inspection checklist.
