CRANDON LAKE DAM
NJ 00267

PHASE 1 INSPECTION REPORT
NATIONAL DAM SAFETY PROGRAM

May, 1979

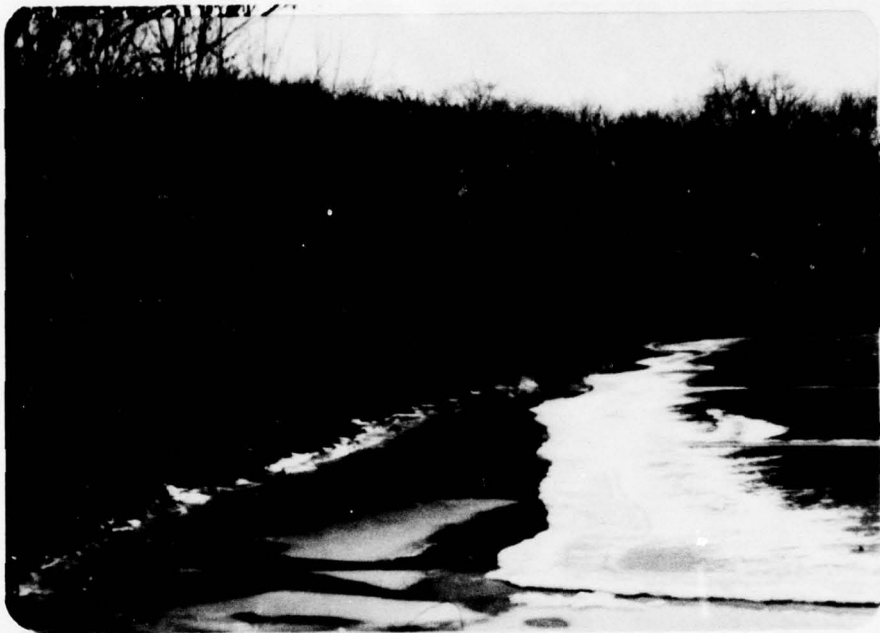
Upstream face of dam. Looking west.

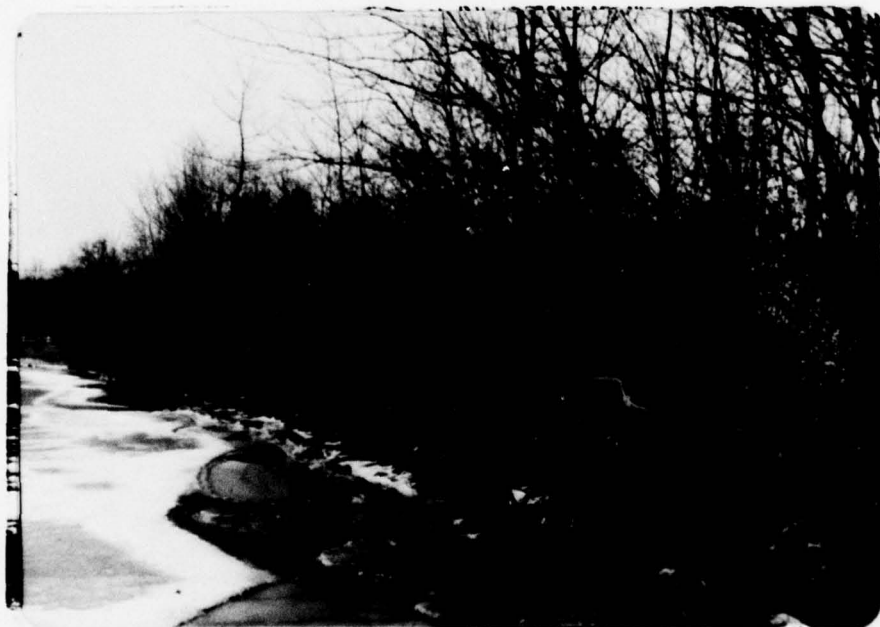
Upstream face of dam. Looking east.

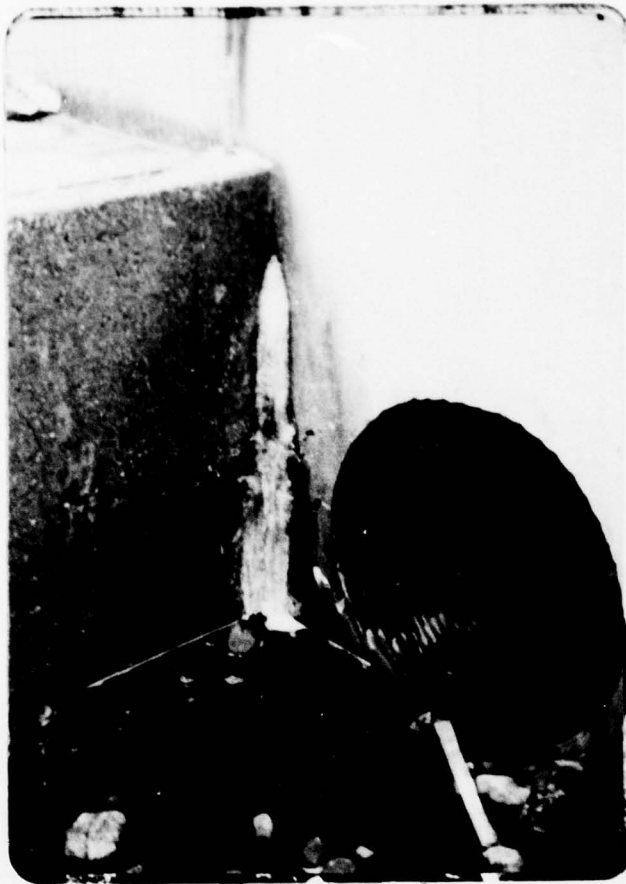
The drop-box spillway structure has a few localized spalled areas and surface deterioration. Small seepage was observed at the left corner abutting the headwall for the outlet conduits.

Water seeping at joint at left
wall of drop box spillway.

5. Eroded areas of the dam should be suitably backfilled and measures taken to prevent future erosion. This should be done soon.
6. Repair leaks in the drop-box spillway. This should be done in the near future.

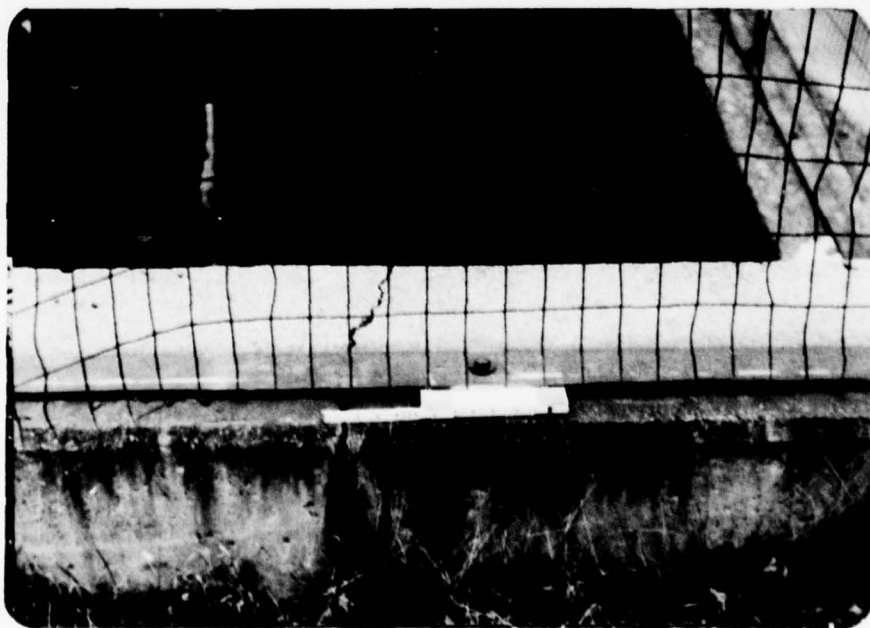
Open crack, 1/2-in at headwall of drop-box
spillway.

1. Replace or reline the two CM pipes passing through the dam. This should be done soon.
2. Repair and, if necessary, strengthen the concrete headwalls for the box spillway and the discharge pipes. This should be done soon.

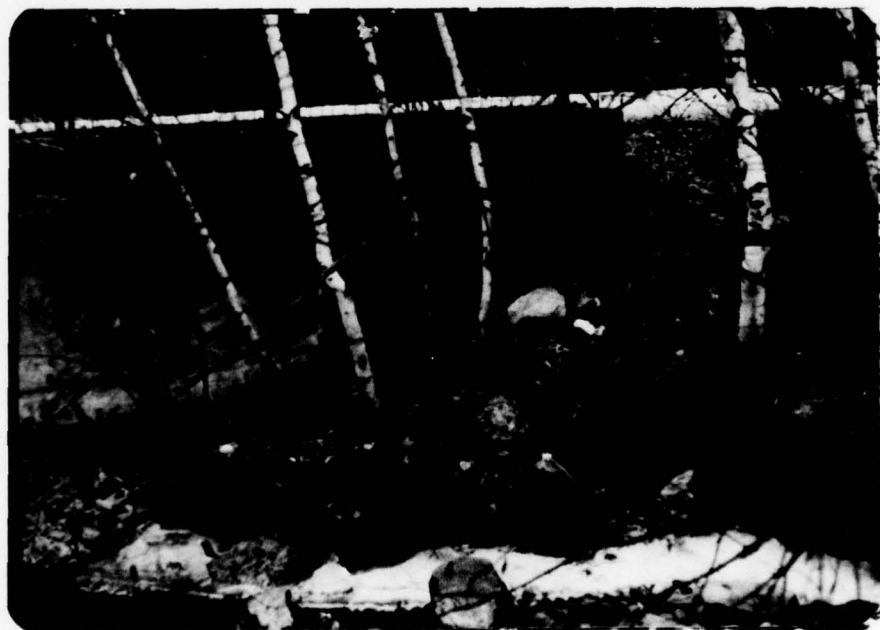
The alignment of the embankment and its junction with the abutments appeared satisfactory. No noticeable seepage or leakage was observed. Both slopes of the embankment are overgrown with small to medium size trees and bushes. Erosion was observed along the sides of the downstream headwalls for the outlet conduits. Some erosion was also observed on upstream slope near the drop-box structure and at a few other locations.

Erosion at right spillway/embankment
junction.

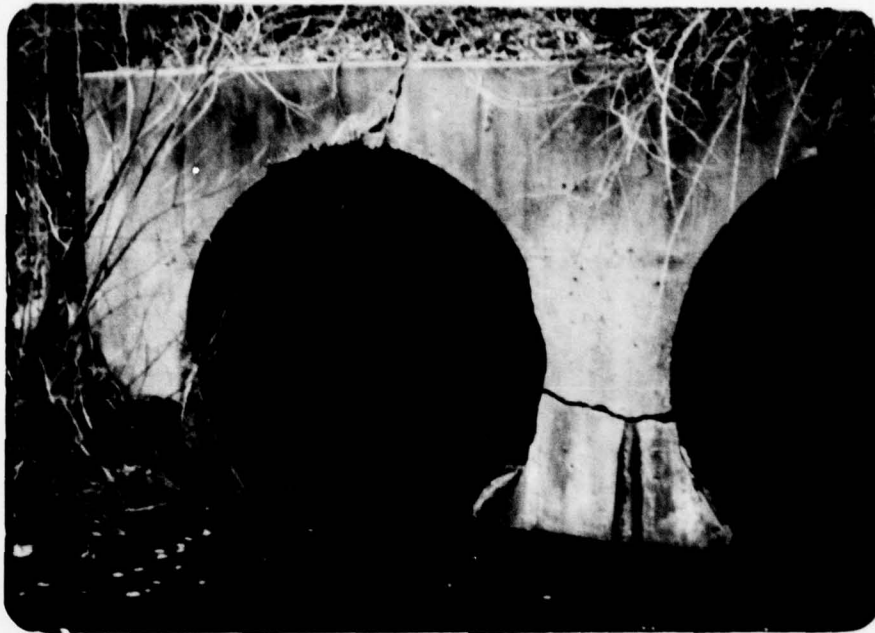
There are numerous cracks on both upstream and downstream headwalls for the two 6-ft-dia CMP outlet conduits which run across the base of the dam. These cracks vary in width from hairline to 1 inch. Some of them extend across the exposed surfaces of the structure.

Spillway outlet conduits. Concrete cracked at top and at spring line.

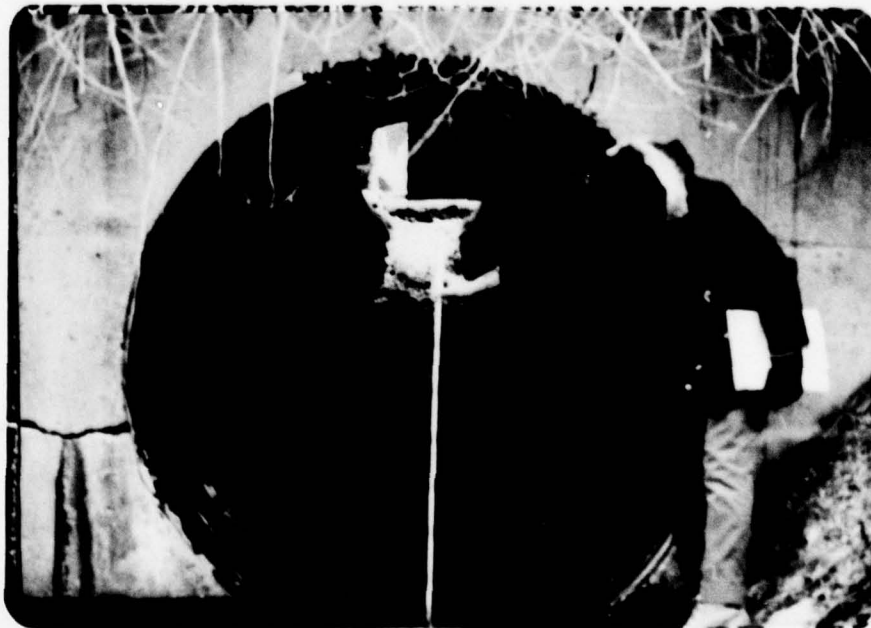
The two 6-ft-dia spillway outlet pipes and the 3-ft-dia low level outlet pipe have rusted over the lower portion of their circumferences.

Left spillway outlet conduit.

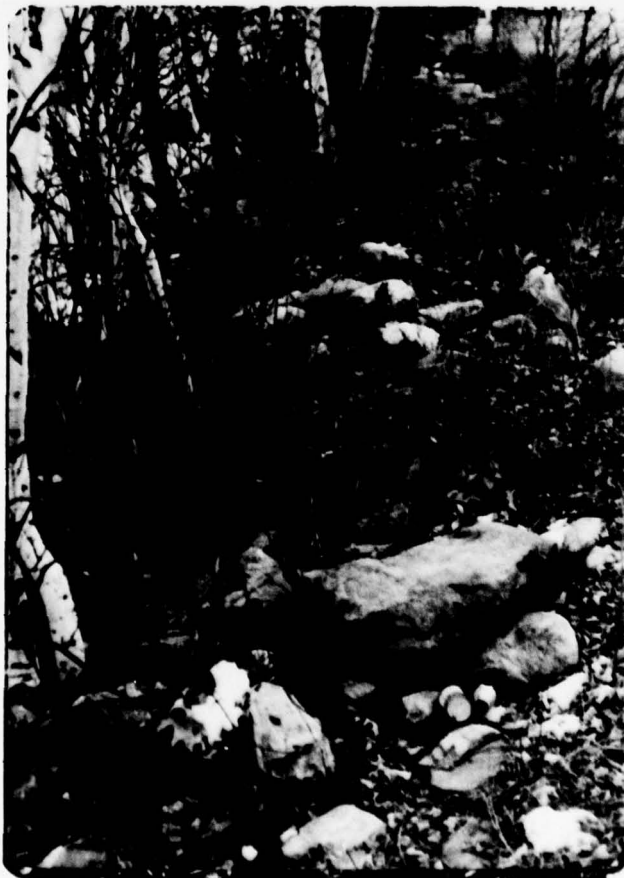
Debris, riprap and trees on
upstream face of dam.

3. Remove all trees from the area of the dam. This should be done soon.
4. Investigation should be conducted to locate the inlet of the 36-in-dia blow-off pipe and to determine the existence and operating condition of its gate. This should be done soon.

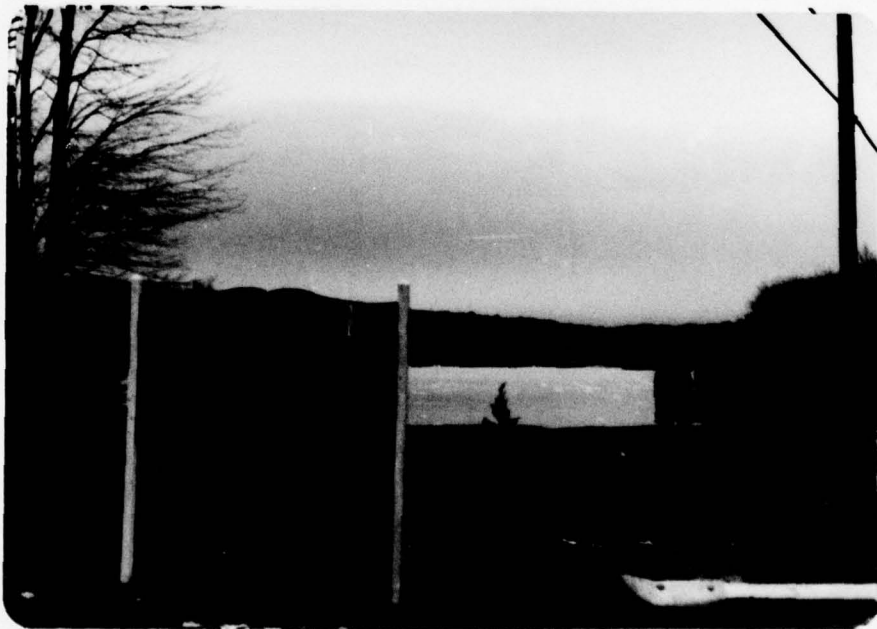
There are numerous homes around the perimeter of the lake. The slopes appear relatively flat and stable with occasional minor erosion. Vertical bulkheads exist in front of some homes at the waterfront. No significant sedimentation was noted.

Crandon Lake.
