PASSAIC RIVER BASIN
CANOE BROOK, ESSEX COUNTY
NEW JERSEY

**CANOE BROOK
RESERVOIR NO. 1 DAM**

NJ 00525

**PHASE 1 INSPECTION REPORT
NATIONAL DAM SAFETY PROGRAM**

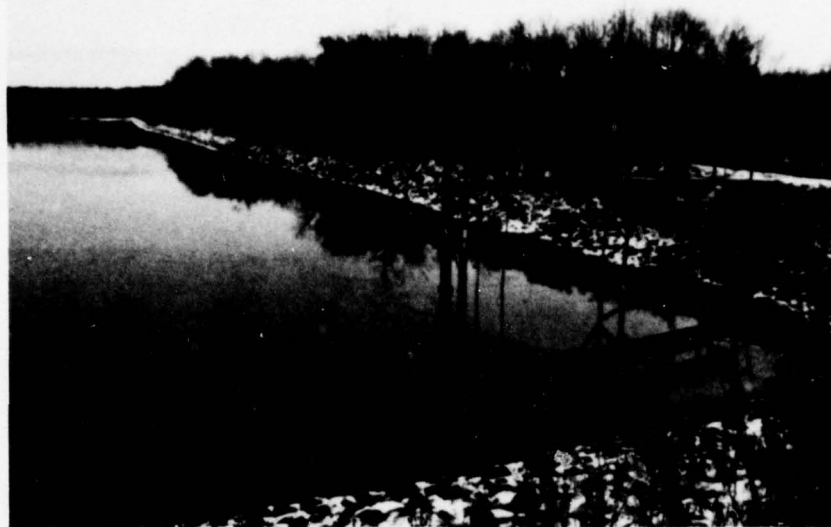
The dam was inspected for signs of settlement, seepage, erosion, cracking and any other evidence of undesirable behavior which might affect the stability of the structure. Several locations were observed where wave action has eroded and undermined the inboard slope of the embankment. Such conditions were particularly evident along the embankment sections bounding the south and

Photo 1 - Southern embankment looking east toward general area of wave erosion. (11-29-78)

Irregularities and eroded surfaces on the crest and slopes should be repaired as soon as possible.

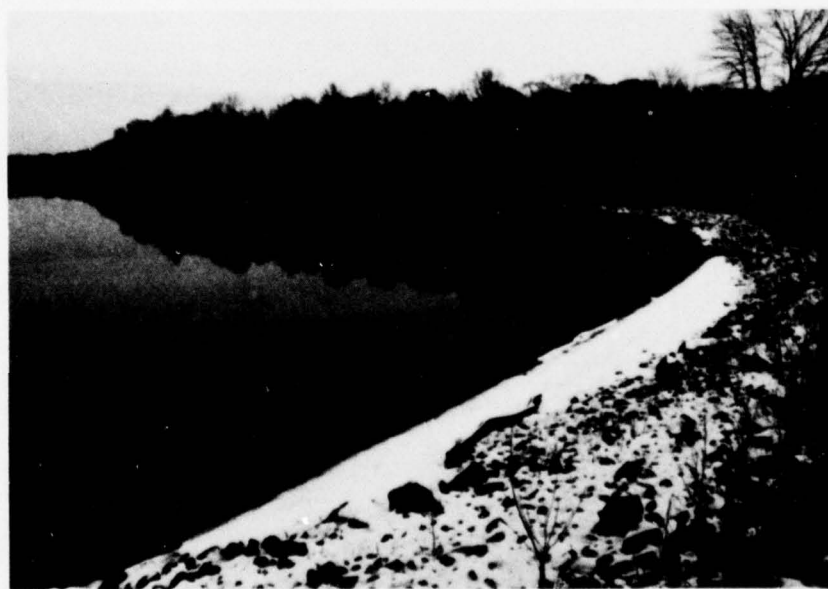
Photo 2 - Southeastern shoreline, showing area of wave erosion. (11-29-78)

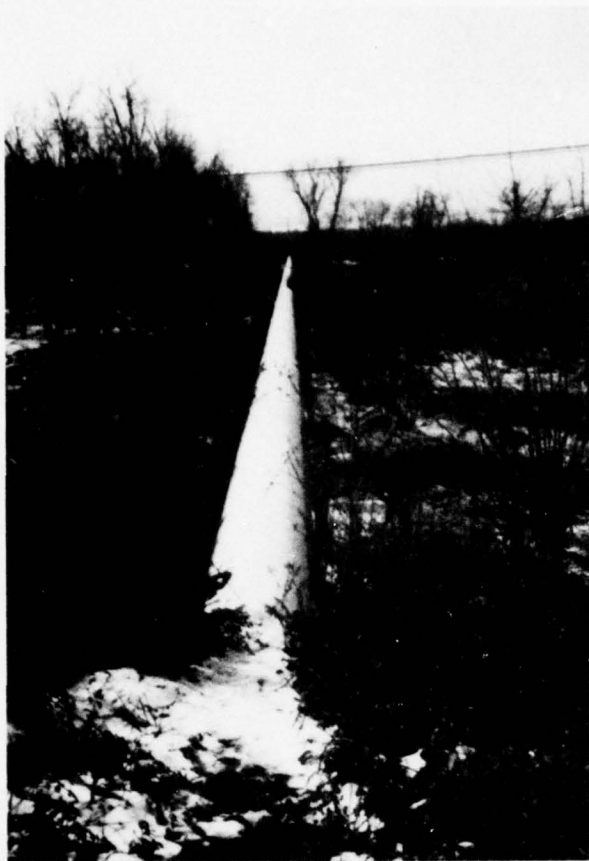
Photo 9 - 48-inch
transfer pipeline
to Canoe Brook
Reservoir No. 2.
(11-29-78)
