6  
National Dam Inspection Program. Twin  
Lakes Number 1 Dam (NDS PA-00487,  
Pennder 65-42), Ohio River Basin, Little  
Crabtree Creek, Westmoreland County,  
Pennsylvania. Phase I Inspection  
Report.

TWIN LAKES NO. 1 DAM

PHASE I INSPECTION REPORT  
NATIONAL DAM INSPECTION PROGRAM

11 APR 1979

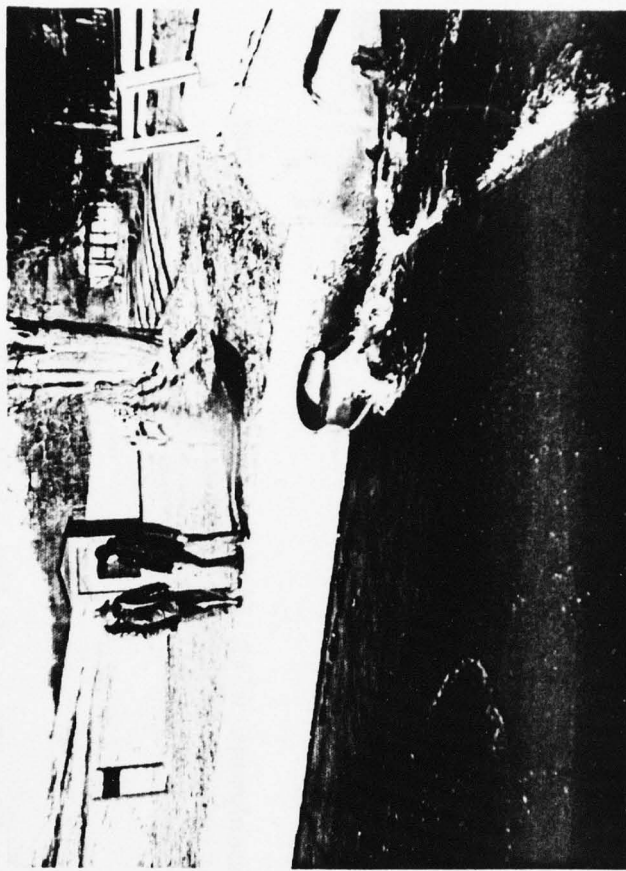
A manhole located on the crest just left of the spillway provides access to a 30-foot vertical reinforced concrete shaft, the bottom of which houses the manually operated gate valve. An extension on the valve stem permits operation from the top of the manhole. At the time of the inspection, the manhole was filled with water to elevation 1085.1 or approximately 5.9 feet below normal pool (see Photograph 10). Despite the flooded condition, the valve was operated by county personnel in the presence of the inspection team. The valve appeared to function normally as water was observed issuing from the outlet conduit at the base of the spillway channel (see Photograph 4).

PHOTOGRAPH 4 View of outlet works discharging near toe of spillway.

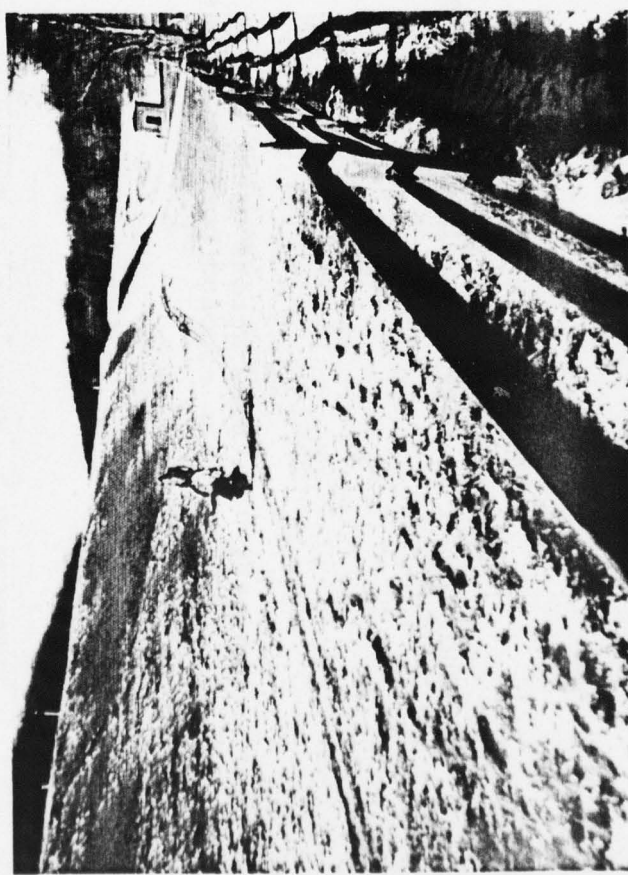
b. Embankment. The visual inspection suggests the embankment to be in good condition. Minor seepage, however, was observed along the downstream toe, particularly to the right of the spillway section (see Photograph 3). Despite the localized saturated areas, no signs of sloughing, erosion, or free flowing water were observed on or immediately below the embankment. A slag-gravel roadbed protects the crest against damage from occasional vehicular use. The downstream slope is covered with grass that requires little maintenance other than occasional mowing (see Photograph 1). The riprap is durable and well graded and provides adequate slope protection.

PHOTOGRAPH 3 View looking west along the downstream toe of the embankment. Inspection team personnel are within areas of noticeable saturation.

d. Monitor wet areas across the downstream embankment face on a continual basis. If seepage increases or turbidity occurs, the condition should be evaluated and necessary remedial measures implemented.

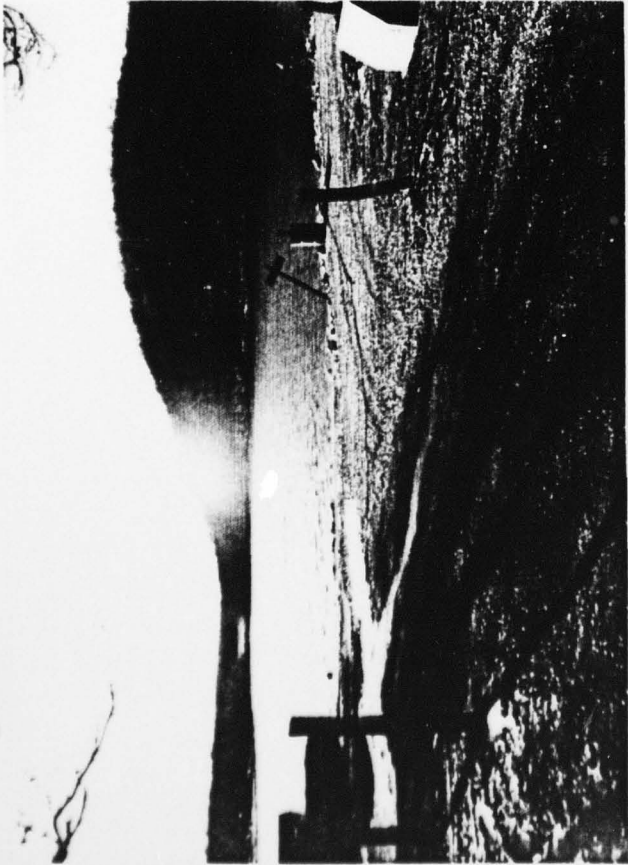
9

d. Reservoir Area. The general area surrounding the reservoir is characterized by gentle to moderate slopes that are partially wooded. No signs of slope distress were observed (see Photograph 9).

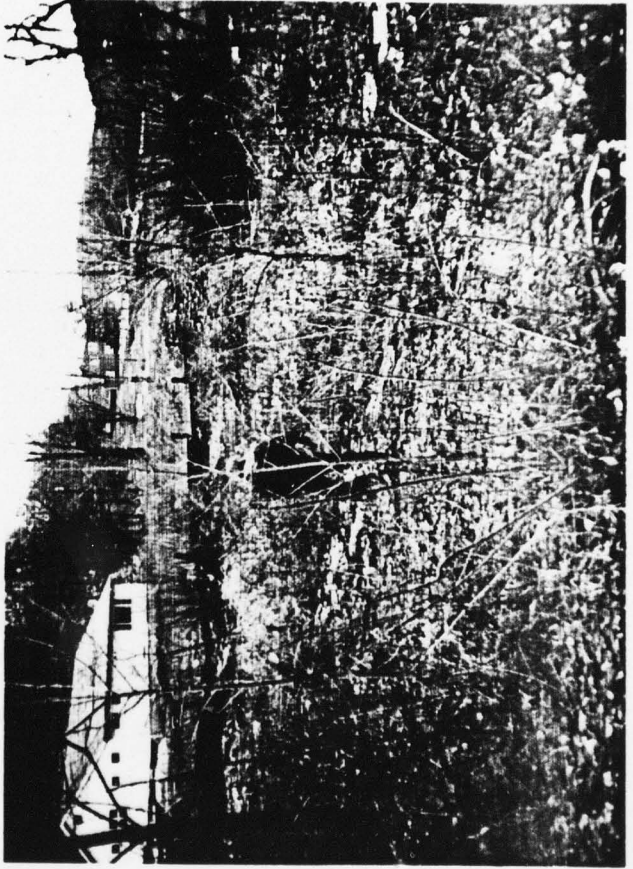
11

Flow discharged into the stream beyond the embankment follows a gently sloping course through a lightly wooded rural area. Approximately 2,500 feet downstream of the dam is the first house that could be affected by a dam failure (see Photograph 11). Many mobile homes are also located within the floodplain in this area. It is estimated that within this reach more than one hundred people could be affected by an embankment breach. Therefore, the hazard classification of the facility is considered to be "high".

View, looking south, of a permanent dwelling approximately 2,500 feet downstream of the dam.
