SUSQUEHANNA RIVER BASIN
BEAR RUN, CLEARFIELD COUNTY

PIKE TOWNSHIP
MUNICIPAL AUTHORITY
DAM

NDS I. D. No. PA-00916
PENNDER I. D. No.17-111

PHASE I INSPECTION REPORT
NATIONAL DAM INSPECTION PROGRAM

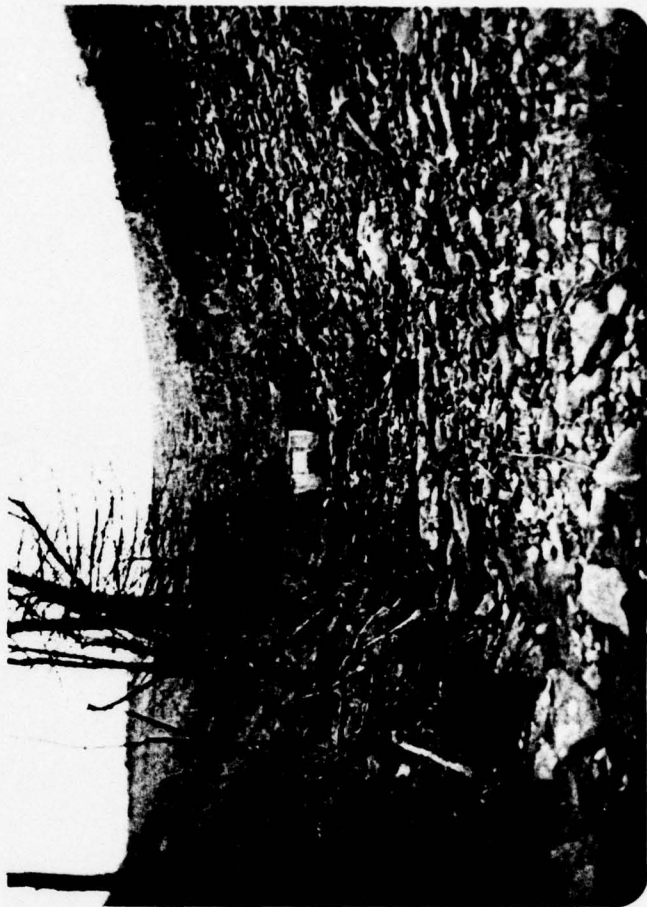
PHOTOGRAPH 4 View of the outlet structure.

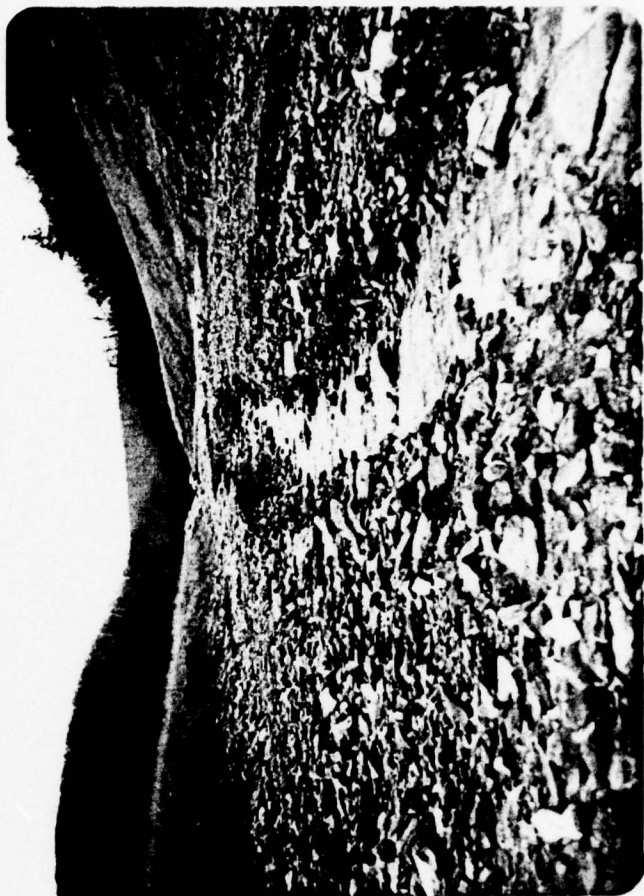
1. Spillway. A single structure has been provided for the facility which operates as both the service and emergency spillway. Visual inspection indicated that it is in poor condition having deep erosion gullies (8 feet deep) immediately downstream of the heavily riprapped segment (see Figures 1 and 3). Active sliding of the left channel wall is also evident and is possibly related to loss of toe support from spillway downcutting. The slide is shown in Photographs 7 and 8.

PHOTOGRAPH 8 View looking upstream through the spillway channel with the slide evident in the upper-right corner.

c. Monitor the movement of the slide on the left abutment. If movement becomes excessive, remedial measures are warranted for protection of the spillway channel.

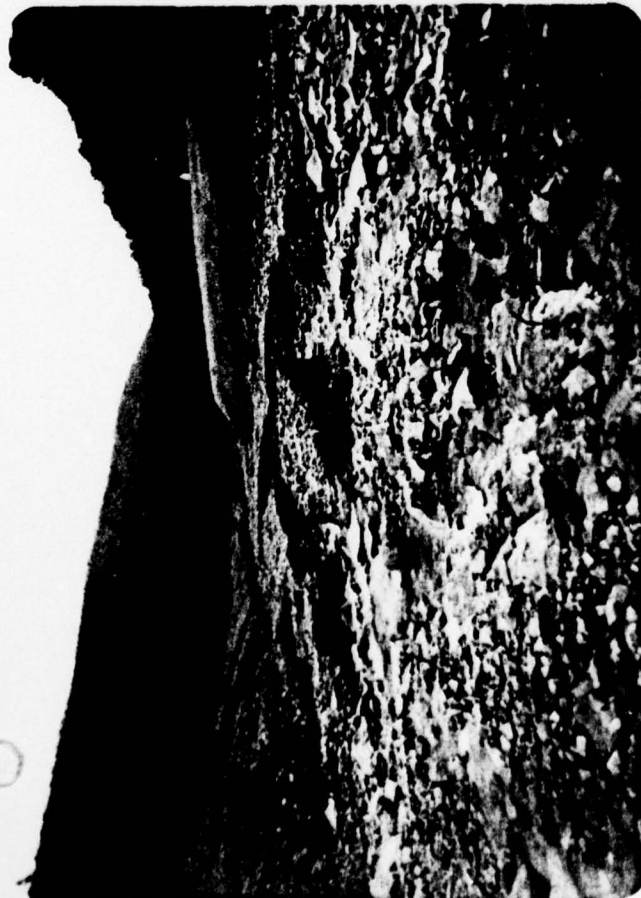
On the date of inspection, severe erosion was observed in the spillway channel as well as instability of the natural slope that forms the left wall of the spillway. In addition, an access road has been constructed through the spillway along the left abutment thereby reducing the spillway capacity.

PHOTOGRAPH 5 View looking downstream from the spillway control slab showing erosion in spillway channel.

b. Complete the current spillway evaluation and take appropriate remedial measures to ensure both the structural and hydraulic adequacy of the system.

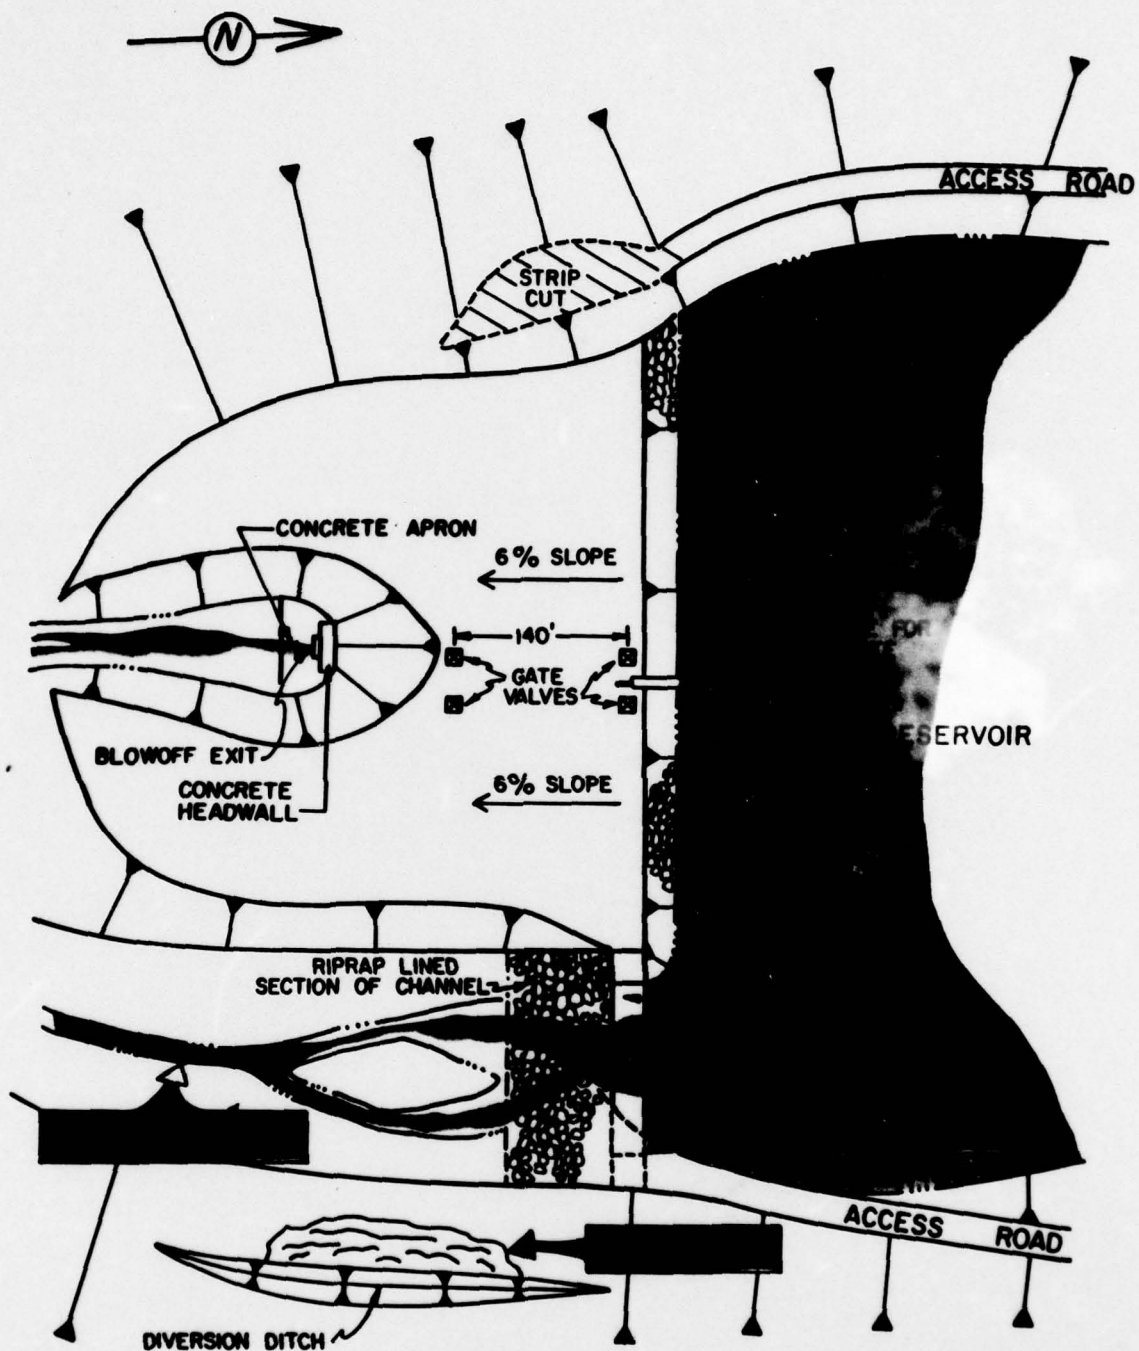
FIGURE 1 - PIKE TOWNSHIP MUNICIPAL AUTHORITY DAM
GENERAL PLAN
FIELD INSPECTION NOTES

2. Outlet System. Discharges through both the supply and blowoff conduits are controlled by a system of gate valves, all of which are manually operated from the crest (see Figure 1). There are two gate valves on each line located approximately 140 feet apart. In addition, the blowoff conduit is equipped with a sluice gate that is controlled by a manual operator, also accessible from the crest. The operator appeared to be in an open position and its condition appeared satisfactory. The outlet end of the discharge pipe is capped with a flap valve and is also in satisfactory condition. No deficiencies were noted that would indicate the system could not operate satisfactorily, if required.

b. Appurtenant Structures. The open channel spillway system has been troublesome since completion. At the time of inspection, severe erosion was evident in the spillway channel and instability of the slope forming the left channel wall was observed (see Figure 1).
