LITTLE SHENANGO DAM

(PA 490)

# PHASE I INSPECTION REPORT

NATIONAL DAM INSPECTION PROGRAM

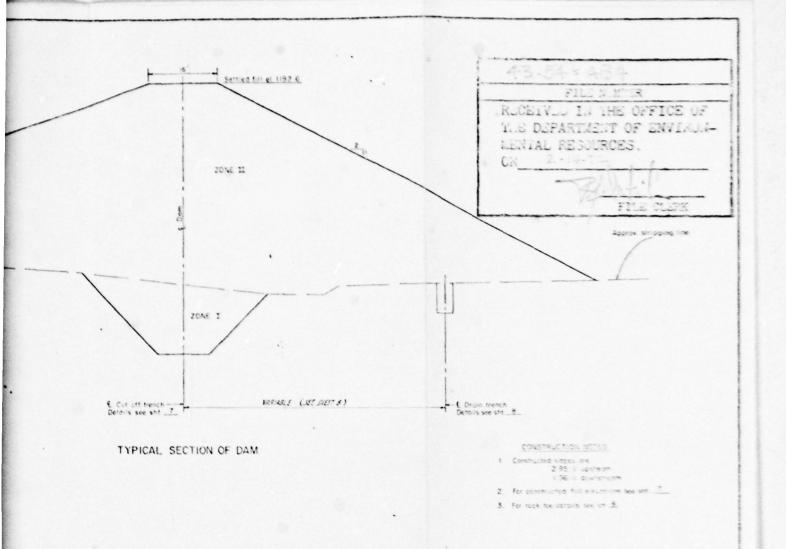
PLATE 4

A foundation cutoff trench was constructed with a base width of 12 feet, 1H:1V side slopes, a length of about 100 feet, and a maximum depth of about 10 feet to glacial till or bedrock (Plates 4, 6, and 7). Cutoff trenches of similar cross-section were also constructed to shallower depths in the abutments (Plate 7).

A 4-foot wide foundation drain trench containing granular material was installed to a maximum depth of about 8 feet beneath the downstream toe of the dam (Plates 4 and 8). Sections of this trench in the valley bottom contain 12-inch diameter perforated corrugated metal collector pipes which discharge from the sides of the reinforced concrete outlet
