6 National Dam Inspection Program, Colyer  
Lake Dam (NDS ID Number PA-00448,  
PennDer ID Number 14-112), Susquehanna  
River Basin, Sinking Creek, Centre  
County, Pennsylvania.

Phase I Inspection Report.

GAI CONSULTANTS, INC.  
570 BEATTY ROAD  
MONROEVILLE, PENNSYLVANIA 15146

APRIL 1979

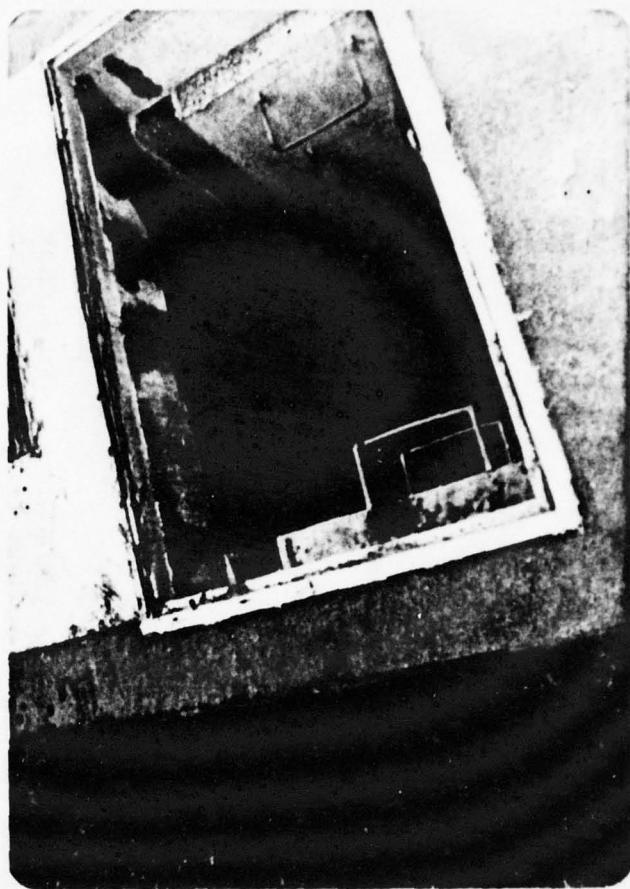
2. Outlet Conduit. Discharge through the outlet works at Colyer Lake Dam controlled by stop logs within the vertical riser (see Photograph 4). The Fish Commission was lowering the reservoir level at the time of inspection; consequently, only the exposed portion of the vertical riser could be inspected. Field team members did enter the horizontal portion of the 4-foot square outlet conduit to a point about 10 feet from the vertical riser. Cracking and efflorescence were observed within the conduit approximately 10 to 15 feet downstream of the riser (Figure 7 indicates a concrete cutoff collar extends into rock in this area).

PHOTOGRAPH 4 Close-up view of the concrete vertical riser portion of the outlet works. Note the stop logs laying to the left of the riser.

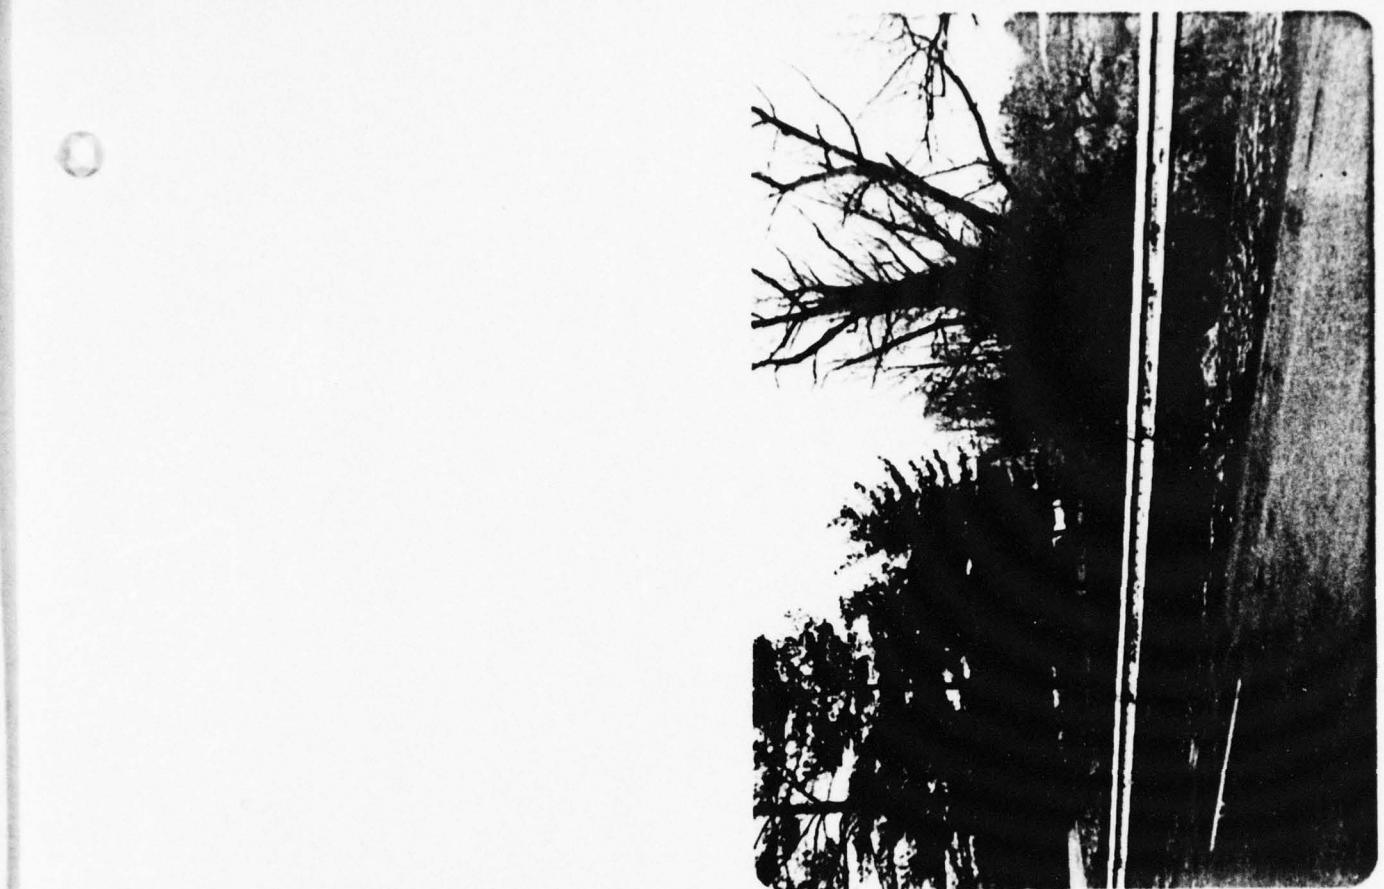
PHOTOGRAPH 10 View of a bridge over Sinking Creek located approximately 2,500 feet downstream of the dam. The bridge represents the first downstream obstruction. Note the home in the left center portion of the photograph.

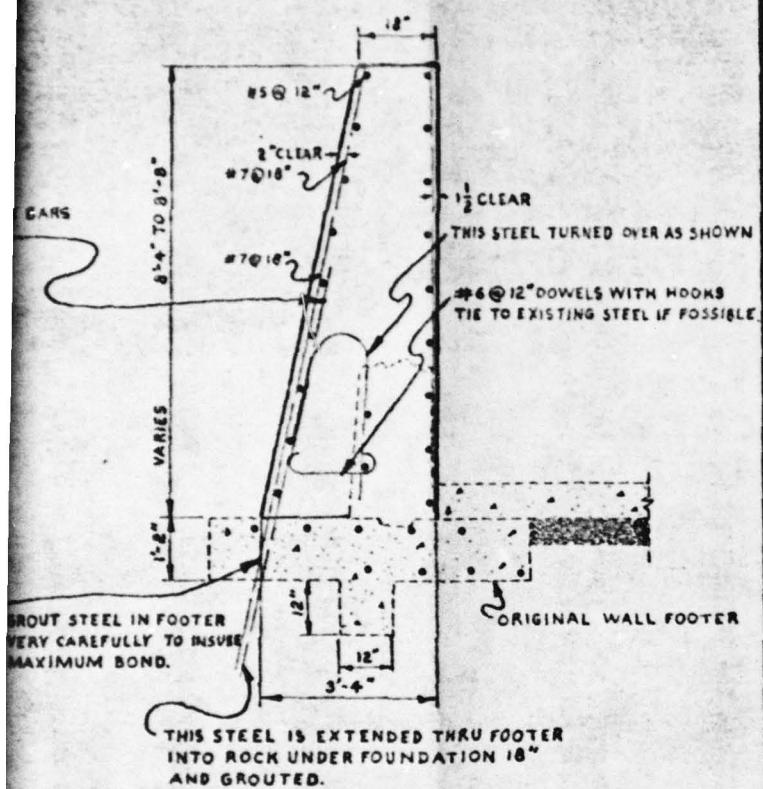
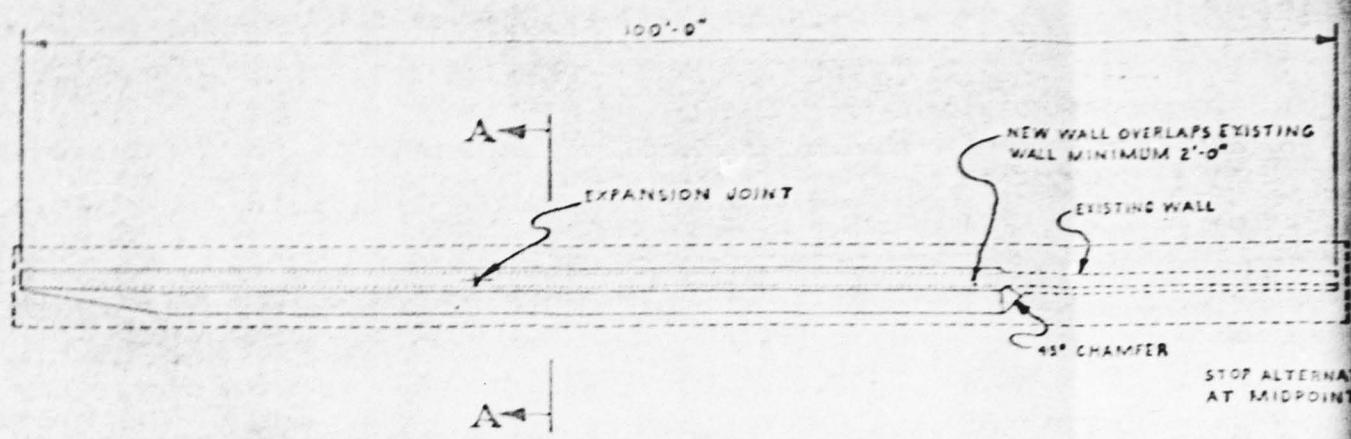
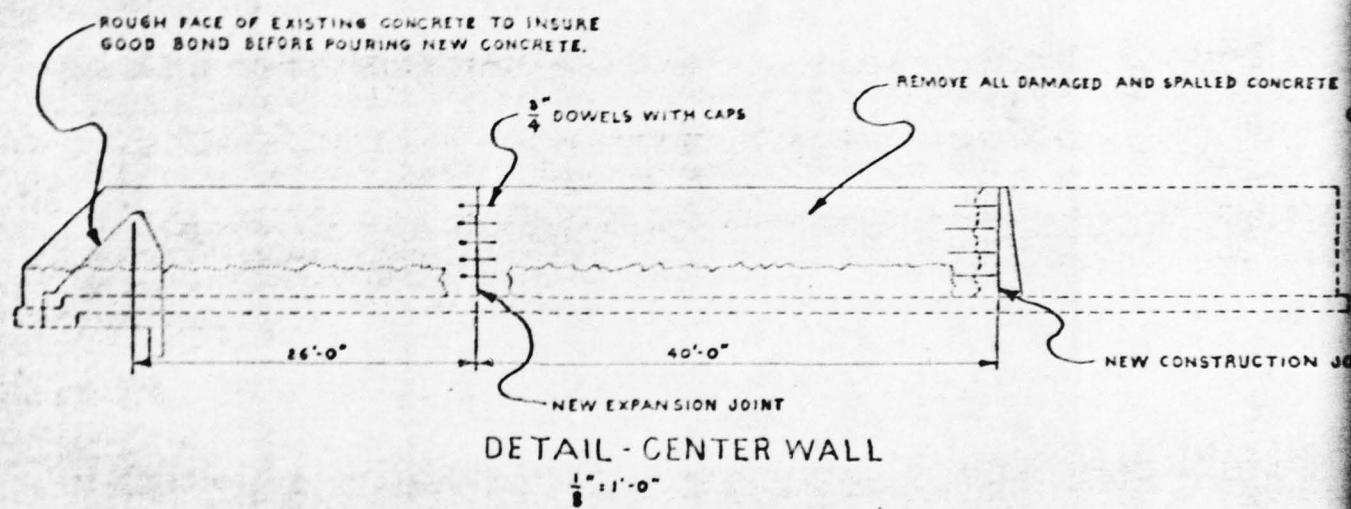
REVISED	
COMMONWEALTH OF PENNSYLVANIA PENNSYLVANIA FISH COMMISSION ENGINEERING DIVISION - BELLEFONTE R.D.3, PA. <b>REPAIRS TO CENTER WALL AT SPILLWAY</b> AT <b>COLYER DAM</b> POTTER TWR - CENTER CO., PENNA.	
DRAWN BY: J.W.B.	SCALE:
DATE: 5-7-68	AS NOTED
APPROVED BY: R.R.F.	FIGURE 11
DATE: 5-10-68

At the time of inspection, the Pennsylvania Fish commission was drawing down the reservoir so as to drain the forebay of the spillway. This is done every winter to reduce ice pressures on the wall separating the trapezoidal weir section and flume section of the spillway. The wall was replaced in 1968 following ice damage (see Figure 11).

b. Appurtenant Structures. In 1968, the wall separating the trapezoidal weir section and flume section of the spillway was replaced following damage incurred from ice pressures within the forebay. Since that time, the Pennsylvania Fish Commission has lowered the water level about 4 feet in the late autumn to drain the forebay prior to the winter season.

ALL DOWELS AND ROSS WERE GROUTED WITH "POR-ROK"  
A FAST SETTING CEMENT AS MANUFACTURED BY  
HALLEMITE MANUFACTURING CO. BEFORE NEW CONCRETE  
WALL WAS Poured.

MAKE SURE ALL EXPOSED CONCRETE IS CLEAN AND  
WET DOWN BEFORE POURING NEW CONCRETE.
